The December 2020 magnitude (Mw) 6.4 Petrinja earthquake, Croatia: seismological aspects, emergency response and impacts

Source / Izvornik: **Bulletin of earthquake engineering, 2023, 21, 5767 - 5808**

Josip Atalić¹ · Marija Demšić¹ · Maja Baniček² · Mario Uroš¹ · Iva Dasović³ · Snježan Prevolnik³ · Alen Kadić² · Marta Šavor Novak¹ · Miroslav Nastev⁴

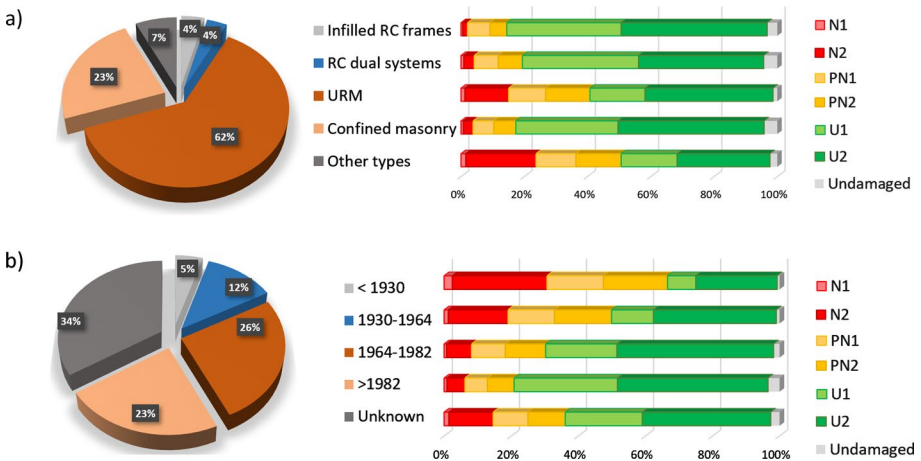
Extensive damage to buildings was widespread in Petrinja, the nearby towns of Glina and Sisak, as well as throughout the rural settlements of the Sisak-Moslavina County. Based on the inspection results, the most damaged buildings were of unreinforced masonry (URM), followed by confined masonry (CM), while the reinforced concrete (RC) structures (consisting of approximately equal parts of infilled frames and dual systems) sustained much lesser damage (Fig. 6a). The building category referred to as “other types”, which accounts for 7% of damaged buildings in this figure, includes traditional wooden houses as well as mixed structural systems, e.g., wood and URM or partially confined masonry (Fig. 25). However, it was observed that the latter building category was frequently classified as the more resistant CM in the inspection forms. The confusion resulted because the inspection form did not provide explicit option for this peculiar typology, however, specific to a relatively large number of buildings. Due to the insufficient time and accelerated training, only a part of the experts managed to recognize these buildings as “other types”. As mentioned in Chapter 2, the partially confined masonry buildings disregard standard engineering practices and seismic regulations resulting in critical structural deficiencies. Furthermore, it should be mentioned that no damage to steel structures was reported, also the inspection of the industrial steel structures of the oil refinery in nearby town Sisak and the industrial plant in Kutina, located about 40 km from Petrinja, did not reveal any significant structural damage caused by this earthquake.

Another important statistical indicator correlated to the usability of buildings is the year (period) of construction. The graphs shown in Fig. 6b clearly indicate that buildings built before 1930 have sustained the most significant structural damage. The damage percentage decreases gradually for more recent structures due to the improvement of the construction practices with the introduction of the new and improved construction standards and seismic regulations.

Fig. 6 Data on building usability assessments in the affected area with respect to: **a** most common structural systems, and **b** period of construction (CCEE 2022)

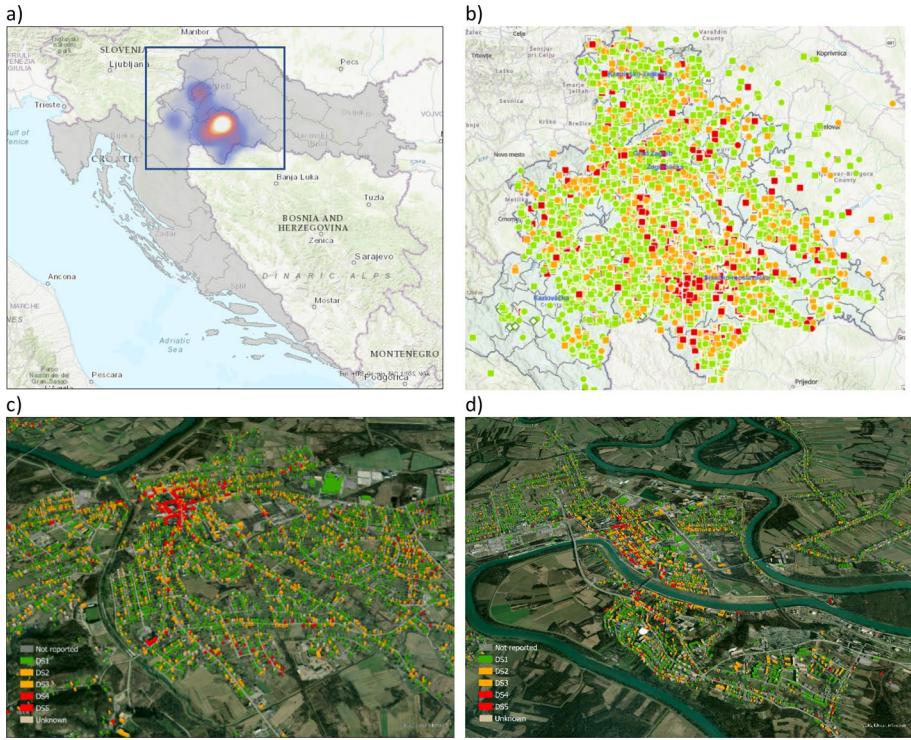
Fig. 7 Building inspection results: **a** heatmap of the affected area, **b** usability assessments in the central Croatia, **c** spatial distribution of structural damage in Petrinja according to EMS-98 scale, **d** spatial distribution of structural damage in Sisak according to EMS-98 scale. The usability states in **(b)** are indicated with: green—usable, yellow—temporarily unusable, red—unusable. The damage states in **(c)** and **(d)** are negligible damage DS1, slight to moderate damage DS2 and DS3, and heavy to very heavy damage DS4 and DS5. (CCEE 2022)

Figure 7a presents the heatmap of the affected area, while the usability assessments for the most affected region of the Central Croatia (marked with blue rectangle in Fig. 8a) are given in Fig. 7b. The spatial distribution of damage in the towns of Petrinja and Sisak

according to the inspection results is shown in Fig. 7c and d. It clearly points out the concentration of damage in the historical centers where mostly URM buildings built in the late 18th and first half of the nineteenth century are located.

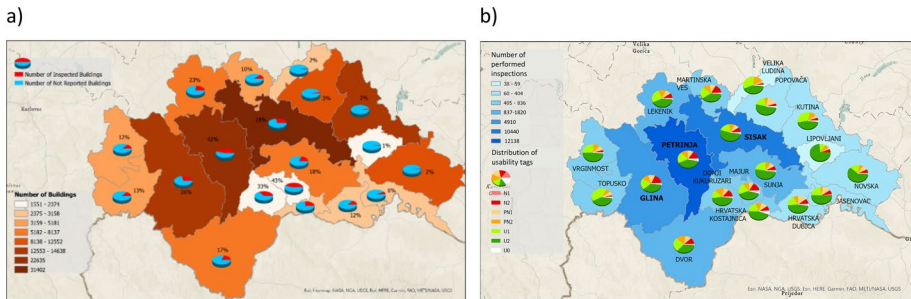
Fig. 8 Building inspection results for Sisak-Moslavina County: **a** percentage of inspected buildings; **b** usability assessment results by municipalities (CCEE 2022)

In the Sisak-Moslavina County only (Fig. 8), 38,320 inspections were conducted with 4,745 red-tagged buildings (N1 1% and N2 11%), 8,397 yellow-tagged (PN1 10% and PN2

12%), 24,475 green-tagged (U1 19% and U2 45%), while 703 inspected buildings showed no damage (U0 1%). In Fig. 8a, the pie chart shows the ratio of inspected buildings to all buildings in the municipalities of Sisak-Moslavina County, while the total number of buildings in a municipality is indicated by shades of brown. In Fig. 8b, the pie chart presents the distribution of the usability assessment results in performed inspections, while the total number of performed inspections in the municipalities is indicated by shades of blue. Obviously, due to its proximity to the epicenter, the municipality of Petrinja was the most affected. Out of the 12,138 buildings inspected there, 15% were red-tagged, 24% yellow-tagged, and 59% green-tagged.

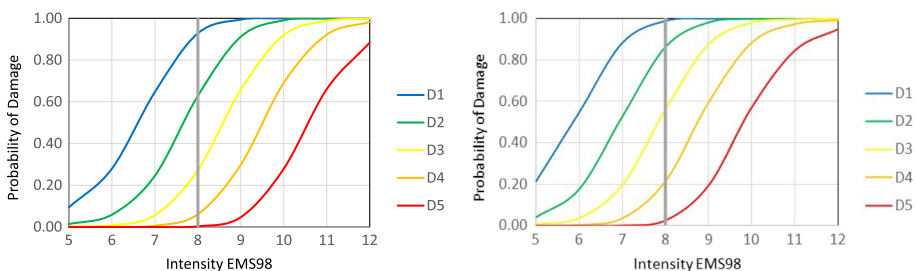
From Fig. 16, it may be observed that for the intensity VIII EMS there is about 7% probability of no damage, 30% of negligible to slight damage, 36% of moderate damage, 21% probability of substantial to heavy damage, 6% probability of very heavy damage and almost no probability of collapse for the low-rise URM buildings with RC slabs.

Fig. 16 Fragility curves in intensity for buildings of M34L type (left) and M31L type (right)
