The December 2020 magnitude (M_w) 6.4 Petrinja earthquake, Croatia: seismological aspects, emergency response and impacts

Josip Atalić¹ · Marija Demšić¹ · Maja Baniček² · Mario Uroš¹ · Iva Dasović³ · Snježan Prevolnik³ · Alen Kadić² · Marta Šavor Novak¹ · Miroslav Nastev⁴

Received: 5 October 2022 / Accepted: 3 August 2023 / Published online: 28 August 2023
© The Author(s) 2023

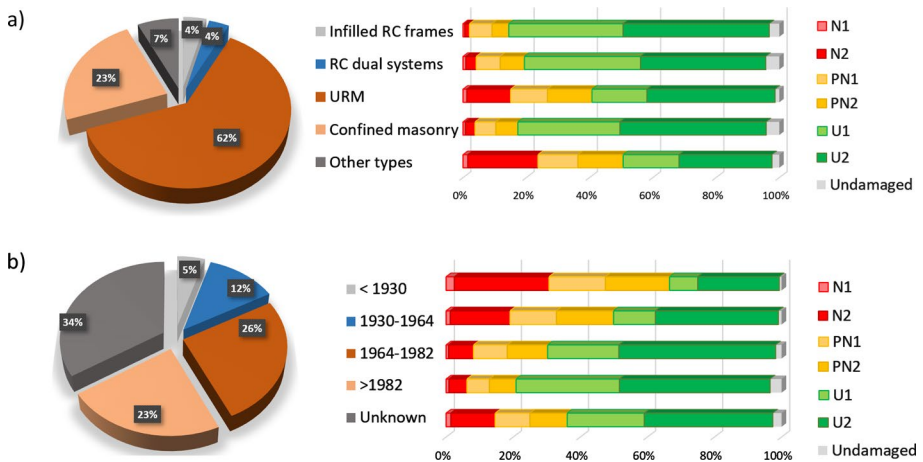
Extensive damage to buildings was widespread in Petrinja, the nearby towns of Glina and Sisak, as well as throughout the rural settlements of the Sisak-Moslavina County. Based on the inspection results, the most damaged buildings were of unreinforced masonry (URM), followed by confined masonry (CM), while the reinforced concrete (RC) structures (consisting of approximately equal parts of infilled frames and dual systems) sustained much lesser damage (Fig. 6a). The building category referred to as “other types”, which accounts for 7% of damaged buildings in this figure, includes traditional wooden houses as well as mixed structural systems, e.g., wood and URM or partially confined masonry (Fig. 25). However, it was observed that the latter building category was frequently classified as the more resistant CM in the inspection forms. The confusion resulted because the inspection form did not provide explicit option for this peculiar typology, however, specific to a relatively large number of buildings. Due to the insufficient time and accelerated training, only a part of the experts managed to recognize these buildings as “other types”. As mentioned in Chapter 2, the partially confined masonry buildings disregard standard engineering practices and seismic regulations resulting in critical structural deficiencies. Furthermore, it should be mentioned that no damage to steel structures was reported, also the inspection of the industrial steel structures of the oil refinery in nearby town Sisak and the industrial plant in Kutina, located about 40 km from Petrinja, did not reveal any significant structural damage caused by this earthquake.

Another important statistical indicator correlated to the usability of buildings is the year (period) of construction. The graphs shown in Fig. 6b clearly indicate that buildings built before 1930 have sustained the most significant structural damage. The damage percentage decreases gradually for more recent structures due to the improvement of the construction practices with the introduction of the new and improved construction standards and seismic regulations.

Fig. 6 Data on building usability assessments in the affected area with respect to: **a** most common structural systems, and **b** period of construction (CCEE 2022)
