# The December 2020 magnitude (Mw) 6.4 Petrinja earthquake, Croatia: seismological aspects, emergency response and impacts

*Source / Izvornik:* **Bulletin of earthquake engineering, 2023, 21, 5767 - 5808**

**Journal article, Published version**

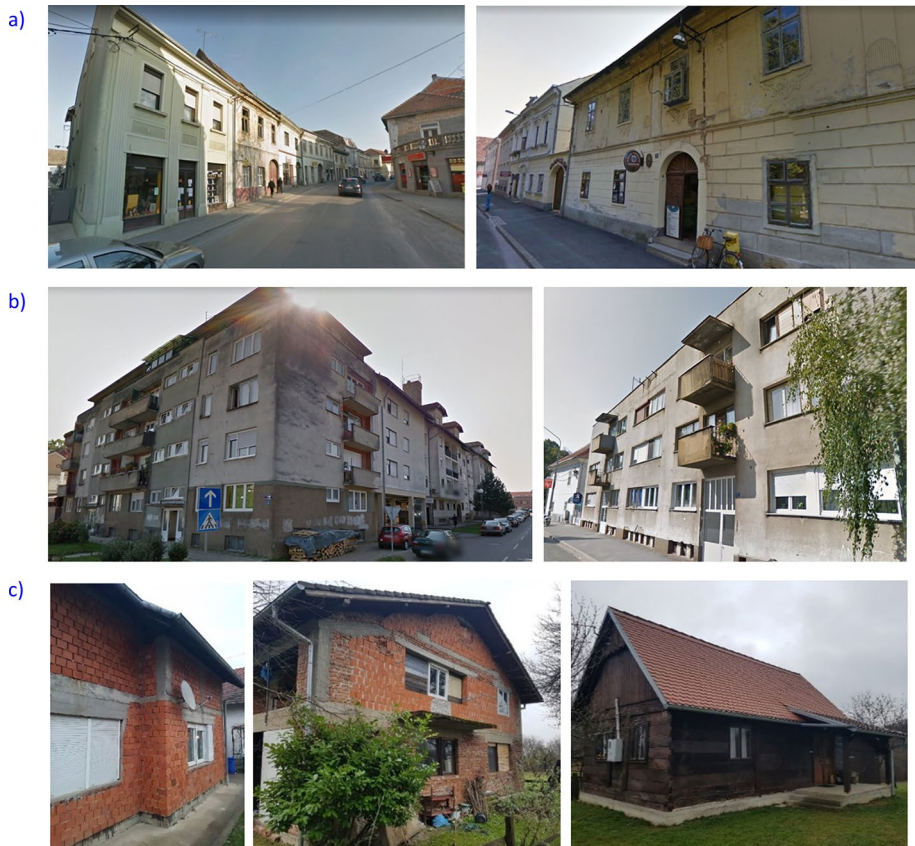
The older URM multi-apartment buildings, frequent in the urban areas, have a semi-precast floor structures of reinforced concrete and masonry with girders and ring beams, the so-called "fert" structure slabs (Fig. 2b). The number of stories varies from two to four. The roof structure in these buildings is made of timber trusses without stabilizing elements. On the other hand, the confined masonry buildings with vertical and horizontal confining elements and semi-precast floor structures started appearing mostly after 1995, as part of the post-war reconstruction. According to the seismic regulations at the time (SFRY 1981), valid until the introduction of Eurocode for the design of masonry structures in 2007, it was not mandatory for low-rise buildings to use confined masonry instead of unreinforced masonry. In other words, masonry structures without vertical confinement elements were allowed for up to G + 2, ground floor plus two storey buildings, in seismic zone VIII and up

**Fig. 2** City of Petrinja **a** URM buildings in the historic centre, **b** Multi-apartment masonry buildings, and **c** Single masonry and wooden residential buildings (Google Maps 2021, CCEE 2022)

In addition to URM and confined masonry buildings, in rural areas are typical the traditional wooden single-family residential buildings with one and rarely with two stories (Fig. 2c). They have a simple rectangular foot-print and the connection of the wooden walls is usually done with hardwood dowels. Often, they are accompanied by outbuildings, which are usually made of poorer material and structural quality.
