Source / Izvornik: **Applied sciences (Basel), 2023, 13, 1 - 19**

Post-Earthquake Dynamic Performance of Intact Masonry Building Based on Finite Element Model Updating

As a case study, a building of a high school in Sisak (Figure 1) built in 1935 was taken. The building has four floors: basement, ground floor, and two upper floors. In the central part of the building there is a three-legged staircase with a landing. The foundations are constructed as a reinforced concrete slab. The load-bearing part of structure consists of walls made of solid bricks of 29(39) cm × 15 cm × 6.5 cm, floor slabs and reinforced concrete ribbed floor slabs. The thickness of the load-bearing walls in the basement is 60 cm and 75 cm, and 50 cm and 60 cm on the ground floor and upper floors. The partition walls are 15 cm, 18 cm, 25 cm or 30 cm thick and are made of hollow blocks. The floor slab is 25 cm thick and the reinforced concrete ribbed floor slab has a total height of 33 cm. The clear distance between the ribs is 60 cm, the width of the ribs is 13 cm, and the height is 23 cm. At the entrance of the building on the first and second floors, there is a load-bearing part of the structure that rests o

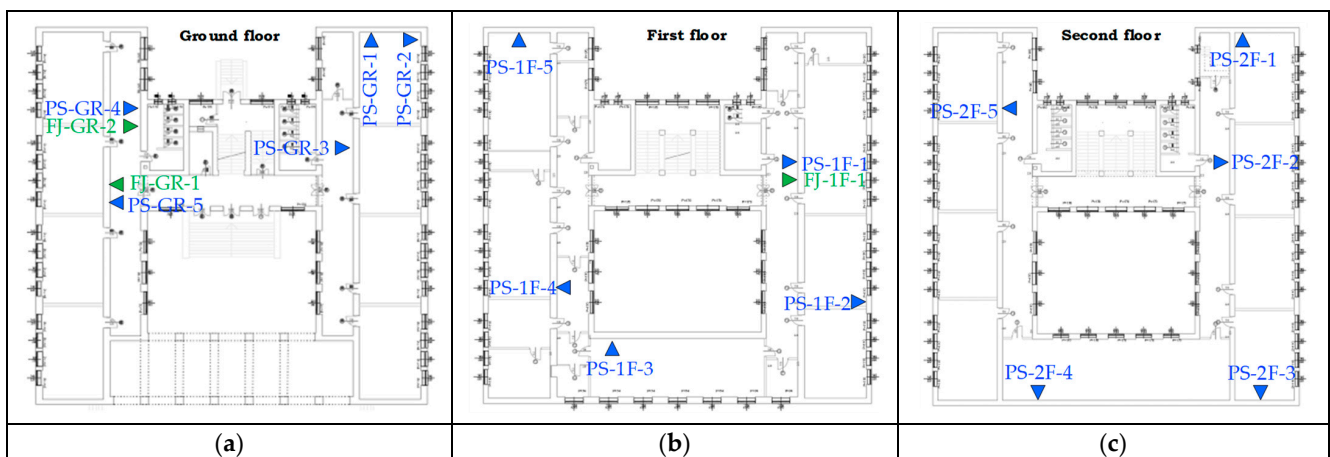
Figure 2. Measurement points for determination of mechanical properties of walls on the (a) Ground Floor (b) First Floor (c) Second Floor.

To determine the mechanical properties of bearing walls, a shear test and flat jack test were performed. As a result of conducted shear test [8], the shear strength, f_v^{exp} , with the contribution of normal compressive stress, σ_0^{exp} , is obtained. On the observed structure, a total of 15 measurement locations were selected (Figure 2), 5 at each floor in which the shear strength test was performed. The obtained test results are shown in Table 1.

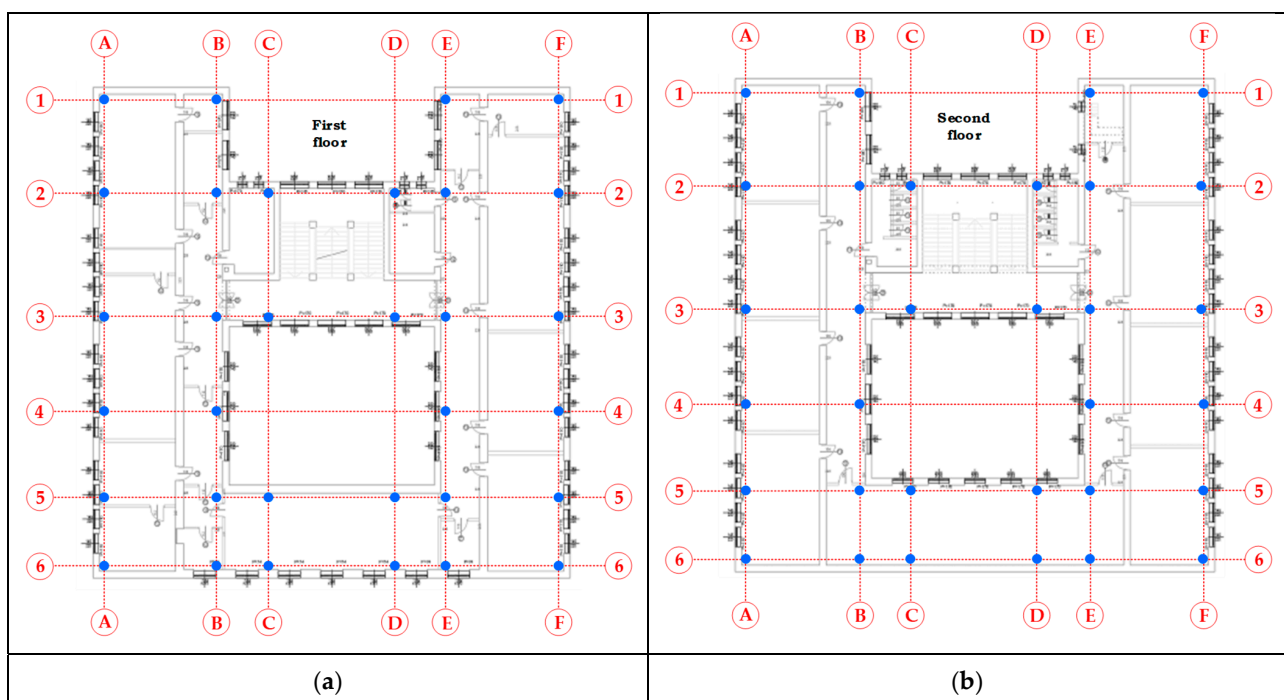
Figure 5. Arrangement of measurement points for determination of the structural dynamic properties at the (a) first and (b) second floor.

The structural response was measured during the ambient excitation. The reference point was located at the measurement point C3 on the second floor. Classical frequency domain decomposition (FDD) and enhanced frequency domain decomposition (EFDD) methods were used for estimation of structural dynamic properties, natural frequencies (Table 3, Figure 6), and mode shapes (Figure 7). The values of experimentally obtained frequencies for the concerned mode shapes were read from the characteristic record (Figure 6).

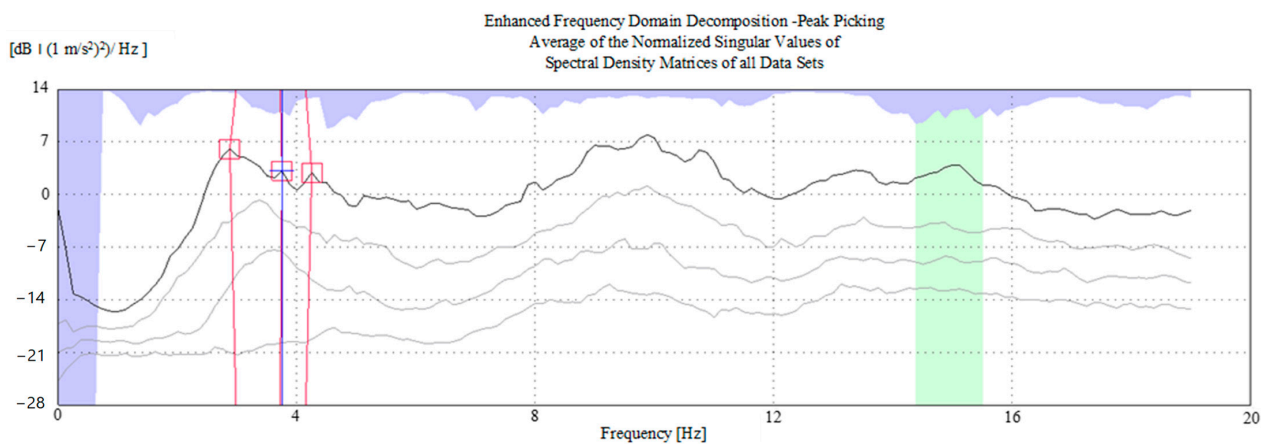
Mode <i>i</i>	$f_i^{exp} \pm st.dev.$
1	2.972 ± 0.10
2	3.742 ± 0.09
3	4.275 ± 0.27

Figure 6. Characteristic record of frequency domain decomposition (FDD) for the determination of natural frequencies.

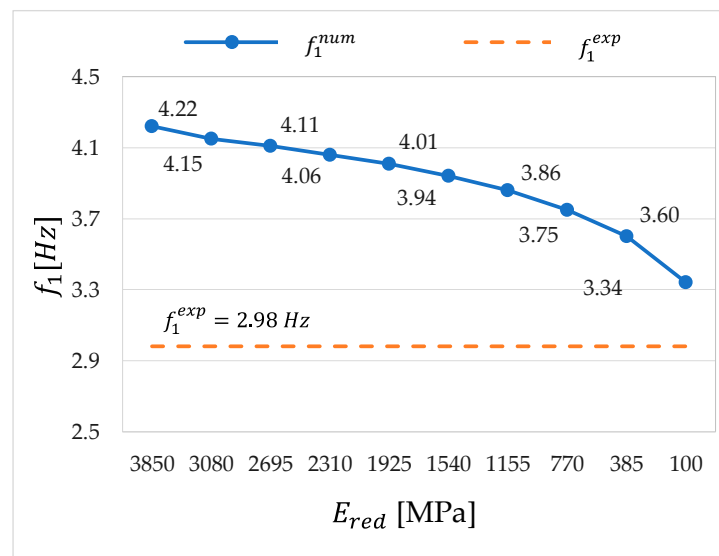
Based on the analysis (Figure 12) of the elasticity modulus reduction for the damage construction elements (E_{red}), a decrease in the first natural frequency (f_1^{num}) can be noticed. However, by imitating the damaged parts of the structure with finite elements with a reduced modulus of elasticity, satisfactory results were not achieved. Regardless of the fact that the previous iteration and analysis did not provide satisfactory results (matching values of numerically predicted and experimentally measured natural frequencies), in the next iteration, the simulation of damages in the specified load-bearing walls is retained.

Figure 12. Changes of the first natural frequency of the numerical Model 3 (f_1^{num}) for different levels of modulus of elasticity reduction (E_{red}) with the comparison of the experimentally obtained natural frequency (f_1^{exp}).
