Zagreb earthquake of 22 March 2020 – preliminary report on seismologic aspects and damage to buildings

Research Paper

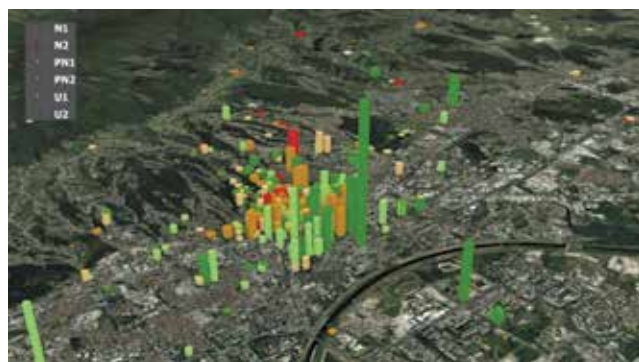
As already stated, the earthquake inflicted enormous damage to buildings belonging to the protected architectural heritage. These are highly valuable private and public sector buildings of various occupancy types, which represent cultural landmarks of the City of Zagreb (Table 1, Figure 31). The damage was mostly inflicted to gable walls and roof structures with chimneys. There follows internal damage to structural elements, mostly vaults, lintels and, less often load bearing walls, mostly at connection with flexible timber floor structures.

Figure 31. Damage to cultural heritage buildings according to usability tags (colours) and gross floor area (columns) on 3D aerial view of the City of Zagreb
