Source / Izvornik: **Građevinar, 2020, 72, 843 - 867**

## Zagreb earthquake of 22 March 2020 – preliminary report on seismologic aspects and damage to buildings

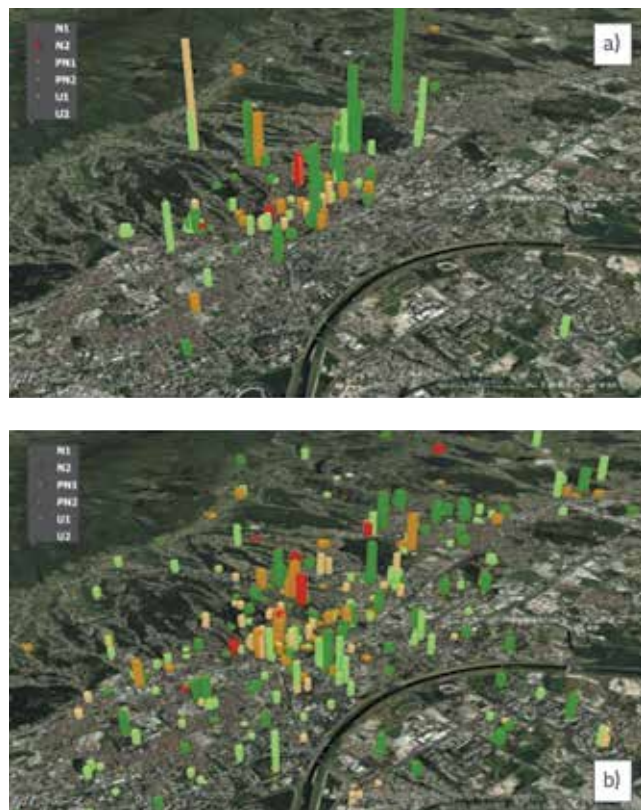
because the works will have to be carried out in accordance with appropriate conservation-restoration requirements. Damage assessments of critical infrastructure (hospitals, schools, faculties, and kindergartens) are shown in Figure 35 according to the level of damage (colour) and gross area (column height). A detailed presentation of two examples of damage to hospitals is given below.

Figure 35. Damage to buildings according to usability tags (colours) and gross floor area (columns) on 3D aerial view of the City of Zagreb for the sectors of a) healthcare and b) education
