Analysis of Tram Traffic-Induced Vibration Influence on Earthquake Damaged Buildings

Keywords: tram track; vibrations; earthquake; masonry structure; vulnerability

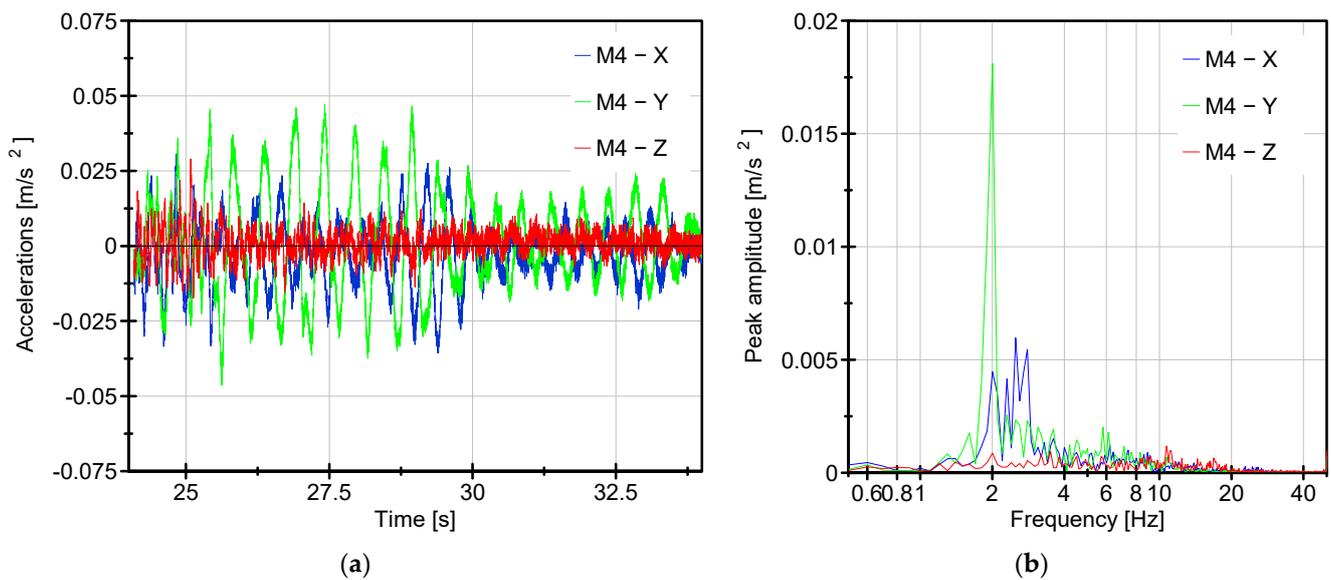
Figure 15. Accelerations represented in (a) time and (b) frequency domains, 3.1 (ML) earthquake structure response on the 3rd floor, M4.
