Evaluation of tramway overhead line system in city of Osijek

Ivo Haladin^{1*}, Stjepan Lakušić¹, and Ivan Duvnjak²

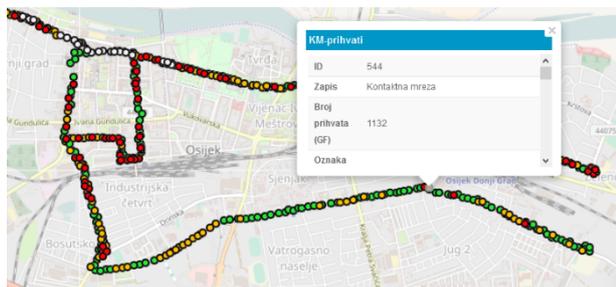
Fig. 1. Acquired GIS dataset of 1214 analysed supports.

According to analysis, 20 % of columns were characterized as substantially damaged (bent out of vertical axis, corrosion damage, shrapnel damage etc.), as presented in Figure 2; 32 % endangered (minor corrosion or dents); 48 % in good state (not bent, no corrosion or dents).

Conducted measurements and further analysis revealed weak spots and sections in overhead line system that are to be replaced or reconstructed due to weakened or damaged support columns (around 20%), worn overhead wire and elevated level of vibrations and shocks on vehicle pantograph. Furthermore recommendations for correction of overhead line alignment in terms of height and stagger have been given for more than 2000 m of track. Priority levels for reconstruction have also been determined.
