Evaluation of tramway overhead line system in city of Osijek

Abstract. Overhead line system is a vital element of any electrified railway infrastructure. Its performance reflects to all vital parameters such as traction, reliability, availability and safety of railway infrastructure. Operator GPP Osijek runs a 27.5 km long tramway network which plays a key role in transit system of the city of Osijek, Croatia. In 2016 GPP Osijek applied to a tender for acquisition of new rolling stock with 85% EU investment. Mayor requirement prior to rolling stock acquisition was to document, analyse and upgrade current infrastructure (including track structure, electric substations and catenary) to an optimal level. Task of measurement and evaluation of tram track structure and catenary has been appointed to University of Zagreb Faculty of Civil Engineering. Overhead line analysis comprised from several measuring procedures, including supporting columns evaluation, catenary stagger, height, shocks and wear. Such extensive analysis included GPS positioning and on-site evaluation of 1214 supporting columns of overhead line, as well as overhead line measurements using an instrumented tram vehicle o

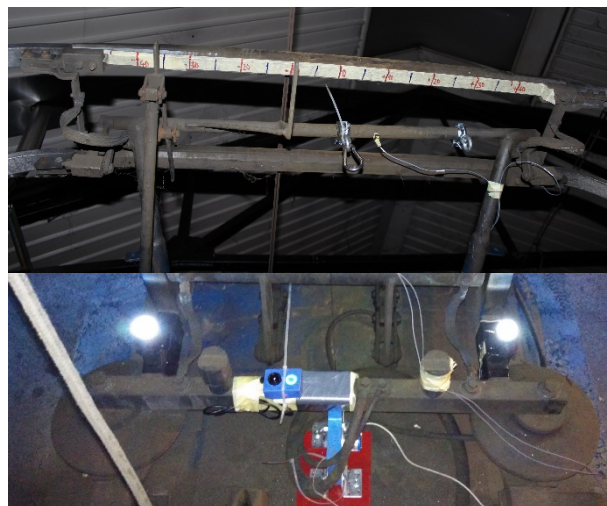
Fig. 7. Overhead wire stagger measurements using camera and measuring strip on the head and camera in the base.

During a tram pass by over 18 km of track, a video camera was used to record the pantograph head with a measuring strip attached to it, to record the stagger of the overhead wire in lateral direction, Figure 7.
