# Case-study of the out-of-plane wall failure of a typical downtown building in Zagreb

*Source / Izvornik:* **1st Croatian Conference on Earthquake Engineering 1CroCEE, 2021, 1557 - 1567**

### 3 Case study: Building in Mrazoviceva street

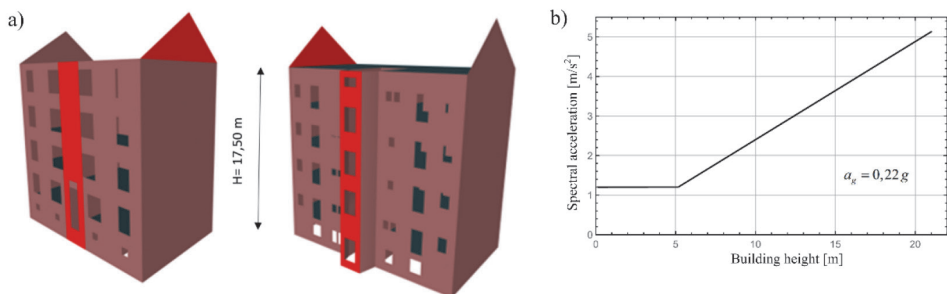
Figure 6.a) shows a three-dimensional view of selected walls that are analysed. All walls were modelled as single rigid block since there is no strengthening elements in the levels of floors that could lead two body motion. For all mechanisms, the plan of virtual displacement is determined for the unit value of control node displacement. This point is also used as control point in the nonlinear analysis. Detail numerical model of the build-

Figure 6. a) 3D view of the analyzed mechanism; b) Acceleration level requirement

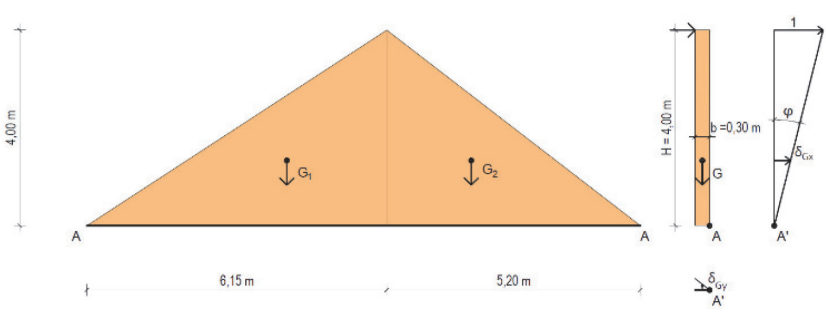
Table 1. Mechanism 1 – attic gable wall

| | | |
|---|---|---|
| $G_1 = 66,42 \text{ kN}; G_2 = 56,16 \text{ kN}$<br>$\delta_{G1,x} = \delta_{G2,x} = 0,333, \delta_{G1,y} = \delta_{G2,y} = 0,037$<br>$z = 17,50 \text{ m}$ | $\alpha_0 = 0,11; a_0^* = 0,81 \text{ m/s}^2$<br>$a_{0,\min}^* = 4,75 \text{ m/s}^2$<br>$a_0^* / a_{0,\min}^* = 0,17$ | $d_{k,0} = 0,45 \text{ m}; d_0^* = 0,15 \text{ m}$<br>$d_u^* = 0,66 \text{ m}; d_s^* = 0,024 \text{ m}$<br>$T_s = 1,18 \text{ s}$<br>$d_{u,\min}^* = 0,3 \text{ m}$<br>$d_u^* / d_{u,\min}^* = 0,2$ |

For mechanism 1, only 17 % of the linear model demand and 20 % of the nonlinear model demand is fulfilled. This wall, however, only partially collapsed in the earthquake in March 2020. The model used in the analysis assumes complete separation of the wall from the rest of the structure, but it can be seen from the photographs on Figure 5. a) and b) that in the thirds of the length the wall was thickened with an additional layer of bricks, that certainly helped to prevent complete separation. It should be noted that cracks exist in these parts of wall that are visible from the outside (Figure 5.b). We also emphasize here that the main direction of the earthquake that happened, was approximately parallel to the gable wall plane, which certainly influenced the maximum value of the acceleration that affected this wall. The same wall was analysed in mechanism 2 where it includes the part of the wall on the storey below the attic. In the linear model, there is the fulfilment of 12 % of the demand, while the displacement capacity demand is fulfilled with 47 %. For this wall the connections with perpendicular walls is not completely impaired, so there are some reserves in terms of friction force that is present at the junction of the walls that was not considered in the analysis. The results of street façade wall considered in mechanism 3 showed that the wall should have been most likely activated during earthquake since linear model had fulfilment of 30 %. However, in the nonlinear model, the model had almost complete fulfilment of the demand that was 98 %. This wall, unlike the gable wall, was exposed to a greater acceleration values when considering the main direction of the earthquake. The façade wall on the courtyard side, mechanism 4, have satisfied requirement of the linear model so it was concluded that it was not activated in earthquake, therefore, the nonlinear model was not considered.

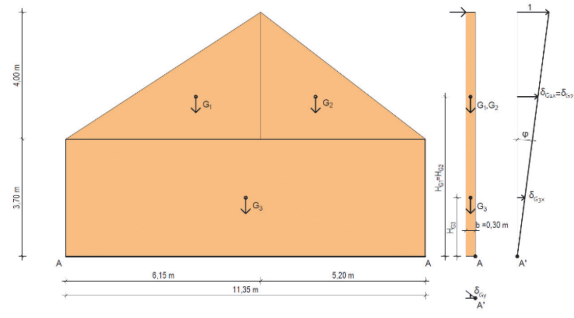
Table 2. Mechanism 2 – gable wall of 3<sup>rd</sup> floor including attic

| | | |
|---|---|---|
| $G_1 = 66,42 \text{ kN}; G_2 = 56,16 \text{ kN};$<br>$G_3 = 214,98 \text{ kN}$<br>$\delta_{G1,x} = \delta_{G2,x} = 0,653, \delta_{G1,y} = \delta_{G2,y} = 0,019$<br>$\delta_{G3,x} = 0,240, \delta_{G3,y} = 0,0019$<br>$z = 13,70 \text{ m}$ | $\alpha_0 = 0,049; a_0^* = 0,451 \text{ m/s}^2$<br>$a_{0,\min}^* = 3,74 \text{ m/s}^2$<br>$a_0^* / a_{0,\min}^* = 0,12$ | $d_{k,0} = 0,385 \text{ m}; d_0^* = 0,19 \text{ m}$<br>$d_u^* = 0,08 \text{ m}; d_s^* = 0,03 \text{ m}$<br>$T_s = 1,77 \text{ s}$<br>$d_{u,\min}^* = 0,17 \text{ m}$<br>$d_u^* / d_{u,\min}^* = 0,47$ |
