POST-EARTHQUAKE ASSESSMENT AND DOCUMENTATION OF TIMBER ROOFS

ABSTRACT: In 2020 Croatia was struck by two strong earthquakes. Croatian building stock is in big part made of masonry with timber floor and roof structures. Given that masonry structures are highly vulnerable to seismic actions, damage occurred to more than 70.000 buildings. Due to widespread damage, there is a great need for a detailed and more comprehensive post-earthquake damage assessment. This paper briefly presents the post-earthquake damage assessment in the historic parts of Zagreb and the surrounding area after the recent earthquakes in 2020. Special focus is set on traditional timber roofs – traditional roof systems in Croatia, damages to the load-bearing elements due to earthquake excitations, maintenance issues, wrong renovation of the attics, etc. Also, the role of UAVs, photogrammetry and laser scanners in the assessment and preservation of heritage buildings is shown.

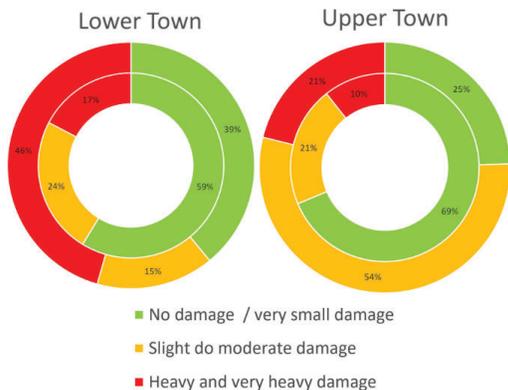
The damage methodology for the roof elements and structure was divided into five damage levels: no damage, very minor damage, moderate damage, significant damage, severe damage. Figure 2 shows the extent of damage to roofing and wooden roof structures in the historic districts of Zagreb. In Donji Grad (Lower Town), the buildings are larger in plan than in Gornji Grad (Upper Town); therefore, the structural systems are also different. In the Upper Town, single-family houses and villas predominate, while in the Lower Town, multi-family houses with mostly 7 to 9 housing units are the most common buildings. According to the engineers' decision, the total number of severely damaged roofs was 274 in the Lower Town and 189 in the Upper Town. Damage to roofing was found on 598 buildings in the Lower Town and 516 buildings in the Upper Town [4,13].

Figure 2: Statistical data about damage to roofs (inner circle: damaged roof systems, outer circle: damaged roof coverings)
