# Assessment and Rehabilitation of Culturally Protected Prince Rudolf Infantry Barracks in Zagreb after Major Earthquake

**Abstract:** Recently, Zagreb was struck by a strong earthquake. Damage throughout the city was tremendous due to numerous aged and vulnerable masonry buildings. Many damaged buildings are under a certain level of cultural heritage protection. Hence, reliable assessment and effective rehabilitation are important to preserve cultural significance and mitigate risk for human life. With that in mind, the procedure of a detailed condition assessment of the building under heritage protection is presented. A detailed historical background of the case study building is shown, and observed damage and conducted in situ tests are discussed. The nonlinear static seismic analysis performed in the 3Muri software is extensively elaborated. Four different levels of reconstruction according to new Croatian law are briefly presented. Additionally, several strengthening scenarios are proposed with various strengthening techniques.

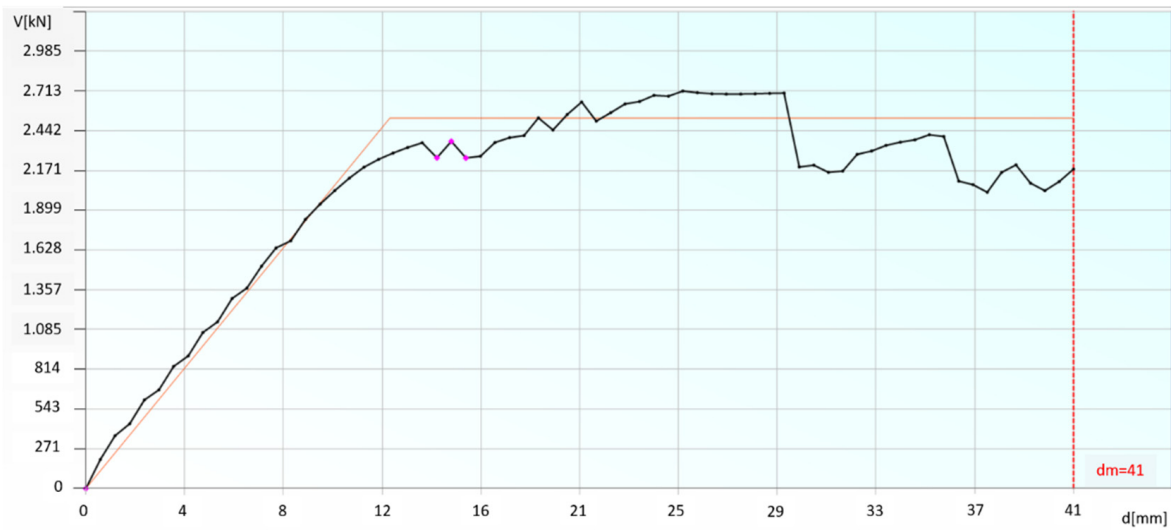
**Figure 16.** Capacity curve (black) and its bilinear idealization (orange) for  $x$ -direction.

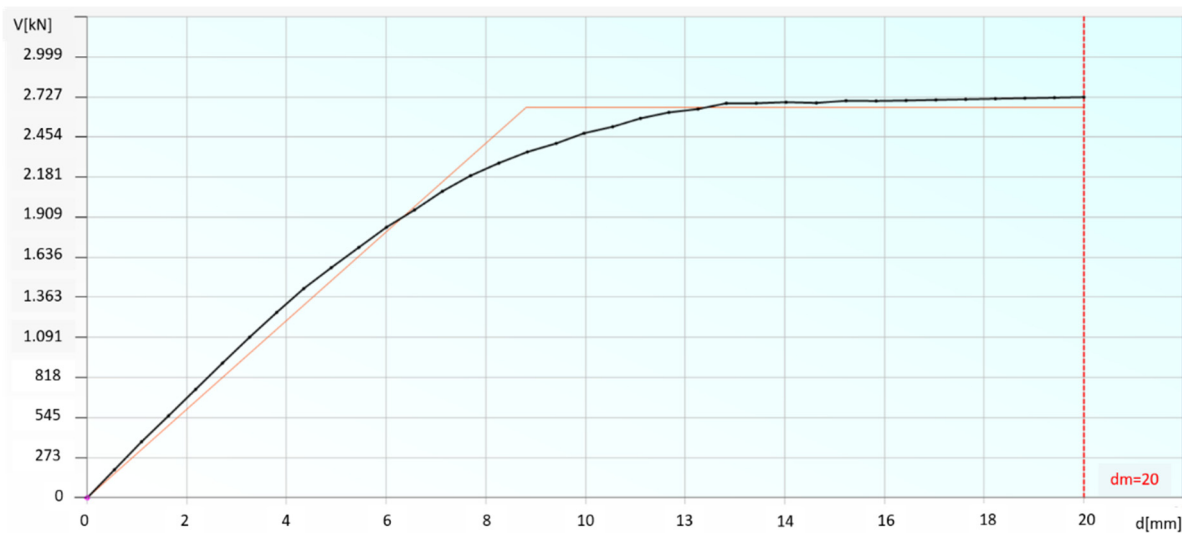
**Figure 17.** Capacity curve (black) and its bilinear idealization (orange) for  $y$ -direction.

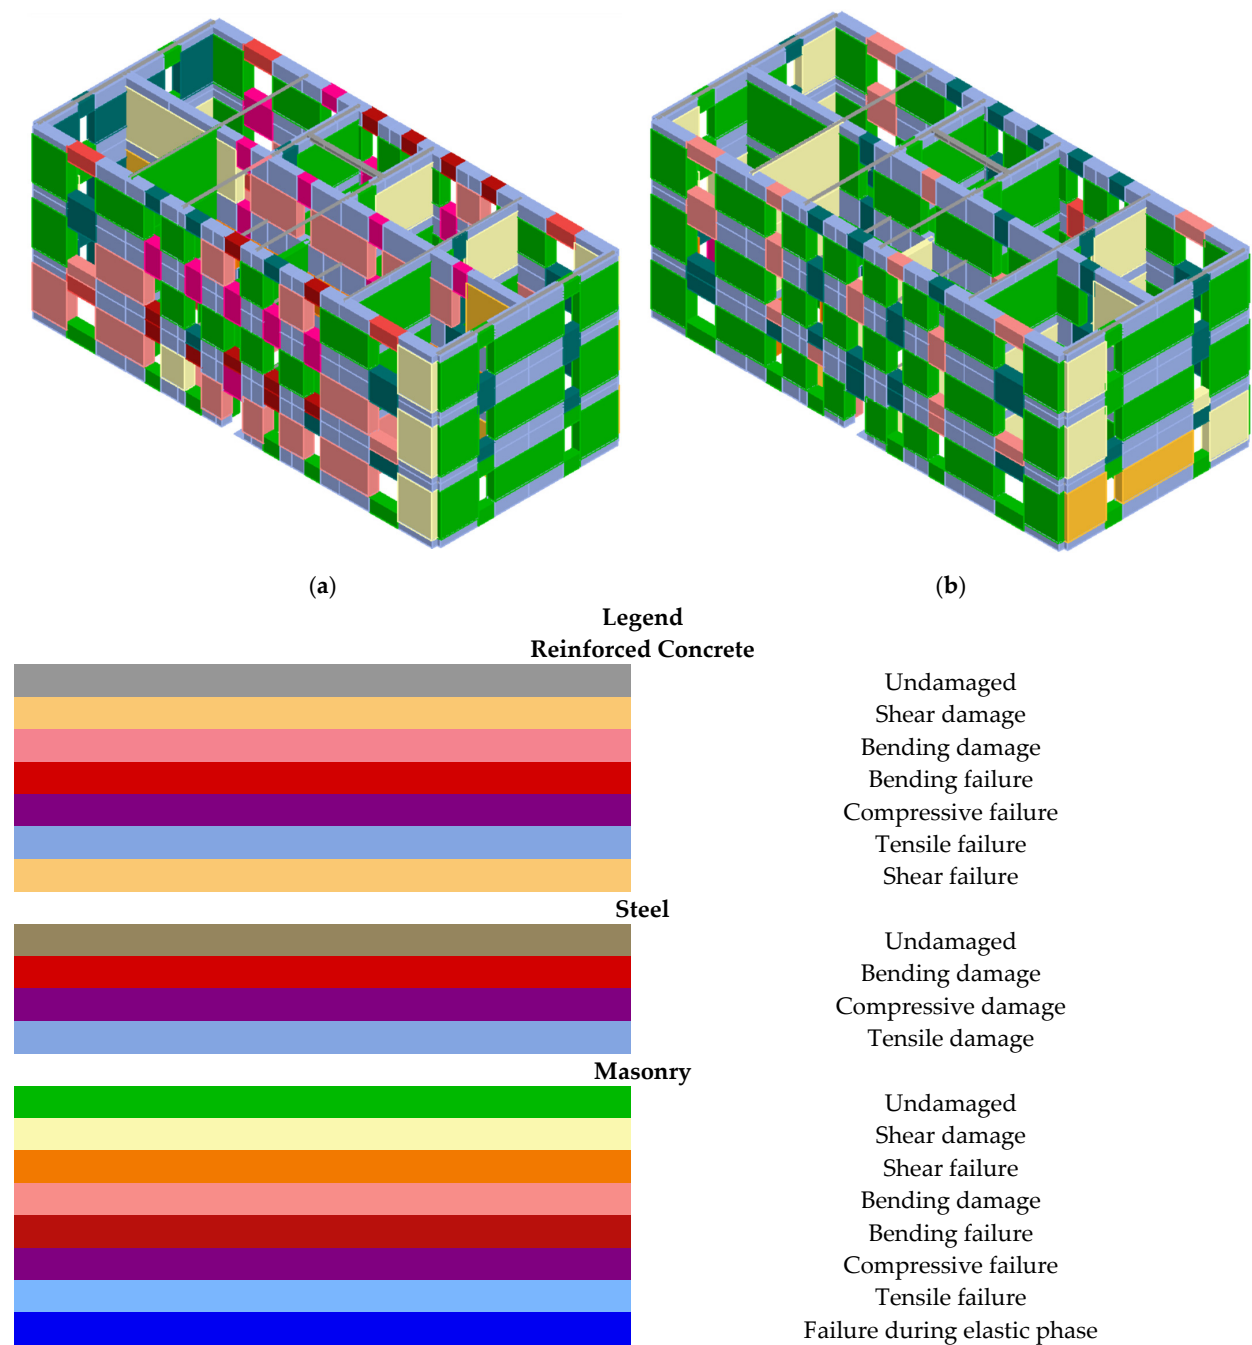
**Figure 18.** Three-dimensional (3D) model with damage for the near-collapse limit state: (a)  $x$ -direction; (b)  $y$ -direction.

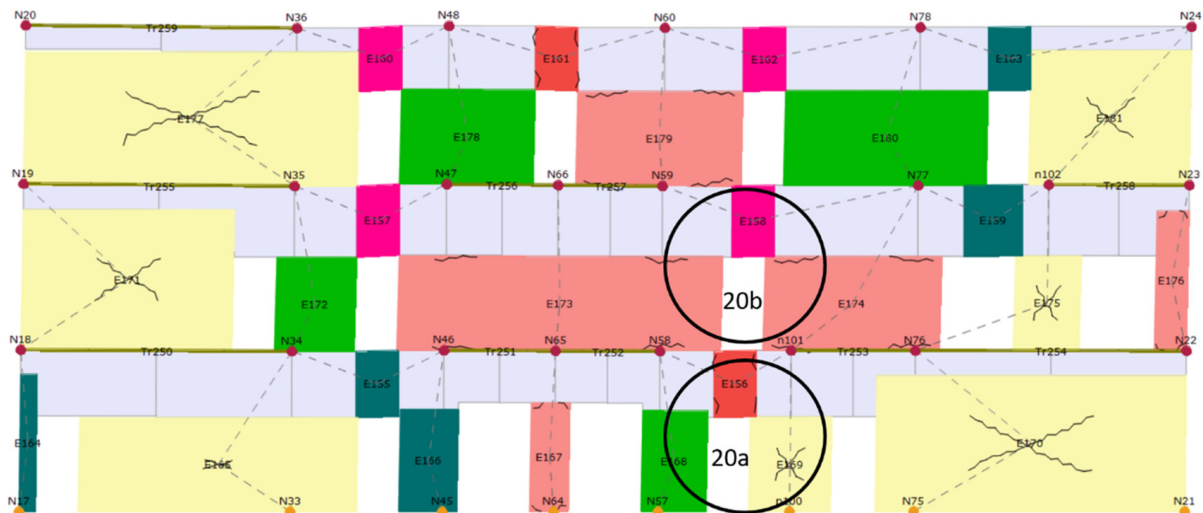
Figure 19. Damage to the central wall in the  $x$ -direction (3Muri).

To compare the actual damage and the damage obtained using the 3Muri software, a uniform lateral load distribution was selected. It is assumed that the peak ground acceleration of the earthquake in Zagreb in 2020 was about 0.18 g. The results of damage are shown in Figure 19, with locations of real damage shown in Figure 20a,b.

Figure 20a shows the actual damage to the right part of the load-bearing wall on the ground floor corresponding to the shear damage. Figure 20b shows the actual damage to the middle part of the load-bearing wall on the first floor, which corresponds to the damage due to bending. Similar damage is detected in height in the building itself, and damage corresponds to the model.
