# The Assessment and Retrofitting of Cultural Heritage—A Case Study of a Residential Building in Glina

Karlo Ožić<sup>1</sup>, Ivan Markić<sup>2</sup>, Antonela Moretić<sup>1,\*</sup> and Luka Lulić<sup>1</sup>

**Abstract:** The focus of the study is on the renovation of a specific case study, which is a 19th century building under cultural heritage protection. It highlights the particular challenges faced by civil engineers in the structural renovation of buildings that are under heritage protection. Preserving the identity of these buildings limits the available methods for strengthening their seismic capacity. At the beginning, information about the seismic activity and the different post-earthquake evaluation procedures are presented to identify the damage and take appropriate further steps. Then, basic information about the building is given and supported by graphic attachments. In the following, the methods and materials are explained, focusing on in situ testing with the semi-destructive flat-jack method and the analysis of the structure with the nonlinear method implemented in the software. Subsequently, the obtained results are presented and discussed, accompanied by gra

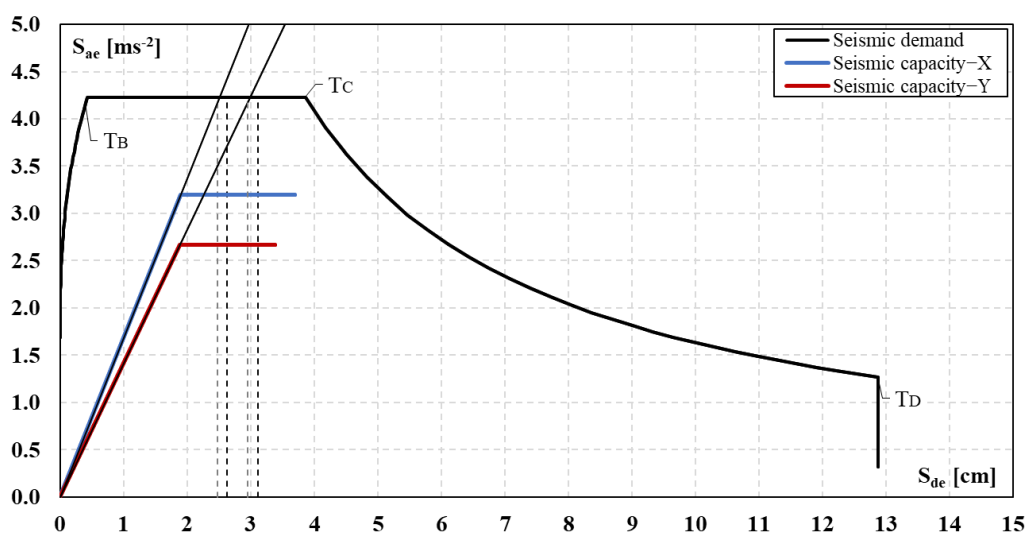
**Figure 22.** Seismic demand and capacity of the strengthened structure.
