Seismic Retrofitting of Dual Structural Systems—A Case Study of an Educational Building in Croatia

Mario Uroš¹

The building of the higher education institution in Petrinja, Croatia, was built in 1963 and underwent energy renovation in 2018. The building consists of the ground, 1st, and 2nd floors; the area on the ground floor is 1294.3 m² and on the upper floors 603.4 m². The total gross floor area of the building is 2501.1 m², while the useful heated area of the building is approximately 2130 m². The building has an irregular T-shaped layout and consists of three volumes connected into one whole (Figure 3). In the northwest–southeast direction (hereafter X-dir), there are two volumes that have only the ground floor. The volume marked as V1 is 3.84 m high, while the volume V2 in the southeastern part of the building is 5.52 m high and consists of a one large hall. The central volume V3 of the building is arranged in a northeast–southwest direction (hereafter Y-dir) and has three stories with a total height of 11.52 m.

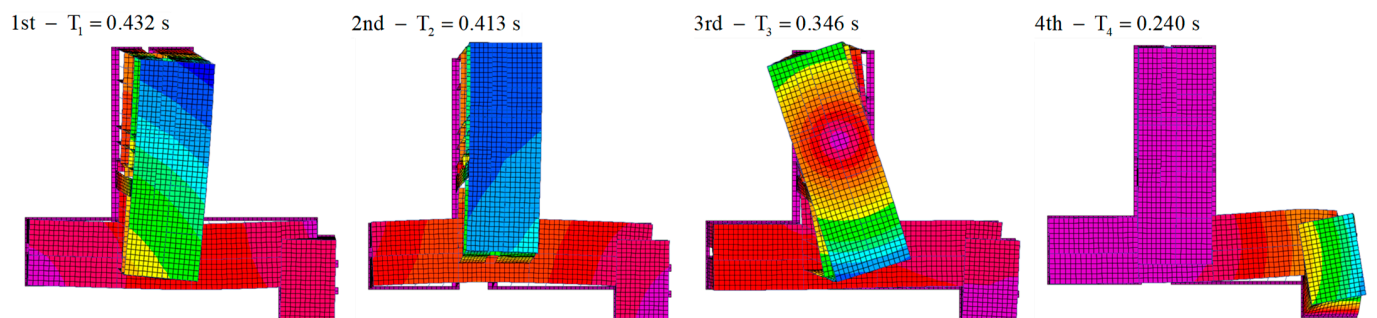
Figure 14. Eigenmodes and corresponding periods values for cracked sections of the as-built state of the building.

Numerical results of the dynamic properties, i.e., eigenperiods and mode shapes, are presented below. Figure 13 shows the results of a model that has a limited crack state since it is loaded only by the weight of the structural elements and other permanent and service loads. Further results for eigenmodes are obtained for the state of the structure near the SD limit state (Figure 14). In this case, the stiffness of the structure is significantly reduced, which is reflected in the prolonged eigenperiods. It should be noted that the irregularity of the building on the ground floor can cause torsional effects that increase the requirements for the relative displacements of the perimeter walls, which could lead to their greater vulnerability during earthquake.
