The December 2020 magnitude (Mw) 6.4 Petrinja earthquake, Croatia: seismological aspects, emergency response and impacts

Source / Izvornik: **Bulletin of earthquake engineering, 2023, 21, 5767 - 5808**

Keywords Physical damage · Masonry buildings · Emergency response · Post-earthquake survey · Social impacts

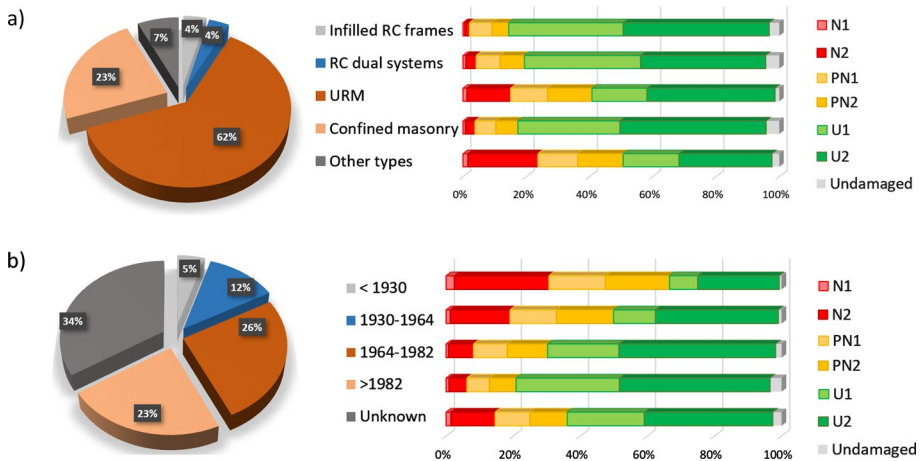
Extensive damage to buildings was widespread in Petrinja, the nearby towns of Glina and Sisak, as well as throughout the rural settlements of the Sisak-Moslavina County. Based on the inspection results, the most damaged buildings were of unreinforced masonry (URM), followed by confined masonry (CM), while the reinforced concrete (RC) structures (consisting of approximately equal parts of infilled frames and dual systems) sustained much lesser damage (Fig. 6a). The building category referred to as “other types”, which accounts for 7% of damaged buildings in this figure, includes traditional wooden houses as well as mixed structural systems, e.g., wood and URM or partially confined masonry (Fig. 25). However, it was observed that the latter building category was frequently classified as the more resistant CM in the inspection forms. The confusion resulted because the inspection form did not provide explicit option for this peculiar typology, however, specific to a relatively large number of buildings. Due to the insufficient time and accelerated training, only a part of the experts managed to recognize these buildings as “other types”. As mentioned in Chapter 2, the partially confined masonry buildings disregard standard engineering practices and seismic regulations resulting in critical structural deficiencies. Furthermore, it should be mentioned that no damage to steel structures was reported, also the inspection of the industrial steel structures of the oil refinery in nearby town Sisak and the industrial plant in Kutina, located about 40 km from Petrinja, did not reveal any significant structural damage caused by this earthquake.

Another important statistical indicator correlated to the usability of buildings is the year (period) of construction. The graphs shown in Fig. 6b clearly indicate that buildings built before 1930 have sustained the most significant structural damage. The damage percentage decreases gradually for more recent structures due to the improvement of the construction practices with the introduction of the new and improved construction standards and seismic regulations.

Fig. 6 Data on building usability assessments in the affected area with respect to: **a** most common structural systems, and **b** period of construction (CCEE 2022)
