Potres u Zagrebu od 22. ožujka 2020. - preliminarni izvještaj o seizmološkim istraživanjima i oštećenjima zgrada

Zagreb earthquake of 22 March 2020 – preliminary report on seismologic aspects and damage to buildings

Research Paper

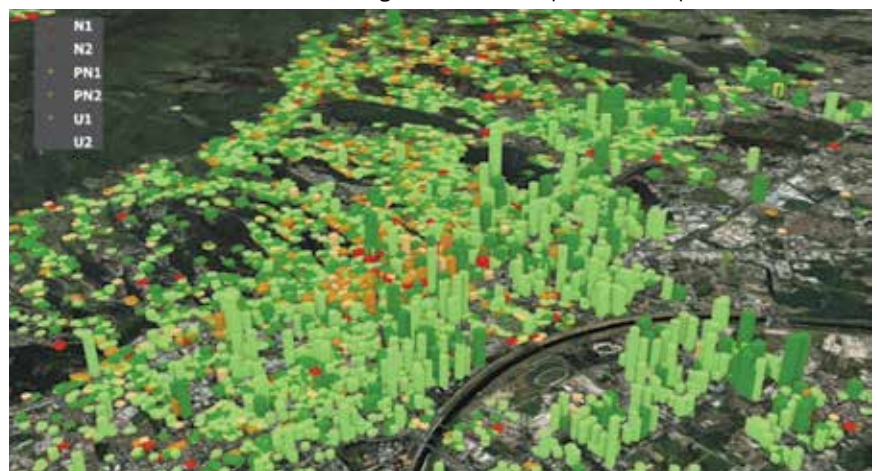
Although cultural heritage and some public buildings have suffered considerable damage, as will be described in the following section, largest damage was still incurred by the housing stock. Results obtained by inspection of usability of residential and commercial-residential buildings are shown in Figure 26, where colours correspond to usability tag, while column heights indicate the gross floor area of buildings. It can be observed that the greatest damage was inflicted on historic centre of the city, which is why we will present below some data about the Down Town (Donji Grad) and a typical building block, as well as photographs of typical damage to houses situated near the epicentre.

- buildings classified as U1 mostly suffered insignificant damage of the roof structure and exhibited some cracks (small in width and length) in structural and non-structural walls, dominantly around staircases;
- in almost all buildings classified as U2 masonry chimneys were damaged or even collapsed (which presented a hazard

Figure 26. Damage to residential and commercial-residential buildings according to usability tags (colours) and gross floor area of buildings (height of columns) on a perspective view of the city of Zagreb

for citizens); damage sometimes included partly collapsed top parts of gable walls, smaller cracks in lintels and some load bearing walls, and damage to partition walls;

- buildings classified as PN1 exhibited moderate to significant damage of structural and non-structural elements, especially at staircases, and heavy damage to the roof structure due to chimneys' collapse. By accelerated inspections it was not possible to assess damage influence on the building load-bearing capacity, and so a detailed inspection was advised;

- buildings classified as PN2 exhibited considerable damage to gable walls, heavy damage to the roof structure due to chimneys' collapse; top floors are often unusable, with imminent collapse hazard;

- in buildings classified as N1 there exists mostly danger of the gable wall collapse (or of other unsupported elements) from a neighbouring house;
- buildings classified as N2 exhibited considerable and heavy damage to structural elements, mostly in staircase area (which makes them dangerous in case of evacuation), then heavy damage to the roof structure due to chimneys' collapse, and considerable detachments and collapses of gable walls.

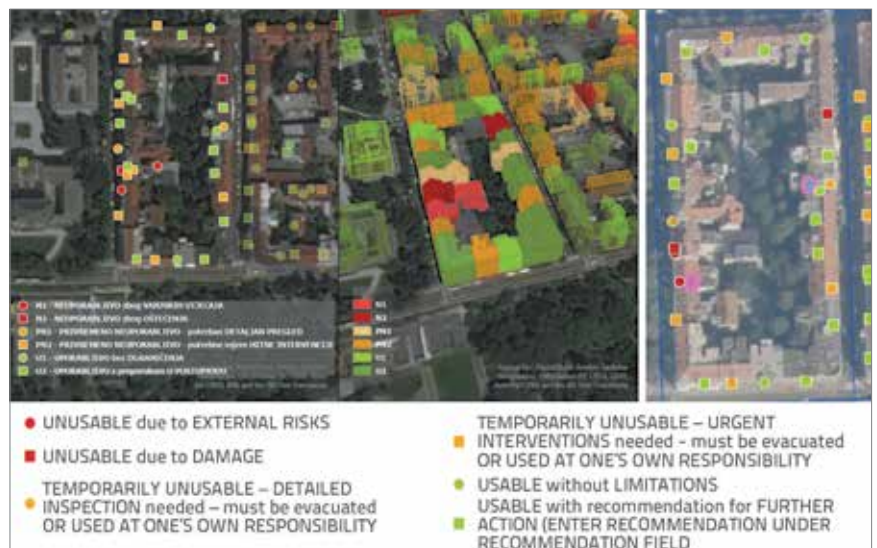
Figure 27. Example of a block selected in Down Town area

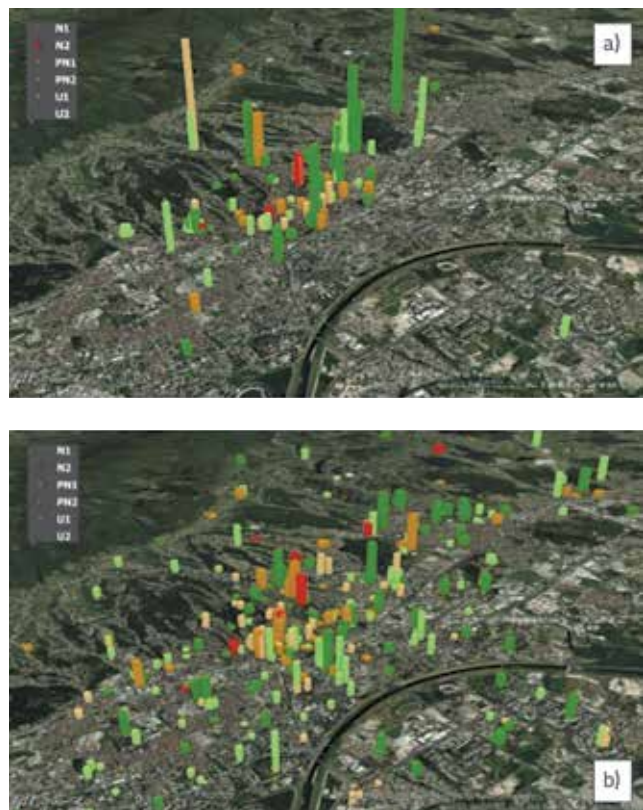
because the works will have to be carried out in accordance with appropriate conservation-restoration requirements. Damage assessments of critical infrastructure (hospitals, schools, faculties, and kindergartens) are shown in Figure 35 according to the level of damage (colour) and gross area (column height). A detailed presentation of two examples of damage to hospitals is given below.

Figure 35. Damage to buildings according to usability tags (colours) and gross floor area (columns) on 3D aerial view of the City of Zagreb for the sectors of a) healthcare and b) education
