Potres u Zagrebu od 22. ožujka 2020. - preliminarni izvještaj o seizmološkim istraživanjima i oštećenjima zgrada

Zagreb earthquake of 22 March 2020 – preliminary report on seismologic aspects and damage to buildings

Research Paper

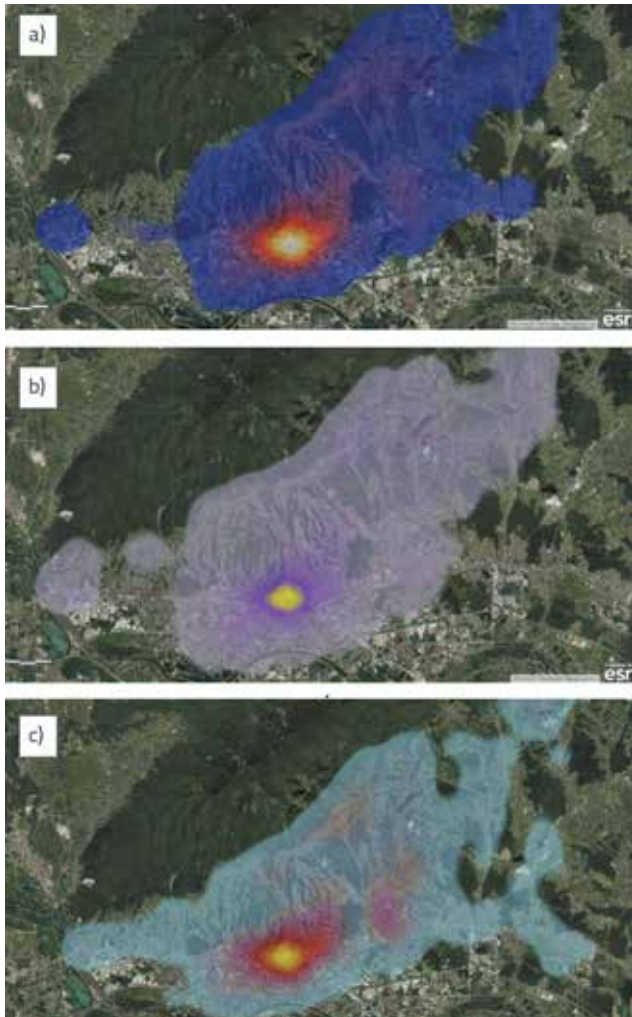
Figure 18. Heatmaps of: a) damaged and collapsed chimneys – data obtained from citizens by survey via *Survey for ArcGIS*; b) damage of gable walls and roofs from the database of on-site damage and usability inspections; c) interventions made for damaged and collapsed chimneys – data obtained from Public Fire Brigade of the City of Zagreb, last time updated on 5 May 2020
