Analysis of Tram Traffic-Induced Vibration Influence on Earthquake Damaged Buildings

Source / Izvornik: **Buildings, 2021, 11**

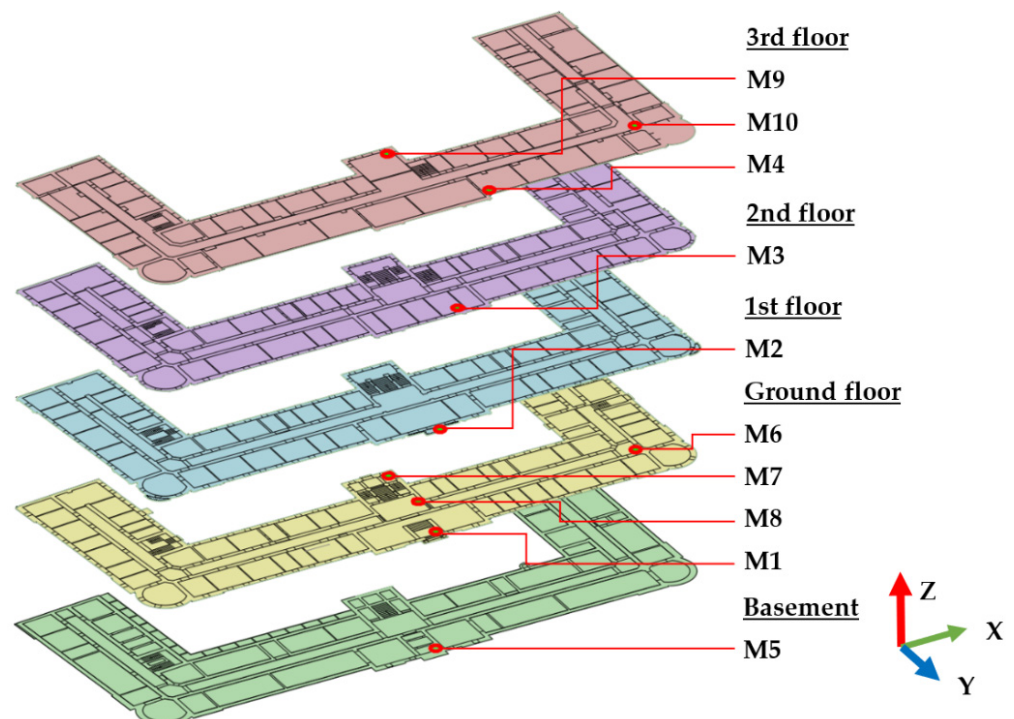
Figure 6. Layout of triaxial accelerometer measurement positions.

The HŽI head office building is composed of three wings (east, south, and west) and five stories (basement, ground floor, first floor, second floor, and third floor). After the initial inspection of the building, its layout, and damage suffered in the earthquake, ten measurement positions for placing triaxial accelerometers were defined, as shown in Figure 6. Measurement locations were mostly distributed throughout the south wing of the structure because it is the closest to the tram line:

- basement (position M5);
- ground floor (positions M1, M6, M7, and M8);
- first floor (position M2);
- second floor (position M3);
- third floor (positions M4, M9, and M10).

Accelerometer positions were carefully selected so as to capture vibrations at the same positions across all floors (M1, M2, M3, M4, and M5) to examine the propagation of vibrations to the central staircase and to the backside of the building (M6, M7, and M9) and to examine the propagation of vibrations in the southeast corner of the building (M8 and M10), where load-bearing walls from both wings meet. Accelerometer positions were also defined according to HRN DIN 4150-3 [19] recommendations so that measurement results can be calculated accordingly. Each location consists of accelerometer measuring positions in three perpendicular directions:

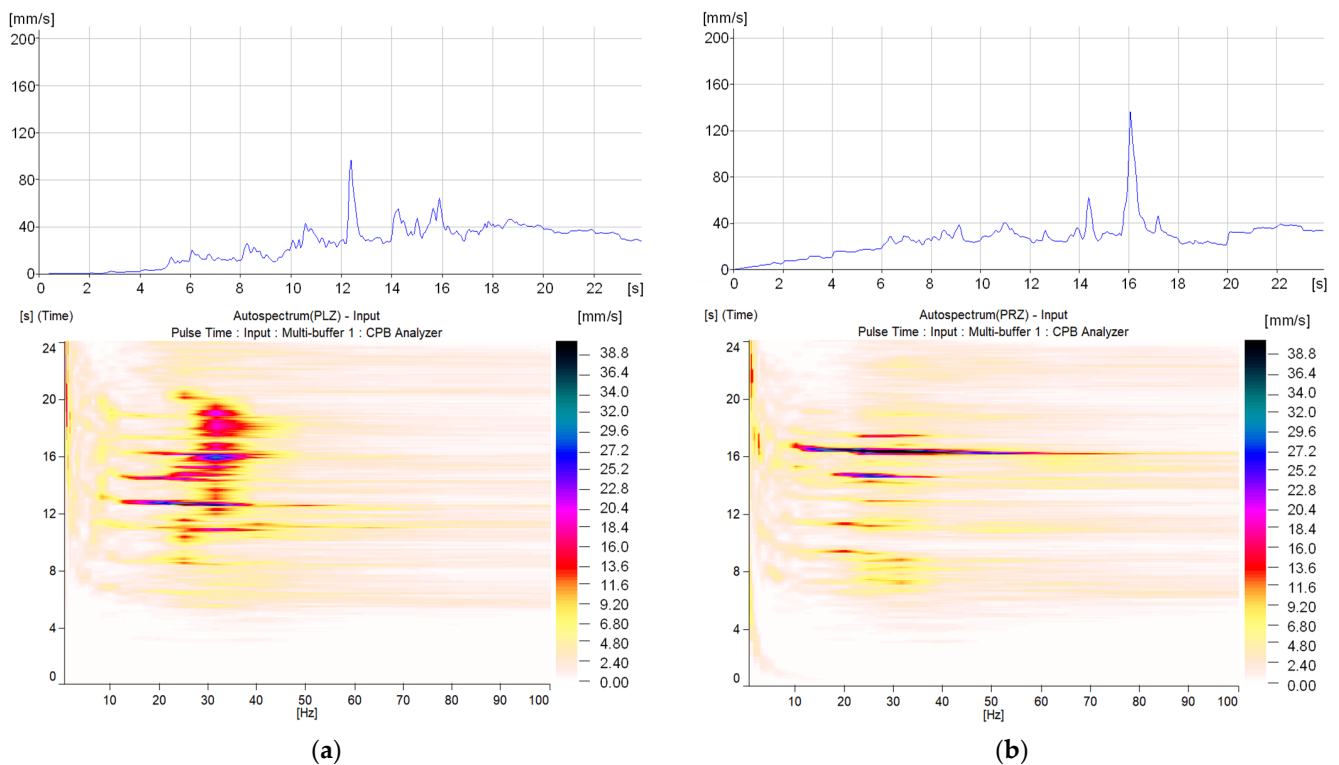
For all pass-bys, dominant recorded vibrations were in the vertical axis (PLZ and PRZ). The higher vibration levels were recorded on pass-bys 2 and 4 (closer to the building). The highest vibration levels were recorded on the second pass-by when the vehicle performed intensive braking at a traffic light west of the building (intersection with Miramarska street). At that moment, prominent vibrations of the bogie were observed in the transverse direction at the frequency of around 1 Hz. Three-dimensional spectrograms show that dominant frequencies vary from 25 Hz to 40 Hz, Figure 9.

Figure 9. Vibration trend (top) and 3D spectrogram (bottom) of vertical vibration velocities in the second pass-by: (a) left side—PLZ; (b) right side—PRZ.

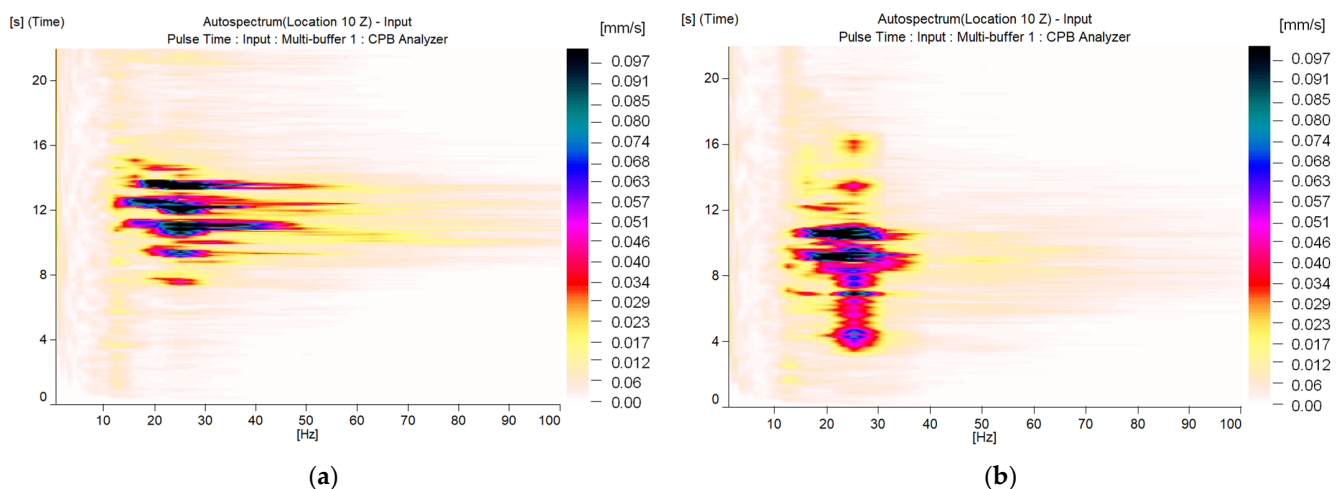
By comparing four pass-bys, the highest vibration amplitudes can be observed in the vertical (Z) direction. Additionally, for all pass-bys, maximum levels were measured at location M10. For each of the tram types, vibrations at M8 are similar in amplitude for all directions. As to the south-central axis (M1–M5), the highest vibrations were induced by TMK 301 tram. Overall maximum vibration levels were induced by TMK 2200 at M10.

If 3D spectrograms for two tram types that induce the highest levels of vibrations are observed, a clear distinction can first be observed in the bogie placement and tram length, Figure 13. In addition, similar levels of vibrations occur at similar frequencies, but it can be observed that TMK 2200 induces a broader spectrum of vibrations in the building (12 Hz to 50 Hz), while TMK 301 induces a narrower spectrum of vibrations (15 Hz to 32 Hz).

Figure 13. Three-dimensional spectrograms of vibration velocities at M10, vertical direction (Z), for trams (a) TMK 2200 and (b) TMK 301.

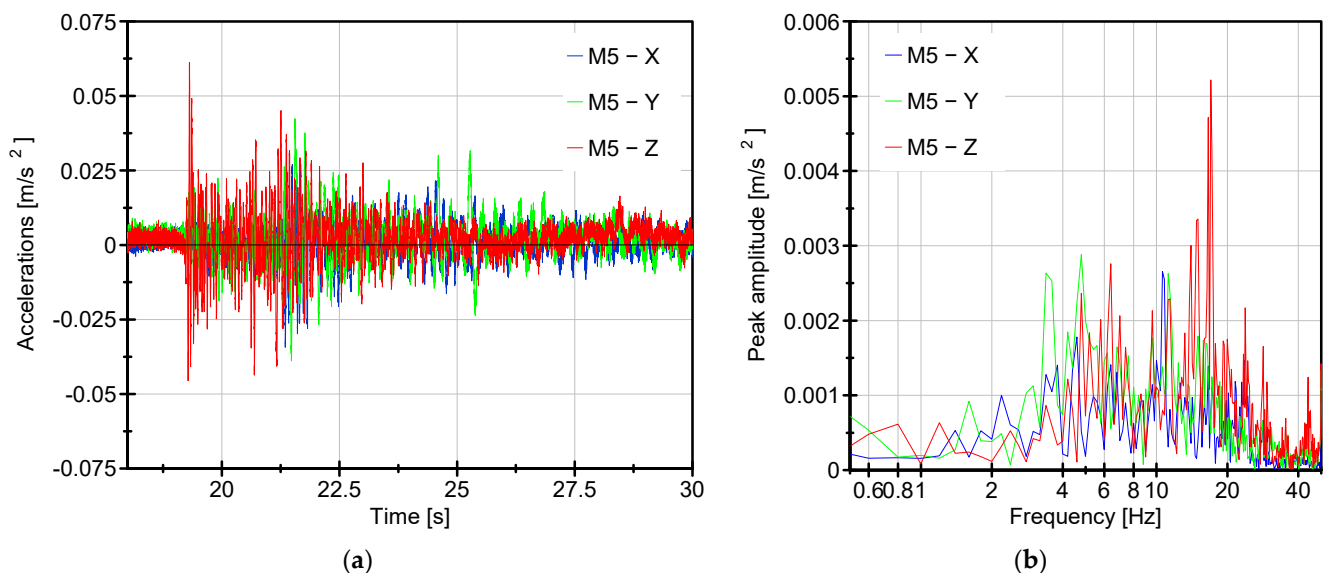
While measuring tram vibrations, a 3.1 (ML) earthquake struck Zagreb at roughly the same epicentre [30]. It was, therefore, interesting to compare the effect of earthquake action and tram action on the same building. The seismic action of this earthquake can be represented as a response of building foundations (M5), Figure 14. The waveform and frequency analysis reveals the nature of earthquake activity, which is much lower in frequency compared to tram excitation, around 4–18 Hz, primarily in the Y direction. Building response can be monitored through different floors in the same cross-section. Frequency analysis reveals that building response is dominant in 2–3 Hz, especially at higher floors (M3 and M4), Figure 15. This distinct response was not observed with tram excitation due to the much higher frequency and lower amplitude of induced vibrations.

Figure 14. Accelerations represented in (a) time and (b) frequency domains, 3.1 (ML) earthquake action at the level of building foundations, M5.

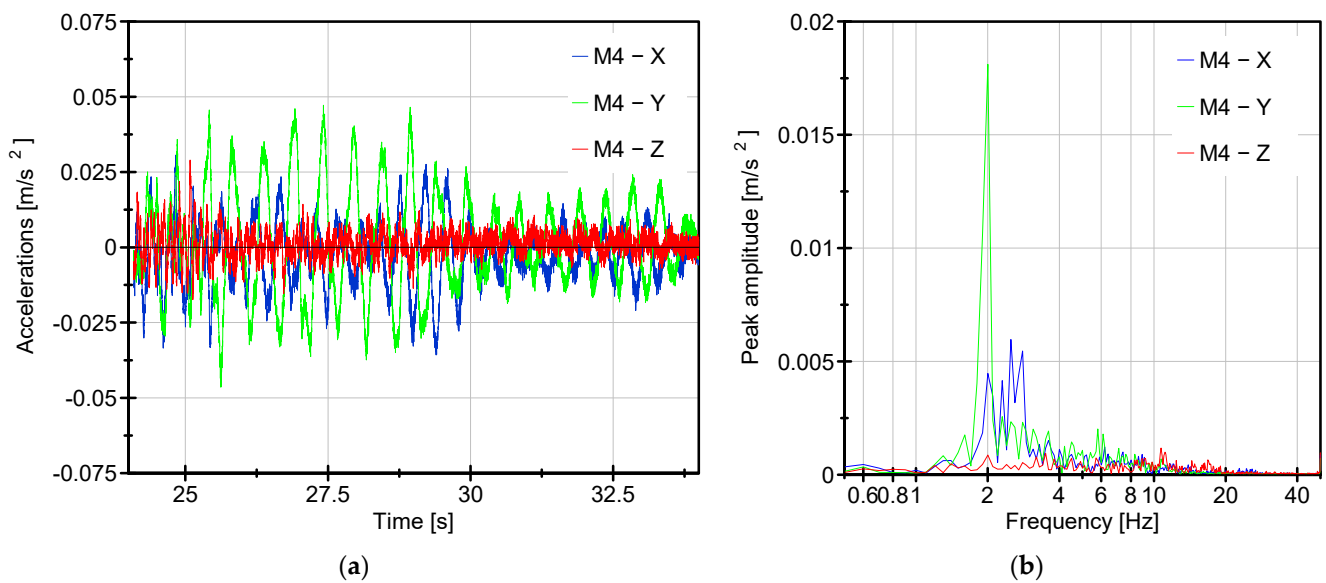
Figure 15. Accelerations represented in (a) time and (b) frequency domains, 3.1 (ML) earthquake structure response on the 3rd floor, M4.

If the 3.1 (ML) response is analysed in terms of PPV according to [19], a direct comparison to the acquired tram response can be made. The results presented for M1 to M5 clearly indicate how even small-intensity earthquake-triggered vibrations are considered harmful for historic masonry structures, Figure 16, while maximum tram vibrations trigger a much smaller response.
