Evaluation of tramway overhead line system in city of Osijek

Ivo Haladin^{1*}, Stjepan Lakušić¹, and Ivan Duvnjak²

Abstract. Overhead line system is a vital element of any electrified railway infrastructure. Its performance reflects to all vital parameters such as traction, reliability, availability and safety of railway infrastructure. Operator GPP Osijek runs a 27.5 km long tramway network which plays a key role in transit system of the city of Osijek, Croatia. In 2016 GPP Osijek applied to a tender for acquisition of new rolling stock with 85% EU investment. Mayor requirement prior to rolling stock acquisition was to document, analyse and upgrade current infrastructure (including track structure, electric substations and catenary) to an optimal level. Task of measurement and evaluation of tram track structure and catenary has been appointed to University of Zagreb Faculty of Civil Engineering. Overhead line analysis comprised from several measuring procedures, including supporting columns evaluation, catenary stagger, height, shocks and wear. Such extensive analysis included GPS positioning and on-site evaluation of 1214 supporting columns of overhead line, as well as overhead

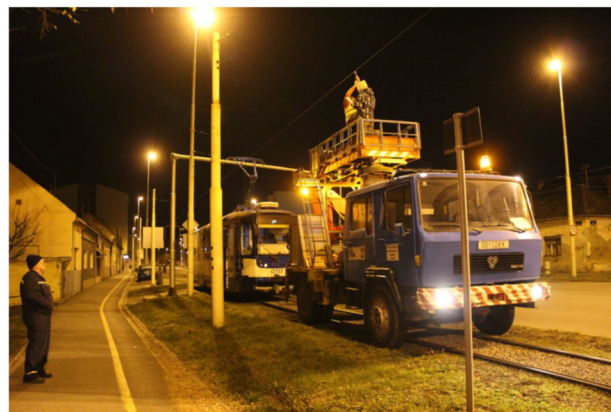
Overhead wire had to be checked along 18 km of track. On these sections, a tram T3 has been instrumented with measurement equipment and towed by a towing truck to conduct measurements off the power grid with a speed of around 10 km/h, Figure 3. Towing truck has also been used as an inspection vehicle for overhead wire wear assessment.

Fig. 3. Towing truck and tram T3 during overhead line measurements.

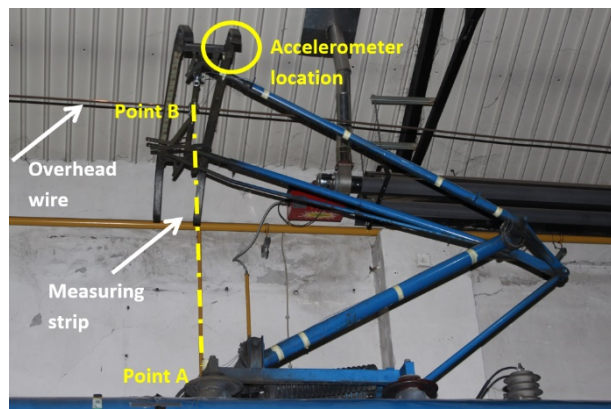
The overhead wire height has been measured using a digital measuring strip attached to pantograph base and pantograph top, recording the height variation, Figure 4. By adding the fixed value of top of rail to pantograph base height, total overhead wire height is calculated. Measurements are recorded continuously at 100 Hz. Such procedure allowed recording of overhead wire along the whole 18 km of tram track.

Fig. 4. Overhead wire height and shock measurement setup.

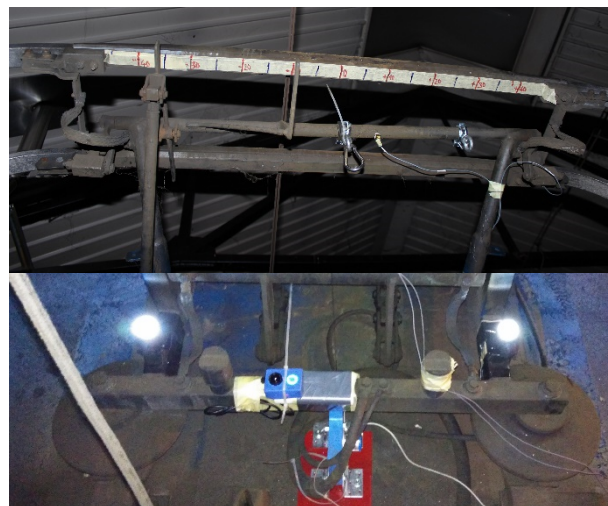
During a tram pass by over 18 km of track, a video camera was used to record the pantograph head with a measuring strip attached to it, to record the stagger of the overhead wire in lateral direction, Figure 7.

Fig. 7. Overhead wire stagger measurements using camera and measuring strip on the head and camera in the base.

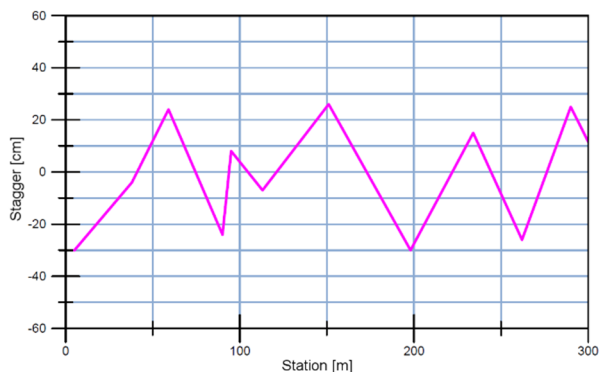
This data has further been processed to create a polygonal curve base on the maximum values the wire has reached in lateral direction, traveling over the pantograph head, Figure 8. Using a GPS signal recorded simultaneously, such data could be geolocated to the tram network and track station.

Fig. 8. Pantograph stagger recording.

Depending on pantograph specifications there is an optimal stagger width that leads to even wear of the photograph contact surface. In case of Osijek tram network, it is +/- 30 cm from pantograph centre line [4]. According to that, by histogram analysis, conclusions can be made on wear of pantograph contact surface. Analysis can also pinpoint locations of undesired wire placement (outside of +/- 30 cm range).
