Evaluation of tramway overhead line system in city of Osijek

Abstract. Overhead line system is a vital element of any electrified railway infrastructure. Its performance reflects to all vital parameters such as traction, reliability, availability and safety of railway infrastructure. Operator GPP Osijek runs a 27.5 km long tramway network which plays a key role in transit system of the city of Osijek, Croatia. In 2016 GPP Osijek applied to a tender for acquisition of new rolling stock with 85% EU investment. Mayor requirement prior to rolling stock acquisition was to document, analyse and upgrade current infrastructure (including track structure, electric substations and catenary) to an optimal level. Task of measurement and evaluation of tram track structure and catenary has been appointed to University of Zagreb Faculty of Civil Engineering. Overhead line analysis comprised from several measuring procedures, including supporting columns evaluation, catenary stagger, height, shocks and wear. Such extensive analysis included GPS positioning and on-site evaluation of 1214 supporting columns of overhead line, as well as overhead line measurements using an instrumented tram vehicle o

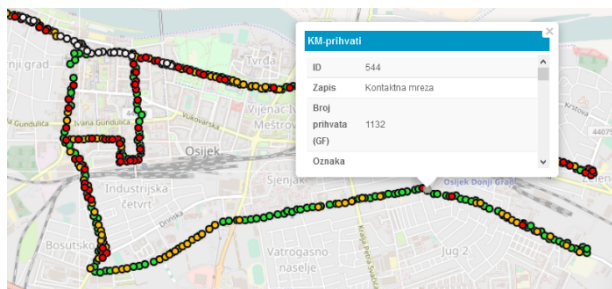
Fig. 1. Acquired GIS dataset of 1214 analysed supports.

According to analysis, 20 % of columns were characterized as substantially damaged (bent out of vertical axis, corrosion damage, shrapnel damage etc.), as presented in Figure 2; 32 % endangered (minor corrosion or dents); 48 % in good state (not bent, no corrosion or dents).

Conducted measurements and further analysis revealed weak spots and sections in overhead line system that are to be replaced or reconstructed due to weakened or damaged support columns (around 20%), worn overhead wire and elevated level of vibrations and shocks on vehicle pantograph. Furthermore recommendations for correction of overhead line alignment in terms of height and stagger have been given for more than 2000 m of track. Priority levels for reconstruction have also been determined.
