Case-study of the out-of-plane wall failure of a typical downtown building in Zagreb

3 Case study: Building in Mrazoviceva street

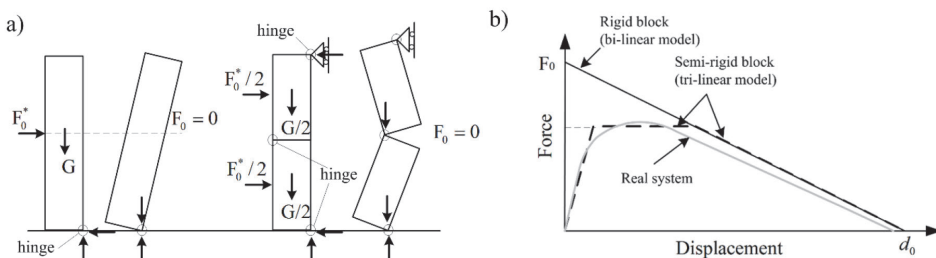
Figure 3. a) Rigid blocks mechanisms; b) Force-displacement relation for the mechanisms [4]

Kinematic chain of blocks is defined as the one-degree-of-freedom system (Figure 3.a). After determining the geometry of the kinematic chain and boundary conditions, it is important to take into account all the forces that affect it, including the inertial force

Finally, the displacement capacity demand prescribe the value of the ultimate spectral displacement as well as value of spectral displacement and spectral acceleration for the determination of secant period of the equivalent system. In the Italian NTC 2008 guidelines [5] the following values are used: for ultimate displacement $d_u = 0.4 d_{0'}$ where $d_{0'}$ is the limit displacement of equivalent system that is related to the limit displacement of the kinematic chain $d_{0'}$ and the value of the displacement $d_s = 0.4 d_u$.
