Assessment and Rehabilitation of Culturally Protected Prince Rudolf Infantry Barracks in Zagreb after Major Earthquake

Abstract: Recently, Zagreb was struck by a strong earthquake. Damage throughout the city was tremendous due to numerous aged and vulnerable masonry buildings. Many damaged buildings are under a certain level of cultural heritage protection. Hence, reliable assessment and effective rehabilitation are important to preserve cultural significance and mitigate risk for human life. With that in mind, the procedure of a detailed condition assessment of the building under heritage protection is presented. A detailed historical background of the case study building is shown, and observed damage and conducted in situ tests are discussed. The nonlinear static seismic analysis performed in the 3Muri software is extensively elaborated. Four different levels of reconstruction according to new Croatian law are briefly presented. Additionally, several strengthening scenarios are proposed with various strengthening techniques.

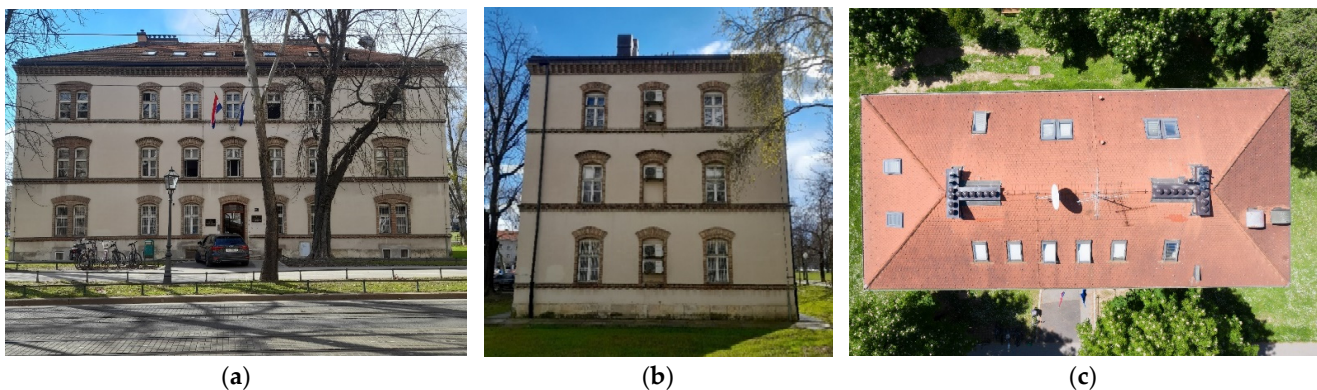
The case study building (Figure 5) is a public-purpose building with a rectangular floor plan of 25.18 m \times 11.42 m and a height of approximately 15.50 m. The floor area is approximately 290.00 m², and the total gross area is approximately 1450 m². The building consists of five floors, all floors of the building are used as office space. The building has undergone minor changes in the original geometry and space over time and has been properly maintained.

Figure 5. (a) View of the east façade; (b) View of the north façade; (c) View of the roof (photo credit: Mislav Stepinac).

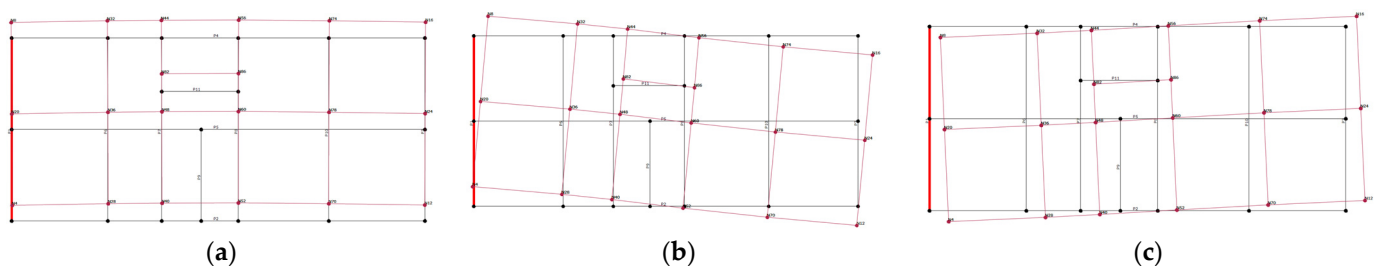
The 3Muri software has a module for conducting modal analysis. This module offers the calculation of all possible mode shapes. In this paper, 10 mode shapes are considered, and 3 are shown in Figure 14 and in Table 4. The first and third modes are predominantly translational, while in the second mode, slight torsion occurs.

Figure 14. (a) First mode; (b) second mode; (c) third mode.
