# Seismic upgrading of cultural heritage – A case study using an educational building in Croatia from the historicism style

Article *in* Case Studies in Construction Materials · May 2022 DOI: 10.1016/j.cscm.2022.e01183

## Seismic upgrading of cultural heritage – A case study using an educational building in Croatia from the historicism style

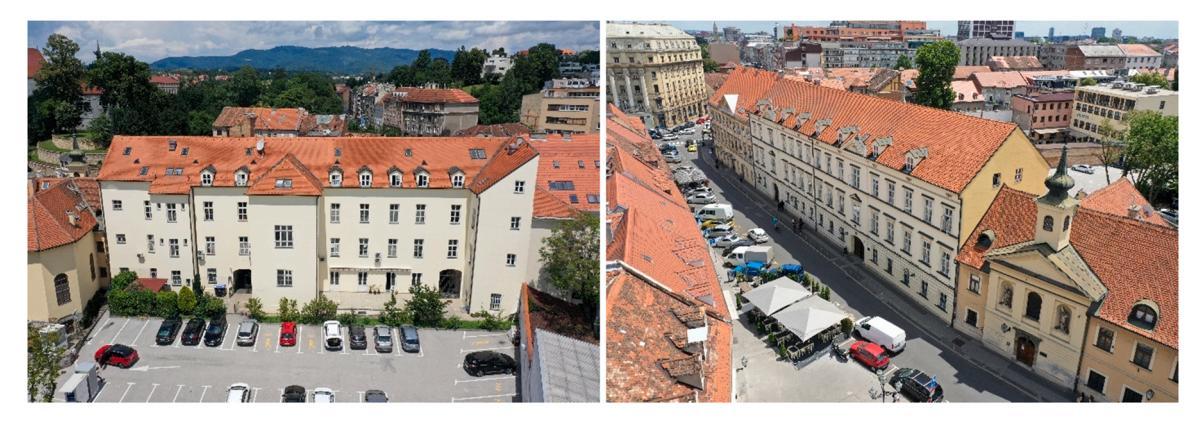
Fig. 3. South and north façade of the case study building.

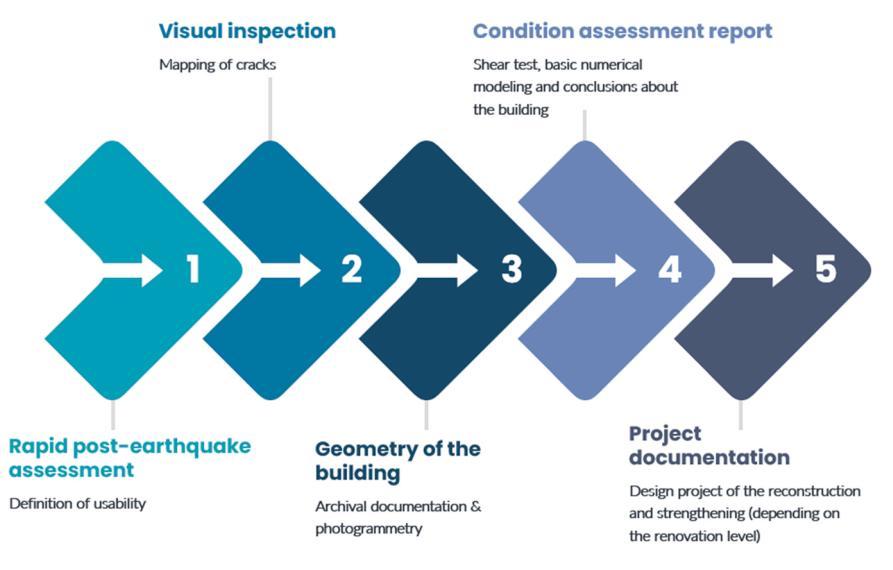
Fig. 7. Structural renovation process.

A few months later, a detailed examination was performed [14,15]. The flowchart of the performed activities is shown in Fig. 7. It was found that the cracks on the walls of the central staircase core coincide from the outside and inside, which indicates that the cracks are not superficial. The walls of the central core extend through the entire height of the building without any lateral restraints, and are weakened by openings, so they are considered to be the most critical part of the building. Cracks in the transverse walls of central core indicate possible out-of-plane failure of the mechanism. Shear strength testing of masonry were performed [14,15]using a hydraulic jack (Fig. 8). Visual inspection followed by in-situ examinations is explained in detail in [11]. It revealed that the masonry was in a good condition. Archival documentation was insufficient for geometry assessment. Photogrammetry was used to assess the true geometry of the building (Fig. 9)[16–18]. DJI Mavic 2 pro drone was used to take photos. Altogether, 87 photos were taken and the basic model was made in Agisoft Metashape software [19]. The full assessment of the presented case study was elaborated more in the detail in [11].

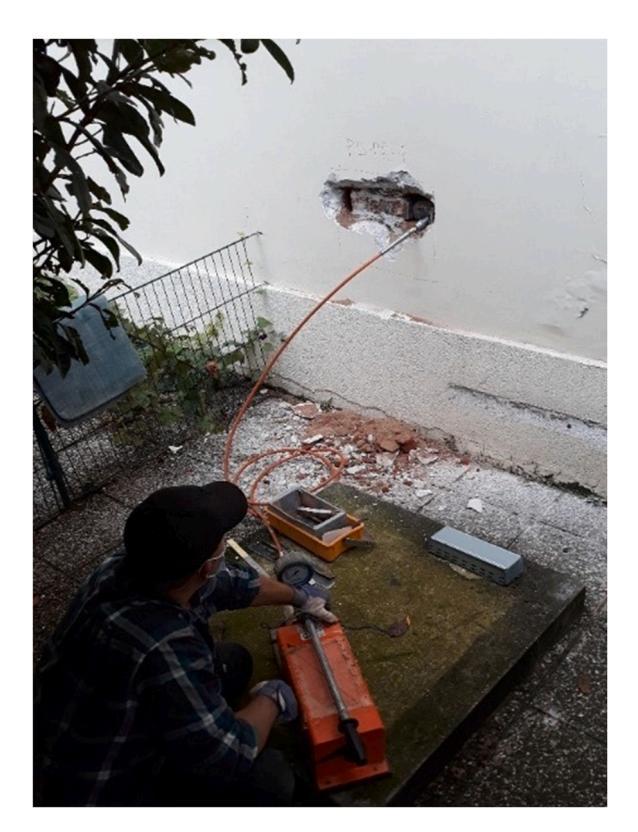
Fig. 8. Shear strength test of masonry [12].

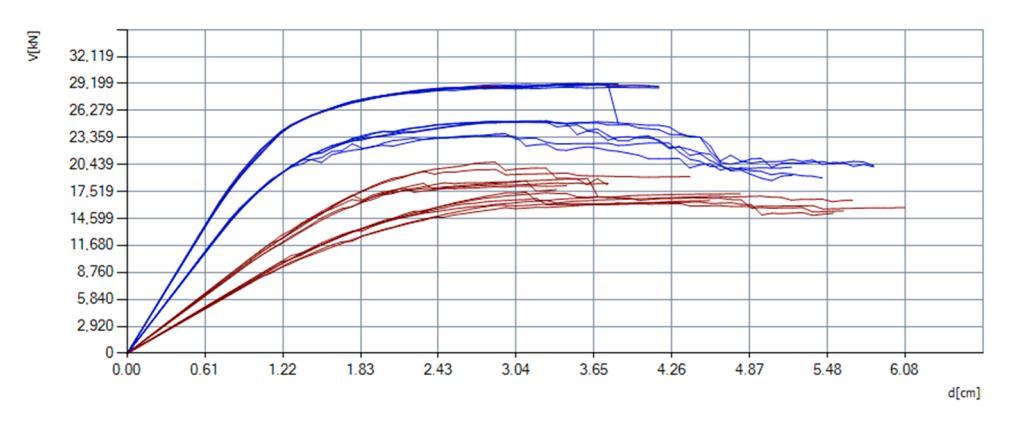
Fig. 13. Pushover curves for model strengthened by the FRCM system for x (blue) and y direction (red).

results of the analysis until the limit states of significant damage and damage limitation were met. Because of the iteration process, the walls were not strengthened equally but with strengthening which gives the best results, despite the stiffness difference. The obtained results are showing dominant translation at failure, so the stiffness difference is not having a large influence on the global behavior of the building. Moreover, the common principles of the new laws and regulations [10,21] in Croatia were respected.

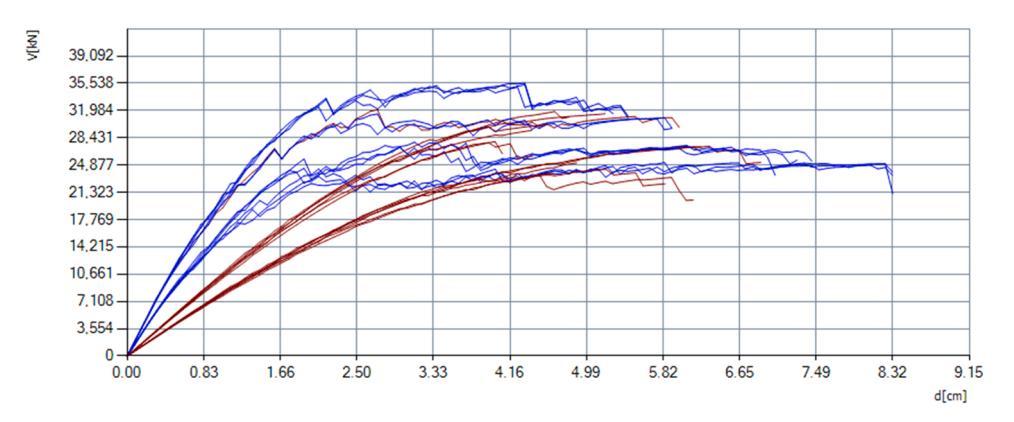
Fig. 14. Pushover curves for model strengthened by shotcrete for x (blue) and y direction (red).

For the strengthening variant in which shotcrete is used, Q503 reinforcement mesh, steel class B500B, has been selected. The mesh is composed of bars with a diameter of 8 mm with 10 cm spacing. Steel class B500B is a standard reinforcing steel, with yield strength of 500 MPa and B ductility class. Since the model whose façade walls were strengthened only on the inner face met all the required checks, such a solution has been accepted. On the remaining walls, the reinforcing mesh is placed on both faces. In this way, the external appearance of the building is not disturbed and the need for the use of scaffolding is reduced, which ultimately results in a lower cost of renovation. The authors are aware that the application of shotcrete with steel reinforcement is a controversial solution but, precisely because of this, it was considered. The capital of Croatia is at the moment being under major reconstruction and is going to be for a few years more at least. So far shotcrete is the most used technique, even in the case of historical construction. The authors estimate that at least 80% of the renovated buildings will be strengthened with concrete shotcreting. In this paper, the downside of this solution was highlighted and the advantages of less "popular" techniques among engineers in Croatia, and also across the world, were emphasized. Environmental impact at the end of the paper is going in favor of the mentioned statements.

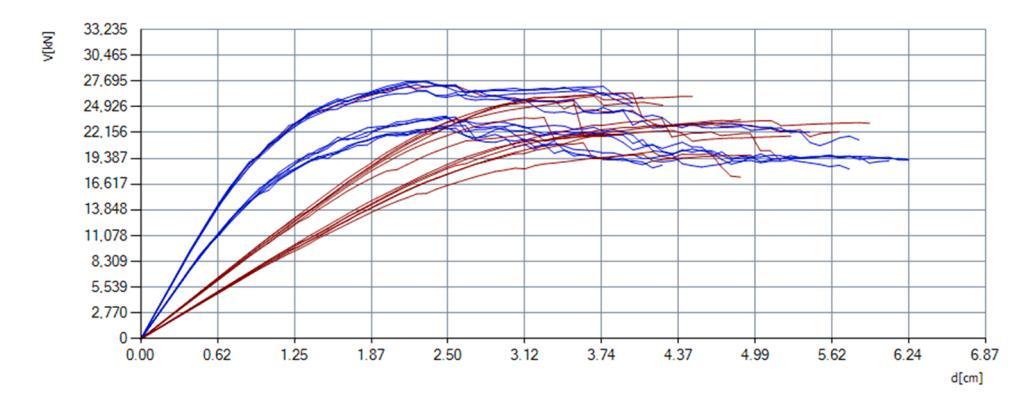
Fig. 15. Pushover curves for model strengthened by FRCM systems and shotcrete for x (blue) and y direction (red).

In the last and third variant, a combination of shotcrete and FRCM system was used (Table 5, Fig. 12). The shotcrete was used on the façade walls and stairwell walls, while the FRCM system was used on the remaining interior walls. Reinforcement meshes Q503 were used for shotcrete application. On the façade walls, they are placed only on the inner face. On the inner walls of the central core and wings, the shotcrete is placed on both faces, because according to the calculations, they are the most critical parts of the building, and it is impossible to strengthen them on one side only. As for FRCM, five different systems were used. The composite is placed on both faces of the walls.

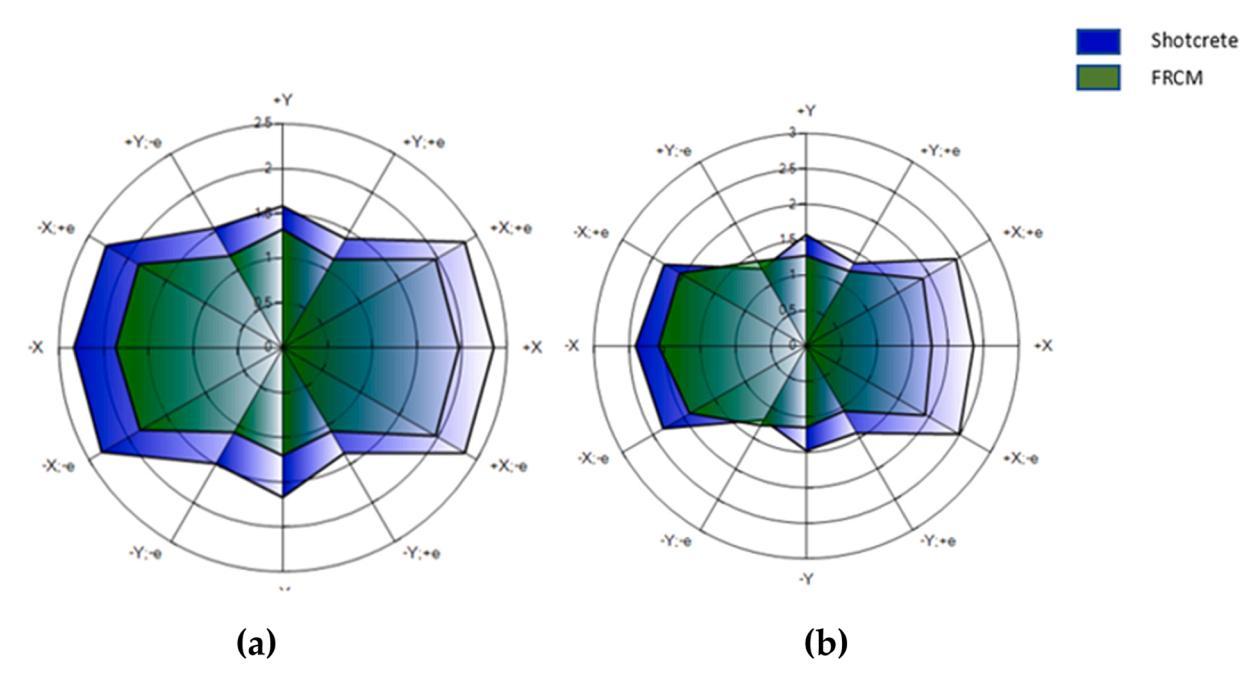
Risk indices vary for each direction, but if the average risk index is taken as the capacity indicator, it is reasonable to conclude that the strengthening by shotcrete is the most favorable variant (Figs. 17, 18).

Fig. 17. Comparison of risk indices of models strengthened by FRCM and model strengthened by shotcrete (a) uniform load distribution; (b) modal load distribution.

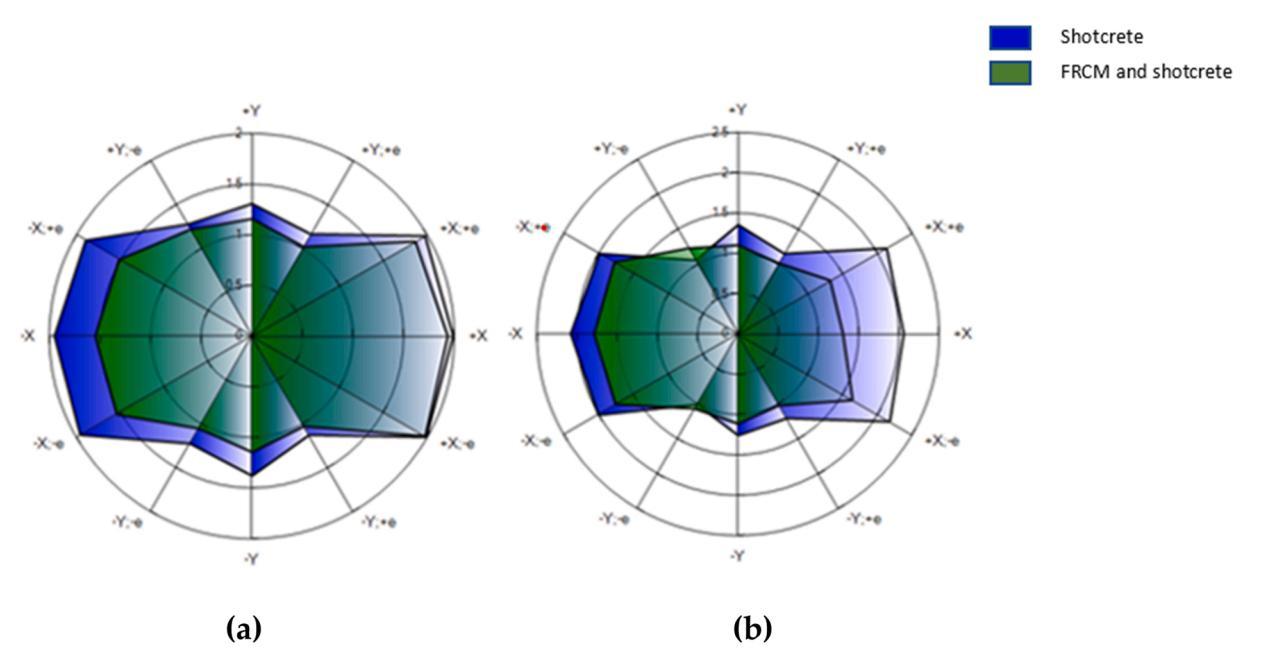
Fig. 18. Comparison of risk indices of model strengthened by FRCM and model strengthened by combination of shotcrete and FRCM (a) uniform load distribution; (b) modal load distribution.

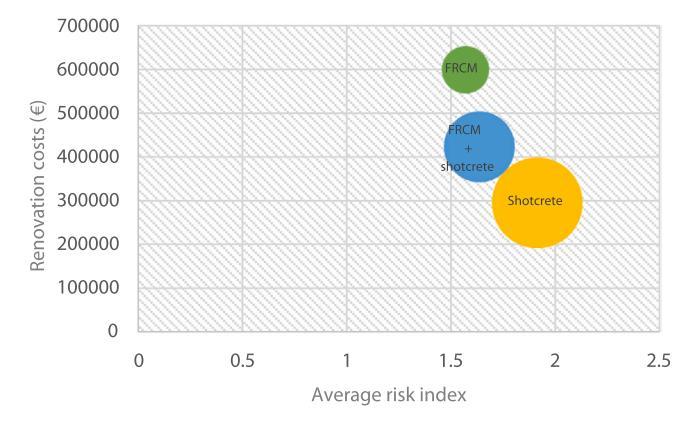
Fig. 19 shows the comparison of strengthening variants considering capacity and renovation costs. Given that the requirements of sustainability in the construction sector are becoming more and more important, the approximate environmental impact was also calculated. The diameter of the circles represents the ratio of  $CO_2$  emissions during the production of the required quantities of materials for each variant of strengthening. It must be noted that ratios do not include the emissions of  $CO_2$  during the phases of transportation, construction, use and demolishing or recycling but only during the material production phase. Carbon dioxide emissions are calculated using software SimaPro [44]. The following values were taken (referring to climate change impact category only): 3,91 kg  $CO_2/kg$  fibers, 282 kg  $CO_2/m^3$  concrete, 5,01 kg  $CO_2/kg$  steel (Table 12). Carbon cost in Croatia in 2020 was estimated to 25,6  $\ell$ /t  $CO_2$ , while it is expected to increase to 93,1  $\ell$ /t  $CO_2$  by 2050 [45]. Total carbon costs for each strengthening variant are displayed in Fig. 20. Although the application of shotcrete is often used in practice and is the only variant by which the resistance of the structure is brought to the level 4 defined by the relevant codes, in this case, its invasiveness and environmental impact should not be neglected.

Fig. 19. Renovation costs, average risk indices and environmental impact.
