Post-Earthquake Rapid Damage Assessment of Road Bridges in Glina County

Abstract: In December 2020, a strong earthquake occurred in Northwestern Croatia with a magnitude of $M_L = 6.3$. The epicenter of this earthquake was located in the town of Petrinja, about 50 km from Zagreb, and caused severe structural damage throughout Sisak-Moslavina county. One of the biggest problems after this earthquake was the structural condition of the bridges, especially since most of them had to be used immediately for demolition, rescue, and the transport of mobile housing units in the affected areas. Teams of civil engineers were quickly formed to assess the damage and structural viability of these bridges and take necessary actions to make them operational again. This paper presents the results of the rapid post-earthquake assessment for a total of eight bridges, all located in or around the city of Glina. For the assessment, a visual inspection was performed according to a previously established methodology. Although most of the inspected bridges were found to be deteriorated due to old age and lack of maintenance, very few of them showed serious damage from the earthquake, with only one bridg

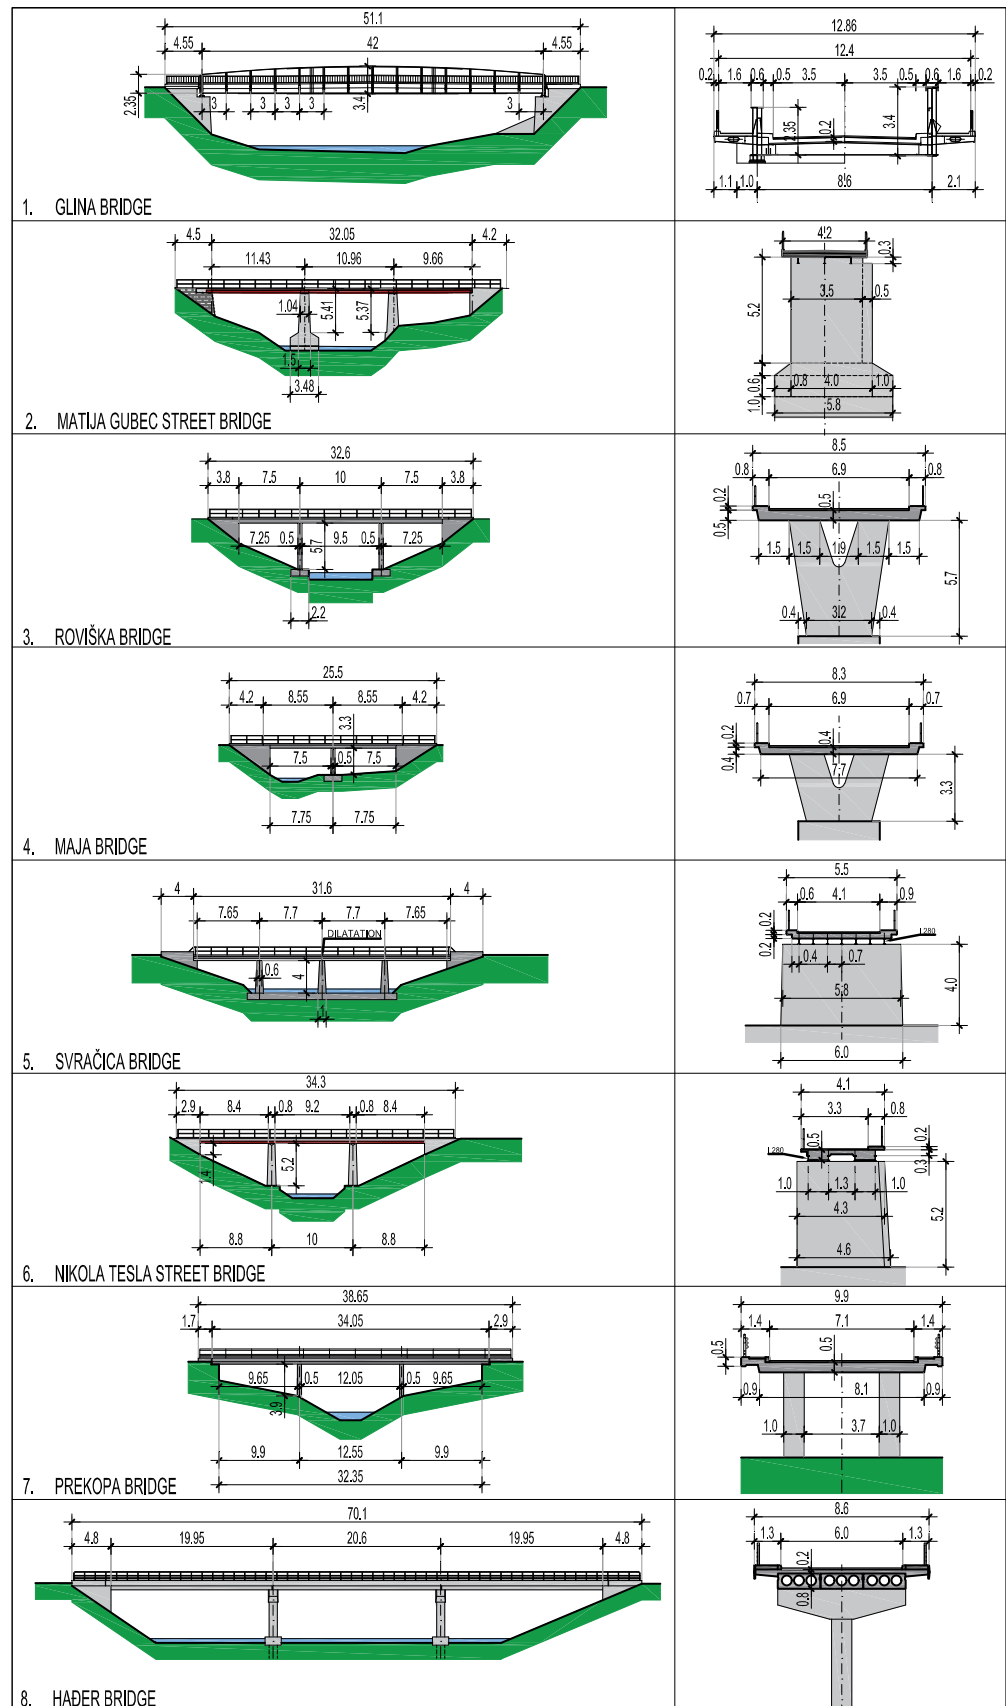
Glna road bridge is the main city bridge over the river Glna, located in the south-west part of the town (Figure 5). It is the newest of all the examined bridges, built in 2003. It is a simply supported girder, crossing the river in one 42 m long span (Figure 6). The superstructure comprises two steel girders with variable height from 2.35 to 3.4 m and at 9.2 m apart (Figure 7a). The concrete road deck is supported by cross girders tapered in-between the main girders, and the footways are supported by consoles on the outside of the main girders. The deck slab is 20 cm thick on the carriageway and 12 cm thick on the footways. The overall width of the bridge is 12.6 m. Abutments are massive, 8.7 m high, reinforced concrete structures. Fixed bearing is positioned on the west abutment, and a movable bearing is on the east abutment. The bridge was found to be in an overall good condition, showing signs of medium structural steel and bearing corrosion, but no loss in the section area due to corrosion was detected. The concrete deck was found to be in almost perfect condition, with no reinforcement corrosion detected. Abutment concrete is also without any damage, there were only small parts of stone cladding detached. The partial erosion of the embankment slope around the abutment wings under the footways consoles was present, but it was not critical or caused by the earthquake.

Figure 6. Glina bridges layouts and cross-sections (units in m).

This bridge is located in the south part of the town, crossing the river Maja and leading to Majske Poljane village (Figure 5). The bridge superstructure is a series of simply supported girders over three spans: 11.43 + 10.96 + 9.66 m (Figure 6). The cross-section comprises three steel girders of 355 mm in height placed at 160 cm apart, as well as an 18 cm thick concrete deck (considering the age of the bridge, the level of section's composite behavior was unknown). The width of the superstructure is 4.15 m. The superstructure is directly supported by columns and abutments without any bearings. Abutments are massive structures, about 4 m high and 4.5 m long. It was evident that the bridge had undergone reconstruction in the past since one of the abutments was found to be a reinforced concrete structure and the other was found to be masonry structure from stone blocks. Its columns are massive, reinforced concrete structures that are 8 and 6.4 m high and 4 m wide. The east column was found to have visible scour signs, with parts of the foundation soil missing. The west column was shown to have a much wider and longer foundation (5.8×3.5 m) than the east column (4×2 m), which suggests that the west column foundation underwent a rehabilitation in the past. This was probably due to scour developing under the west column sooner due to its position in the middle of the riverbed (Figure 8a). It is evident that the bridge was in a poor structural state even

This bridge is located in the south access road to the town Glina (Figure 5). It is a reinforced concrete slab bridge with over three spans of 7.5 + 10 + 7.5 m (Figure 6). The superstructure comprises a 50 cm thick reinforced concrete slab that is directly supported by wide columns branching at the top. The width of the bridge is 8.5 m, columns are of variable cross-section between 3.2 × 0.5 m at the bottom and two branches (arms) at the top, each 1.5 × 0.5 m. The height of the columns is 5.7 m. The abutments are massive reinforced concrete structures with about 3–4 m high walls and 3.8 m long wings. Column foundations are 4.0 × 2.2 m slabs. There are no bearings present on the bridge and bridge is without any drainage elements. There was visible damage on the abutment walls, where the corner part of the side walls was found to be missing on both abutments, and reinforcement bars were protruding out of concrete (Figure 9a).

Maja bridge is located just south of previous Roviška bridge (Figure 5), and it is of similar type but smaller length. The bridge is also a continuous girder slab bridge with over two spans of 7.5 + 7.5 m (Figure 6). The slab girder is 35 cm thick and 7.7 m wide, with short consoles on both sides. The superstructure is skewed in regard to abutments, columns, and the riverbed (Figure 10a). Height of the columns and abutments is about 3.5 m. There were no bearings or expansion joints causing dilatation cracks in the asphalt. There was also a visible vertical dilatation crack between the abutment wall and wing, suggesting that they were not fixed together and moved separately. The superstructure concrete was seen to be in relatively good condition, without signs of progressive reinforcement corrosion or concrete spalling but with visible signs of discoloration due to water leakage. Although drainage was present on the bridge, gutters were clogged and caused water to seep through the concrete slab. The slab consoles (footways) were observed to be heavily degraded due to a lack of waterproofing and poor concrete quality. Abutment walls were exposed to water draining from above (Figure 10b). There was no visible damage due to the earthquake. No new cracks or movements of the substructure or superstructure elements were detected. No restrictions regarding traffic were given. Further inspection and maintenance were recommended due to the noticeable water leakage due to failed waterproofing and drainage.

Svračica bridge is the furthest south bridge from town Glina that was examined (Figure 5). Its superstructure is a series of two continuous composite girders with over four even spans of 7.7 m (Figure 6). Dilatation is in the middle of the bridge. The superstructure comprises a multi-girder composite cross-section with 7 I280 steel girders placed 0.7 m apart, and a 20 cm thick reinforced concrete deck slab. The superstructure is 5.45 m wide in total, with 4.05 m wide roadway and asymmetric footways of 0.55 and 0.85 m partly supported by deck consoles (Figure 6). Columns are massive, 4 m high reinforced concrete structures with a variable cross-section ranging from 6 × 1 m at the bottom to 5.8 × 0.6 m at the top. All columns have a joint foundation slab that covers the whole riverbed (two spans), approximately 18 m long and 10 m wide. Abutments are minimal structures, about 2 m high and 4 m long with variable width and skewed abutment wings due to a road junction located immediately at their end. The superstructure is directly supported on the substructure elements without bearings. The bridge was in fairly good structural condition, showing moderate signs of steel girder corrosion, mostly in the vicinity of their supports (abutments) due to the longitudinal displacements at the ends of the bridge not being properly managed (no bearings) and water leakage from behind the abutment wall (Figure 11a). Since expansion joints are not present on the bridge, cracks

Nikola Tesla street bridge is located in the northeast part of town (Figure 5). It is a three span continuous girder bridge of 9.2 + 10 + 9.2 m (Figures 6 and 12a). Its superstructure comprises four I280 steel girders and two 52 cm high concrete ribs that are concreted in between two pairs of steel girders (Figure 6). Steel girders are thus partly concreted inside these ribs, also serving as a side formwork for concrete. The width of the concrete ribs is 1.0 m, and the inside distance between the ribs is 1.3 m. The width of the superstructure is 4.1 m, with an asymmetrical traffic area and footway only on one side. The superstructure is directly supported by columns and abutments. Columns are 5.2 m high, 4.3–4.6 m wide in the transverse, and 0.8–1 m wide in the longitudinal direction.

Prekopa bridge crosses the river Maja at the north access road to Glina (Figure 5). The bridge has a continuous girder slab superstructure with over three spans of 10.15 + 12.55 + 10.15 m (Figure 6). Its reinforced concrete slab is 50 cm thick and 8.1 m wide, with 0.9 m consoles on each side. Its superstructure is supported by twin 3.9 m high columns at each side of the riverbed (the cross-section of each column is 1.0 × 0.5 m) and 2 m high and 1.7 m long abutments. There are no bearings on the bridge, and supports are realized as concrete hinged sections at the top of the substructure elements (Figure 13a). In comparison to the other examined bridges, this bridge was found to be fairly new, erected in 1999. An open drainage system and waterproofing were observed, so no serious long-term water damage was found.
