Post-Earthquake Rapid Damage Assessment of Road Bridges in Glina County

Source / Izvornik: **Buildings, 2022, 12(1)**

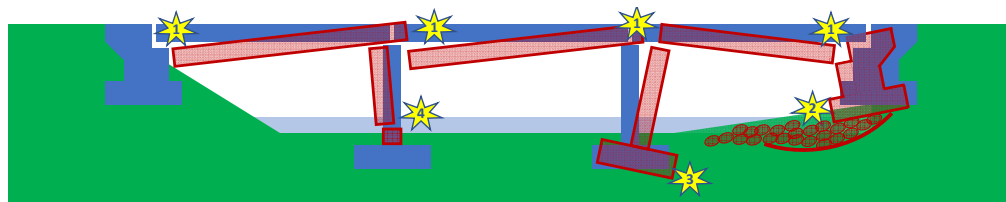
Figure 4. Most common earthquake types of bridge sudden collapses (any or all can occur): 1—bearing slippage; 2—abutment foundation soil landslide; 3—column turnover; 4—column shear failure.
