# Post-Earthquake Rapid Damage Assessment of Road Bridges in Glina County

Source / Izvornik: **Buildings, 2022, 12(1)**

**Journal article, Published version**

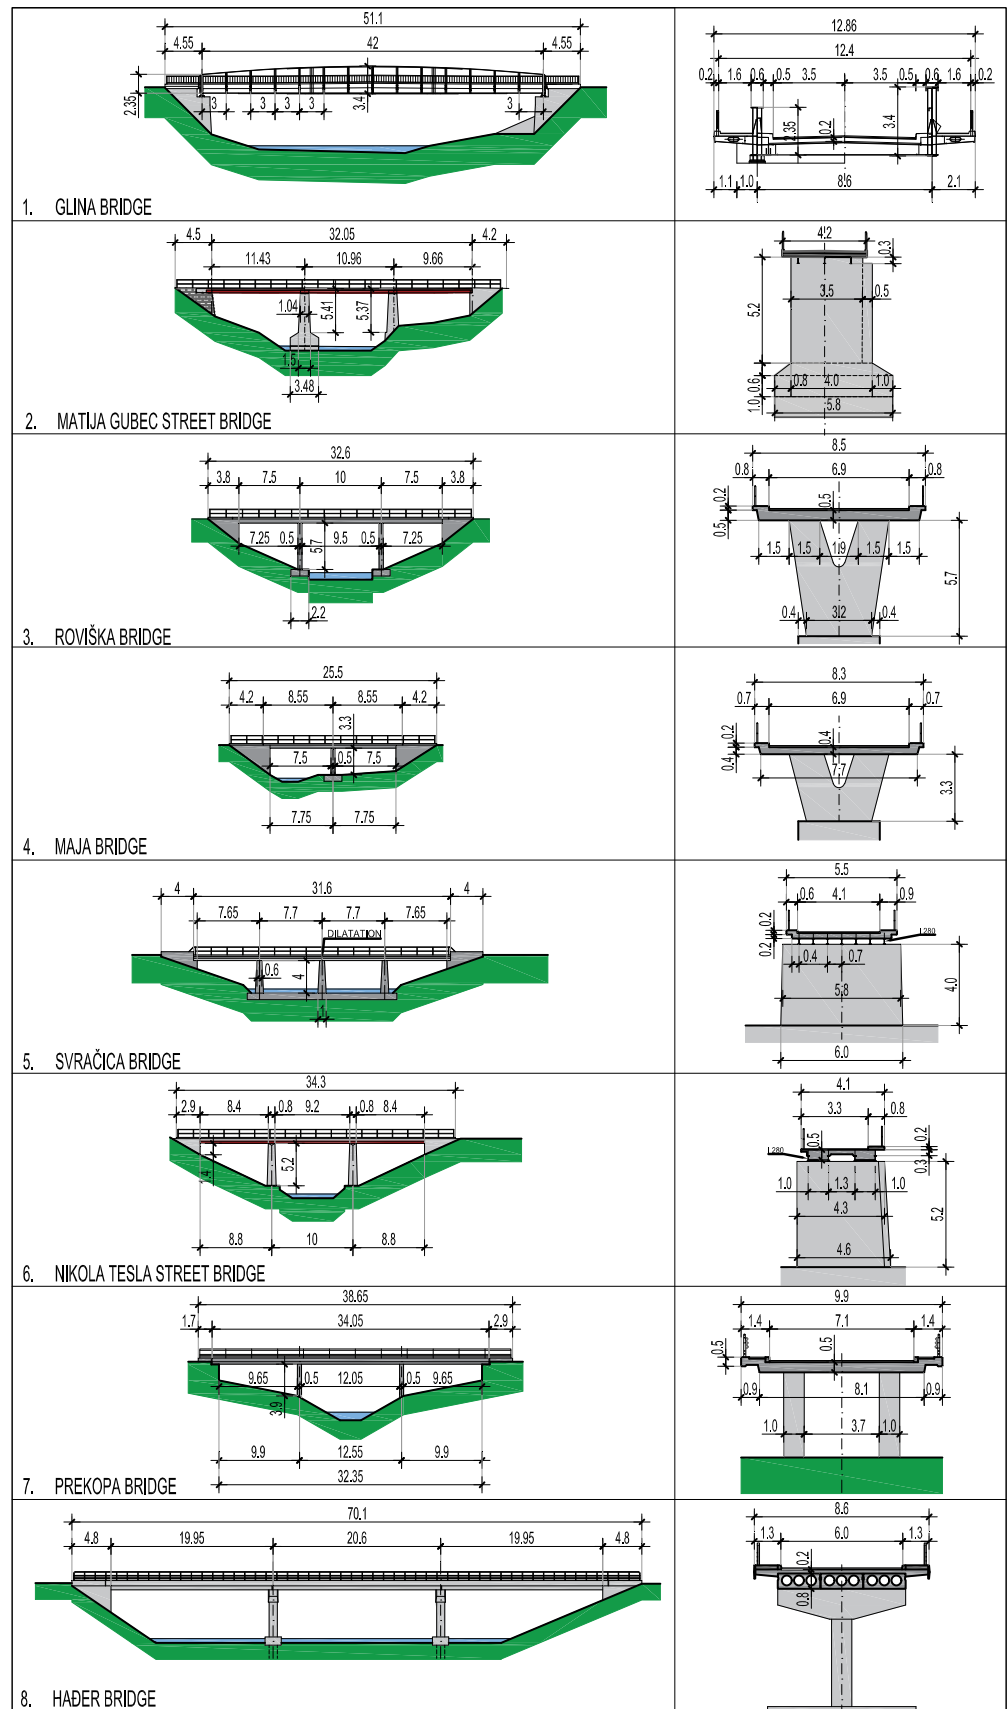
Figure 6. Glina bridges layouts and cross-sections (units in m).

Glna road bridge is the main city bridge over the river Glna, located in the south-west part of the town (Figure 5). It is the newest of all the examined bridges, built in 2003. It is a simply supported girder, crossing the river in one 42 m long span (Figure 6). The superstructure comprises two steel girders with variable height from 2.35 to 3.4 m and at 9.2 m apart (Figure 7a). The concrete road deck is supported by cross girders tapered in-between the main girders, and the footways are supported by consoles on the outside of the main girders. The deck slab is 20 cm thick on the carriageway and 12 cm thick on the footways. The overall width of the bridge is 12.6 m. Abutments are massive, 8.7 m high, reinforced concrete structures. Fixed bearing is positioned on the west abutment, and a movable bearing is on the east abutment. The bridge was found to be in an overall good condition, showing signs of medium structural steel and bearing corrosion, but no loss in the section area due to corrosion was detected. The concrete deck was found to be in almost perfect condition, with no reinforcement corrosion detected. Abutment concrete is also without any damage, there were only small parts of stone cladding detached. The partial erosion of the embankment slope around the abutment wings under the footways consoles was present, but it was not critical or caused by the earthquake.

This bridge is located in the south part of the town, crossing the river Maja and leading to Majske Poljane village (Figure 5). The bridge superstructure is a series of simply supported girders over three spans: 11.43 + 10.96 + 9.66 m (Figure 6). The cross-section comprises three steel girders of 355 mm in height placed at 160 cm apart, as well as an 18 cm thick concrete deck (considering the age of the bridge, the level of section's composite behavior was unknown). The width of the superstructure is 4.15 m. The superstructure is directly supported by columns and abutments without any bearings. Abutments are massive structures, about 4 m high and 4.5 m long. It was evident that the bridge had undergone reconstruction in the past since one of the abutments was found to be a reinforced concrete structure and the other was found to be masonry structure from stone blocks. Its columns are massive, reinforced concrete structures that are 8 and 6.4 m high and 4 m wide. The east column was found to have visible scour signs, with parts of the foundation soil missing. The west column was shown to have a much wider and longer foundation ( $5.8 \times 3.5$  m) than the east column ( $4 \times 2$  m), which suggests that the west column foundation underwent a rehabilitation in the past. This was probably due to scour developing under the west column sooner due to its position in the middle of the riverbed (Figure 8a). It is evident that the bridge was in a poor structural state even

This bridge is located in the south access road to the town Glina (Figure 5). It is a reinforced concrete slab bridge with over three spans of 7.5 + 10 + 7.5 m (Figure 6). The superstructure comprises a 50 cm thick reinforced concrete slab that is directly supported by wide columns branching at the top. The width of the bridge is 8.5 m, columns are of variable cross-section between 3.2 × 0.5 m at the bottom and two branches (arms) at the top, each 1.5 × 0.5 m. The height of the columns is 5.7 m. The abutments are massive reinforced concrete structures with about 3–4 m high walls and 3.8 m long wings. Column foundations are 4.0 × 2.2 m slabs. There are no bearings present on the bridge and bridge is without any drainage elements. There was visible damage on the abutment walls, where the corner part of the side walls was found to be missing on both abutments, and reinforcement bars were protruding out of concrete (Figure 9a).

Maja bridge is located just south of previous Roviška bridge (Figure 5), and it is of similar type but smaller length. The bridge is also a continuous girder slab bridge with over two spans of 7.5 + 7.5 m (Figure 6). The slab girder is 35 cm thick and 7.7 m wide, with short consoles on both sides. The superstructure is skewed in regard to abutments, columns, and the riverbed (Figure 10a). Height of the columns and abutments is about 3.5 m. There were no bearings or expansion joints causing dilatation cracks in the asphalt. There was also a visible vertical dilatation crack between the abutment wall and wing, suggesting that they were not fixed together and moved separately. The superstructure concrete was seen to be in relatively good condition, without signs of progressive reinforcement corrosion or concrete spalling but with visible signs of discoloration due to water leakage. Although drainage was present on the bridge, gutters were clogged and caused water to seep through the concrete slab. The slab consoles (footways) were observed to be heavily degraded due to a lack of waterproofing and poor concrete quality. Abutment walls were exposed to water draining from above (Figure 10b). There was no visible damage due to the earthquake. No new cracks or movements of the substructure or superstructure elements were detected. No restrictions regarding traffic were given. Further inspection and maintenance were recommended due to the noticeable water leakage due to failed waterproofing and drainage.

Svračica bridge is the furthest south bridge from town Glina that was examined (Figure 5). Its superstructure is a series of two continuous composite girders with over four even spans of 7.7 m (Figure 6). Dilatation is in the middle of the bridge. The superstructure comprises a multi-girder composite cross-section with 7 I280 steel girders placed 0.7 m apart, and a 20 cm thick reinforced concrete deck slab. The superstructure is 5.45 m wide in total, with 4.05 m wide roadway and asymmetric footways of 0.55 and 0.85 m partly supported by deck consoles (Figure 6). Columns are massive, 4 m high reinforced concrete structures with a variable cross-section ranging from 6 × 1 m at the bottom to 5.8 × 0.6 m at the top. All columns have a joint foundation slab that covers the whole riverbed (two spans), approximately 18 m long and 10 m wide. Abutments are minimal structures, about 2 m high and 4 m long with variable width and skewed abutment wings due to a road junction located immediately at their end. The superstructure is directly supported on the substructure elements without bearings. The bridge was in fairly good structural condition, showing moderate signs of steel girder corrosion, mostly in the vicinity of their supports (abutments) due to the longitudinal displacements at the ends of the bridge not being properly managed (no bearings) and water leakage from behind the abutment wall (Figure 11a). Since expansion joints are not present on the bridge, cracks

Nikola Tesla street bridge is located in the northeast part of town (Figure 5). It is a three span continuous girder bridge of 9.2 + 10 + 9.2 m (Figures 6 and 12a). Its superstructure comprises four I280 steel girders and two 52 cm high concrete ribs that are concreted in between two pairs of steel girders (Figure 6). Steel girders are thus partly concreted inside these ribs, also serving as a side formwork for concrete. The width of the concrete ribs is 1.0 m, and the inside distance between the ribs is 1.3 m. The width of the superstructure is 4.1 m, with an asymmetrical traffic area and footway only on one side. The superstructure is directly supported by columns and abutments. Columns are 5.2 m high, 4.3–4.6 m wide in the transverse, and 0.8–1 m wide in the longitudinal direction.

Prekopa bridge crosses the river Maja at the north access road to Glina (Figure 5). The bridge has a continuous girder slab superstructure with over three spans of 10.15 + 12.55 + 10.15 m (Figure 6). Its reinforced concrete slab is 50 cm thick and 8.1 m wide, with 0.9 m consoles on each side. Its superstructure is supported by twin 3.9 m high columns at each side of the riverbed (the cross-section of each column is 1.0 × 0.5 m) and 2 m high and 1.7 m long abutments. There are no bearings on the bridge, and supports are realized as concrete hinged sections at the top of the substructure elements (Figure 13a). In comparison to the other examined bridges, this bridge was found to be fairly new, erected in 1999. An open drainage system and waterproofing were observed, so no serious long-term water damage was found.

Hađer bridge is just north of town Glina, leading to a nearby settlements west of the river Glina (Figure 5). It crosses river Glina just at the mouth of river Maja. It is the longest of all the bridges, with relatively large spans and tallest columns, so the seismic action was certainly the highest here. Being built in 1987, it was presumably designed with a certain degree of seismic behavior in mind. The bridge comprises a series of one continuous slab girder with over two spans of 19.95 + 20.6 m and one simply supported girder spanning 19.95 m (Figure 6). Between these girders, there is a visible dilatation above one pier (Figure 14d). The superstructure comprises three hollow girders (each girder with a 210 × 75 cm cross-section) connected by longitudinal in situ concrete joints and in situ 20 cm thick concrete deck plate above them. The deck plate continues to consoles at each side of the cross-section to support footways. This type of cross-section can be regarded as a slab cross-section. The overall width of the superstructure is 8.6 m. The substructure comprises two single circular cross-section columns with a wide consoled head cross girder to accommodate the supports of each girder. The abutments are massive reinforced concrete structures. The bridge has no drainage system, no bearings, and no expansion joints, all of which resulted in durability problems and limited displacement capacity (as is elaborated later). The bridge showed signs of heavy water leakage from the superstructure on abutment walls, causing concrete degradation and spalling, and reinforcement corrosion on both the superstructure and abutment (Figure 14c). The same problem was present at the dilatation above the central column, where the water is leaking through the dilatation and causing damage to the ends of the girder slabs. The head of the column, as well as the abutment wall and wing console (Figure 14c,d), already showed progressive reinforcement corrosion, with parts of the concrete protective layer missing due to delamination. There were wide visible cracks in the column head girder and visible reinforcement bars due to corrosion (Figure 14d). It was also noticeable that the girders were not symmetrically supported on the column head, i.e., one girder was found to have a longer support length than the other, which was not correctly executed in the erection process. This poses a potential danger in an event of even stronger earthquake since inadequate support length could cause the girder to slip from the column head. No horizontal seismic limiting element was found, so only support length insured this from happening.
