# Post-Earthquake Condition Assessment and Seismic Upgrading Strategies for a Heritage-Protected School in Petrinja, Croatia

Source / Izvornik: **Buildings, 2022, 12(12)**

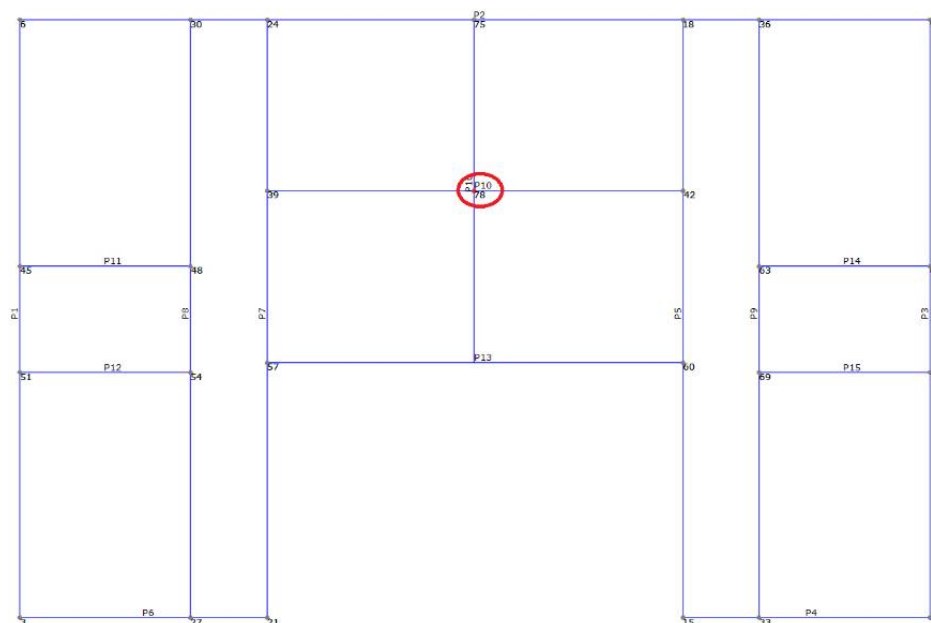
**Figure 13.** Position of the selected control mode on the top floor.

Another important parameter that needs to be defined for pushover analysis is the control node, whose displacement is used to draw the capacity curve. The control node is located on the top floor and as close as possible to the center of mass. The selected node is shown in Figure 13.

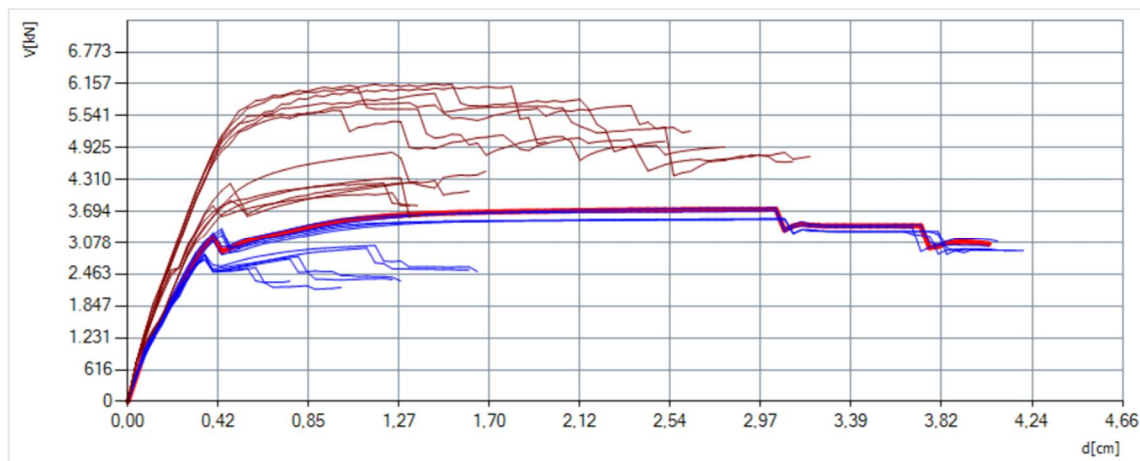
**Figure 14.** Capacity curves for  $x$  (blue) and  $y$  (red) direction. The bright red color represents a critical result.

The results of the performed analyses are presented as 24 corresponding capacity curves (Figure 14).

Table 4 shows the values of the vulnerability index for the most significant analysis in the  $x$  and  $y$  directions. Since the values for both Significant Damage and Damage Limitation limit states are lower than 1.00, it can be concluded that the current building structure is deficient and requires seismic strengthening.

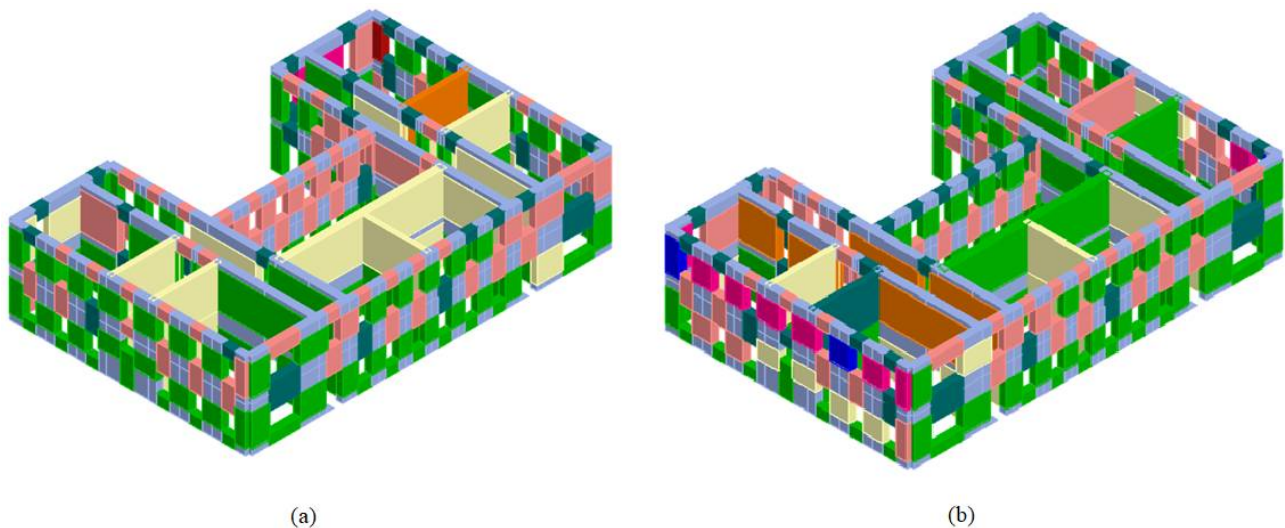
**Figure 15.** 3D view of damage for the most significant pushover analysis: (a) in  $x$ -direction; (b) in  $y$ -direction.

Figure 15 shows a 3D representation of different types of damage to the building at the last step of the pushover analysis. In  $x$  direction, most of the damage is bending (pink color) and shear (beige and orange color) damage, but serious failure has not yet occurred. This is not the case for the  $y$  direction where the wall elements of the southwestern façade are in serious crisis (pink color) and are failing during the elastic phase (blue color). This is in accordance with the actual recorded damage of the building.

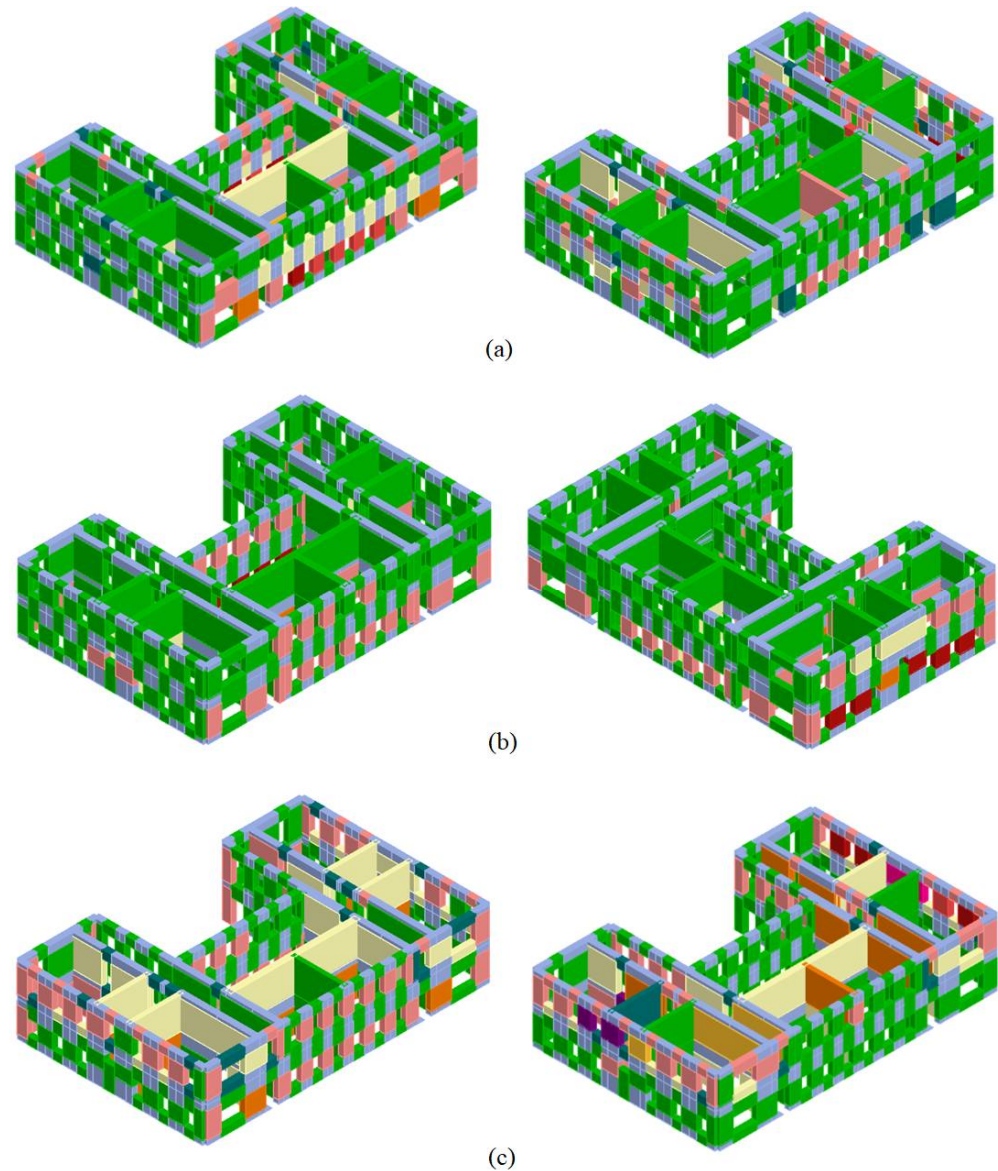
**Figure 24.** Three-dimensional visualization of damage in the last step of the most significant pushover analyses in  $x$  and  $y$  direction: (a) FRCM strengthening; (b) FRP strengthening; (c) shotcrete strengthening.

All 24 pushover analyses for all strengthening methods satisfied this check. A 3D visualization of damage for the most significant analysis in  $x$  and  $y$  directions for all strengthening methods is shown in Figure 24.

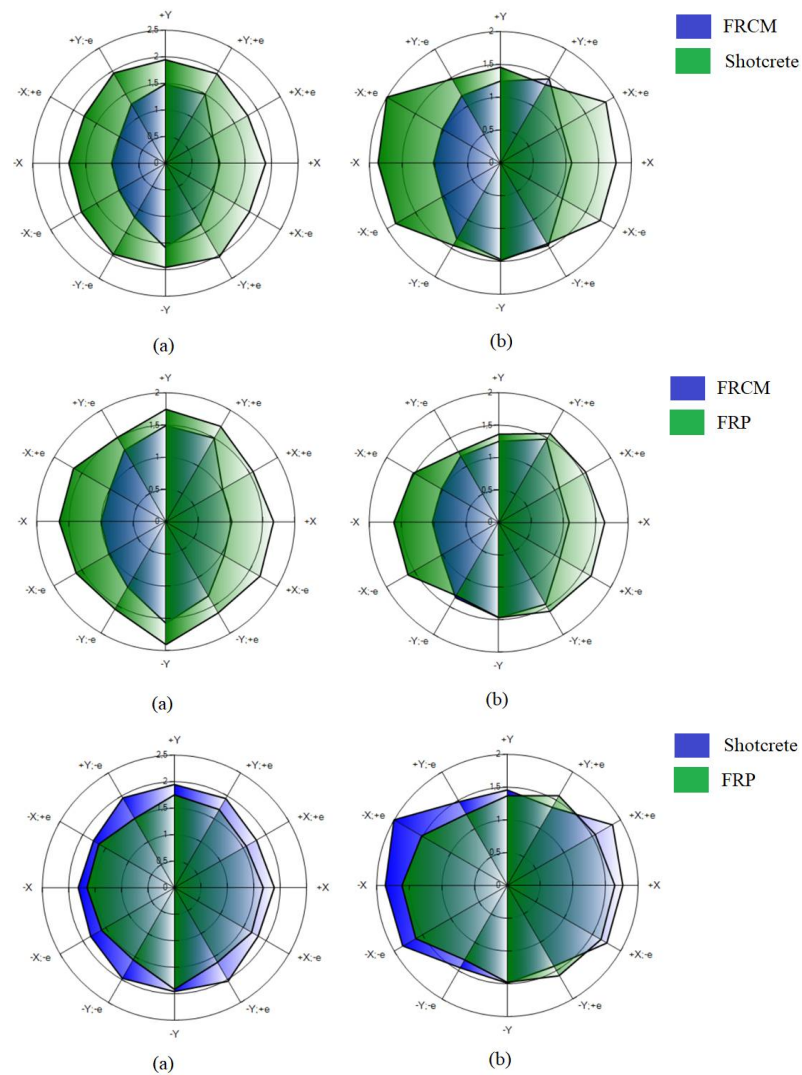
Figure 25. Comparison of vulnerability indices (Significant Damage limit state) of the different strengthening methods: (a) uniform load distribution; (b) modal load distribution.

A graphical comparison of vulnerability indices for all 24 pushover analyses is shown in Figure 25. Figure 26 shows the comparison of the risk indices for the unreinforced model and all reinforcement variants. The results show that the highest values of the vulnerability index are mostly obtained for the model reinforced with shotcrete.

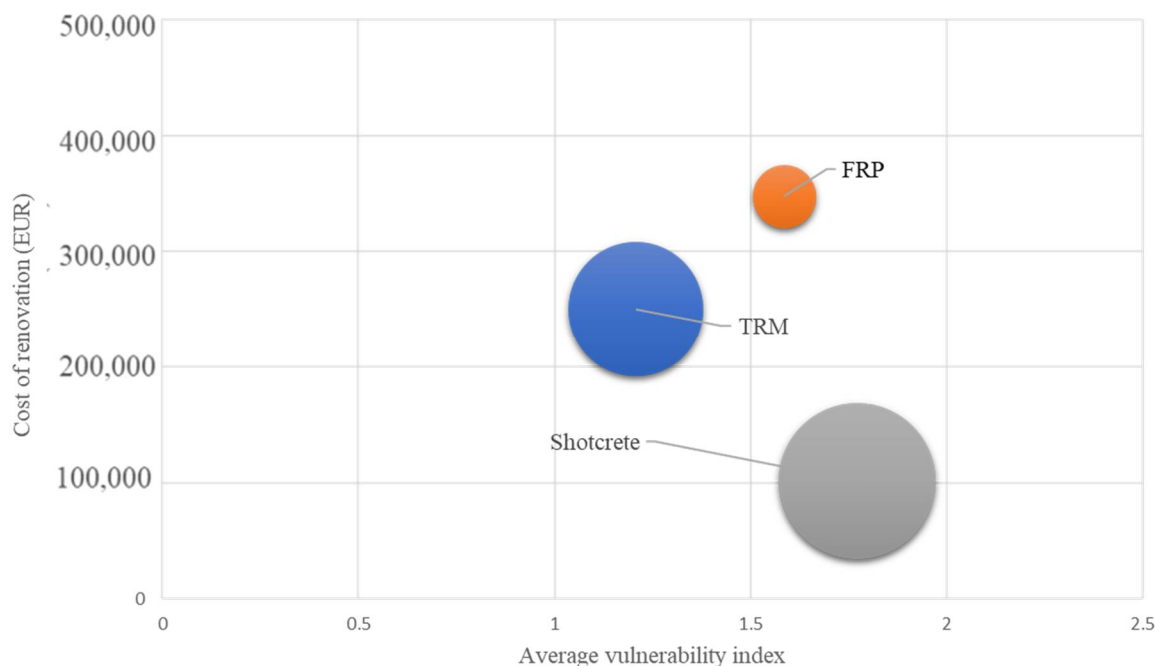
**Figure 27.** Comparison of methods based on renovation costs, average vulnerability index, and environmental impact.

The final goal of this paper is to compare the strengthening methods based on the achieved earthquake capacity, cost, and environmental impact (Figure 27). The diameter of the bubbles represents the CO<sub>2</sub> emissions. The production of concrete emits the largest amount of CO<sub>2</sub> but, from an economic standpoint, this option is the most favorable. Furthermore, glass fibers have a much smaller carbon footprint than concrete and, despite the slightly higher price, the application of the FRCM system should be seriously considered. The FRP system, despite low CO<sub>2</sub> emissions, is quite costly compared to the other variants.
