Post-Earthquake Condition Assessment and Seismic Upgrading Strategies for a Heritage-Protected School in Petrinja, Croatia

Post-Earthquake Condition Assessment and Seismic Upgrading Strategies for a Heritage-Protected School in Petrinja, Croatia. *Buildings* **2022**, *12*, 2263. <https://doi.org/10.3390/buildings12122263>

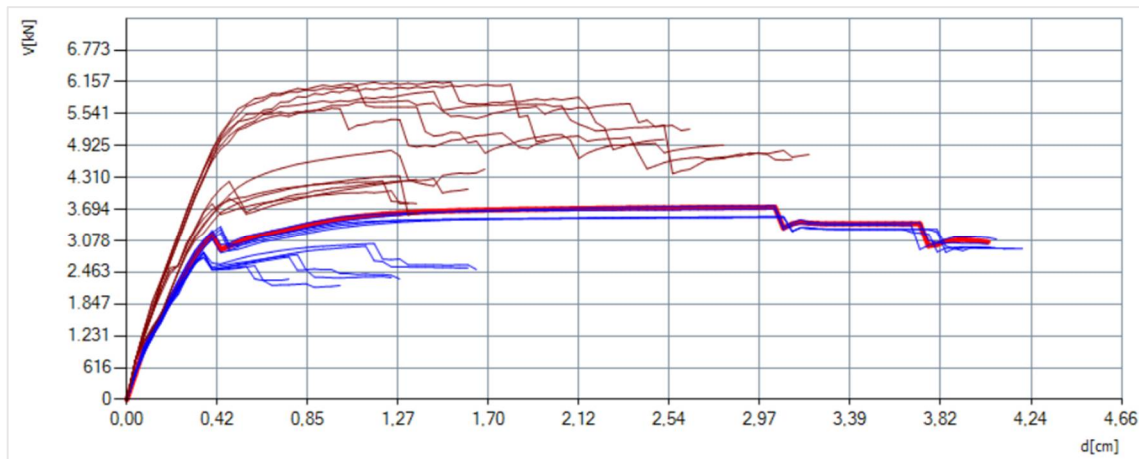
Figure 14. Capacity curves for x (blue) and y (red) direction. The bright red color represents a critical result.

The results of the performed analyses are presented as 24 corresponding capacity curves (Figure 14).

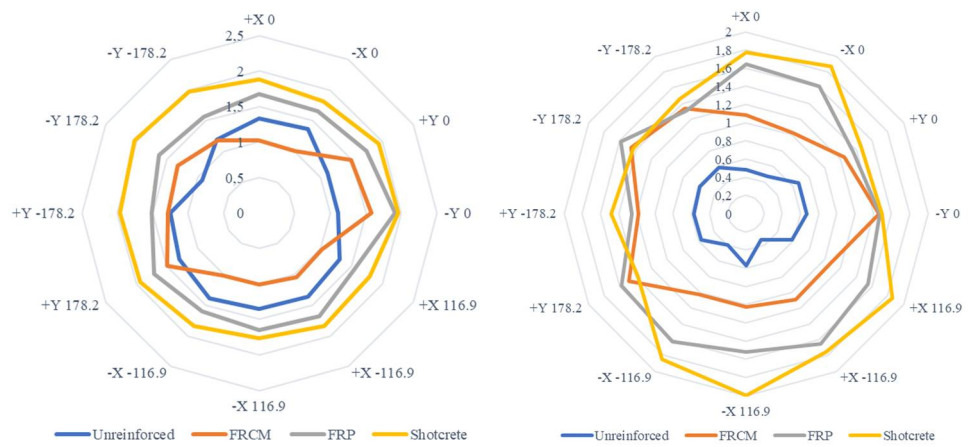
Figure 26. Comparison of vulnerability indices (Significant Damage limit state) of the unreinforced model and all strengthening methods (uniform load distribution—(left), modal load distribution—(right)).

A graphical comparison of vulnerability indices for all 24 pushover analyses is shown in Figure 25. Figure 26 shows the comparison of the risk indices for the unreinforced model and all reinforcement variants. The results show that the highest values of the vulnerability index are mostly obtained for the model reinforced with shotcrete.

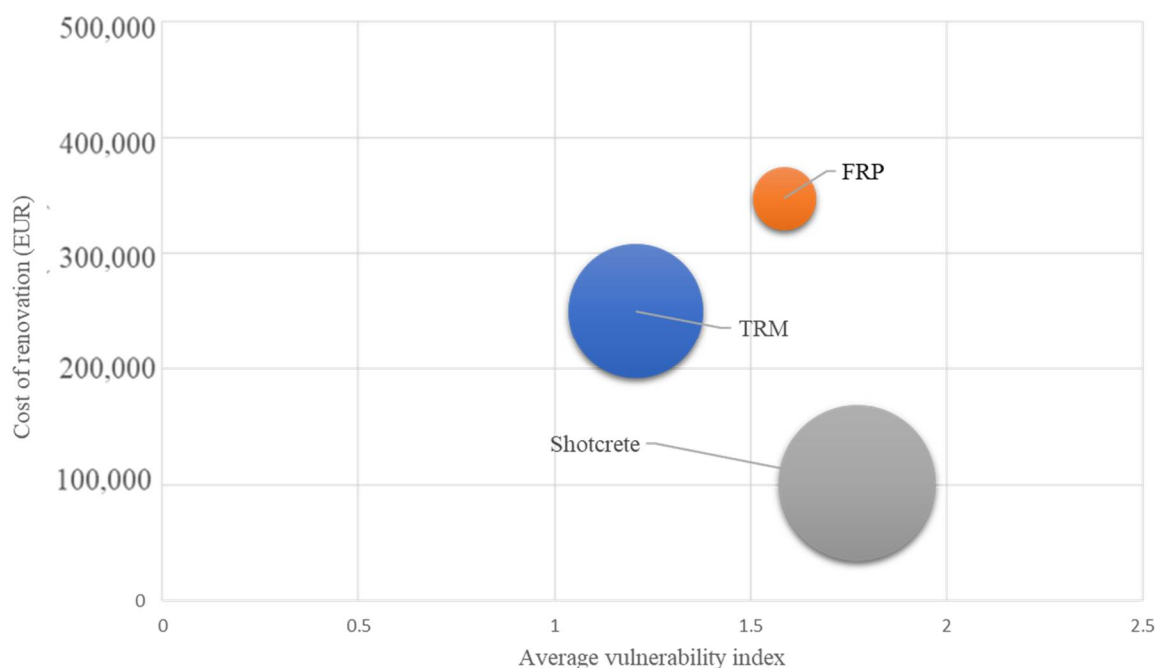
Figure 27. Comparison of methods based on renovation costs, average vulnerability index, and environmental impact.

The final goal of this paper is to compare the strengthening methods based on the achieved earthquake capacity, cost, and environmental impact (Figure 27). The diameter of the bubbles represents the CO₂ emissions. The production of concrete emits the largest amount of CO₂ but, from an economic standpoint, this option is the most favorable. Furthermore, glass fibers have a much smaller carbon footprint than concrete and, despite the slightly higher price, the application of the FRCM system should be seriously considered. The FRP system, despite low CO₂ emissions, is quite costly compared to the other variants.
