# The Assessment and Retrofitting of Cultural Heritage—A Case Study of a Residential Building in Glina

**Abstract:** The focus of the study is on the renovation of a specific case study, which is a 19th century building under cultural heritage protection. It highlights the particular challenges faced by civil engineers in the structural renovation of buildings that are under heritage protection. Preserving the identity of these buildings limits the available methods for strengthening their seismic capacity. At the beginning, information about the seismic activity and the different post-earthquake evaluation procedures are presented to identify the damage and take appropriate further steps. Then, basic information about the building is given and supported by graphic attachments. In the following, the methods and materials are explained, focusing on in situ testing with the semi-destructive flat-jack method and the analysis of the structure with the nonlinear method implemented in the software. Subsequently, the obtained results are presented and discussed, accompanied by graphics. An approach for strengthening the structure is presented, which includes a combination of traditional

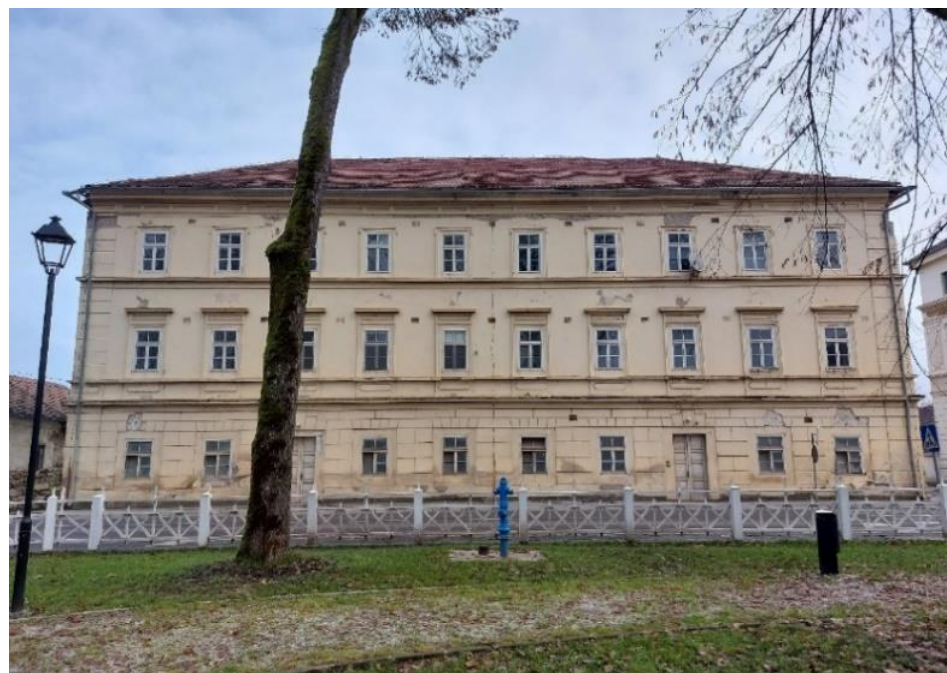
**Figure 2.** South-west facade of case study building.

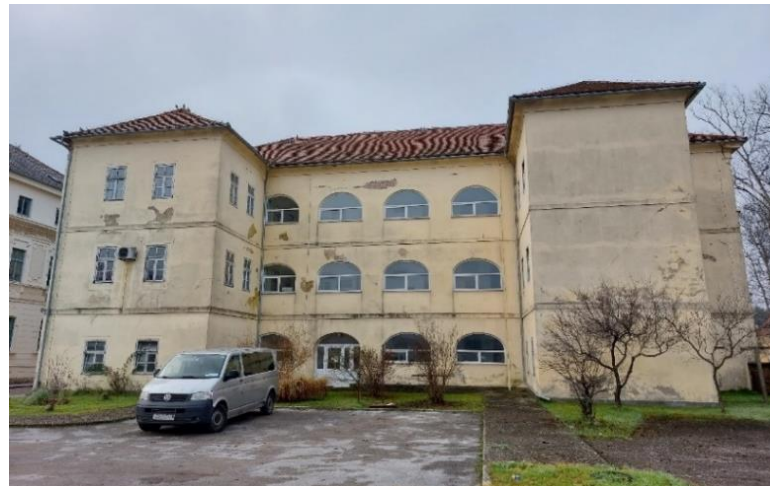
**Figure 3.** North-east facade of case study building.

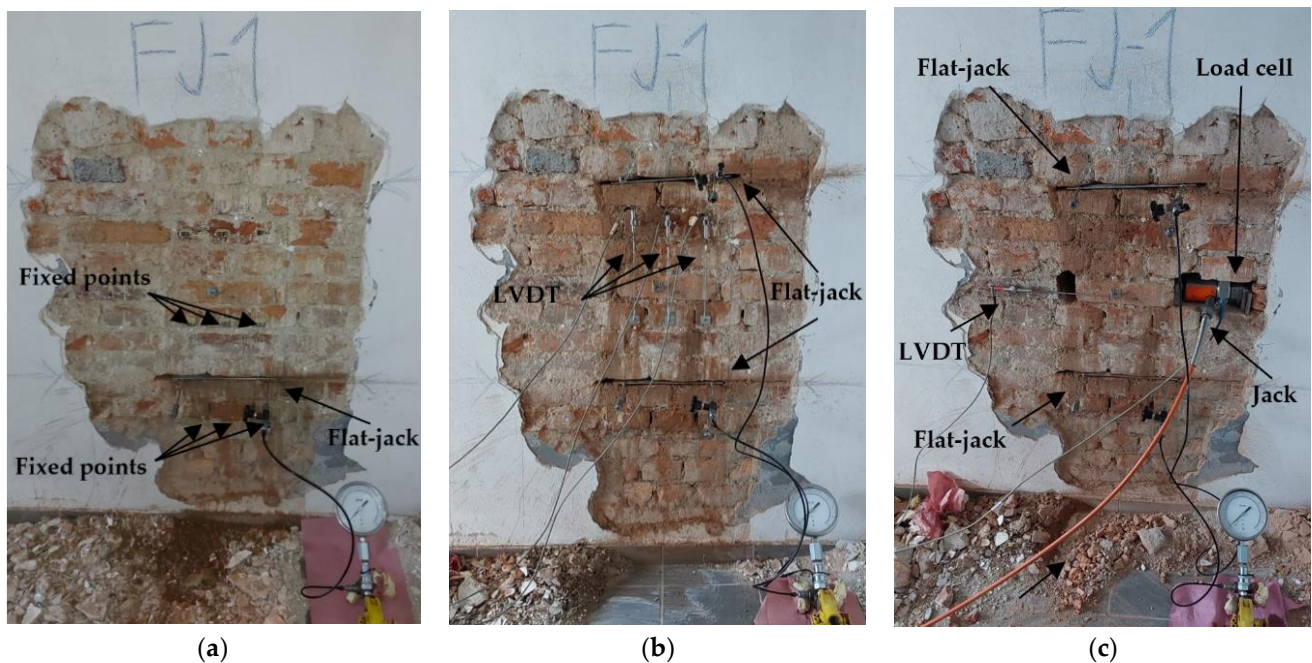
**Figure 12.** Flat-jack method: (a) single flat-jack test, (b) double flat-jack test, and (c) shear test.

The principle of the single flat-jack test is to partially relieve the compressive stress in the wall by removing the mortar from the horizontal bed joint. This is achieved by making the opening with an eccentric circular saw. The stress is then compensated by means of a flat-jack inserted in the opening. The stress is gradually increased until the original stress and strain state is established, which is verified by measuring the displacements perpendicular to the opening. Measurements are made with a portable extensometer, and fixed measurement points glued to the bricks can be seen in Figure 12a. The results of the single flat-jack tests are shown in Table 1.

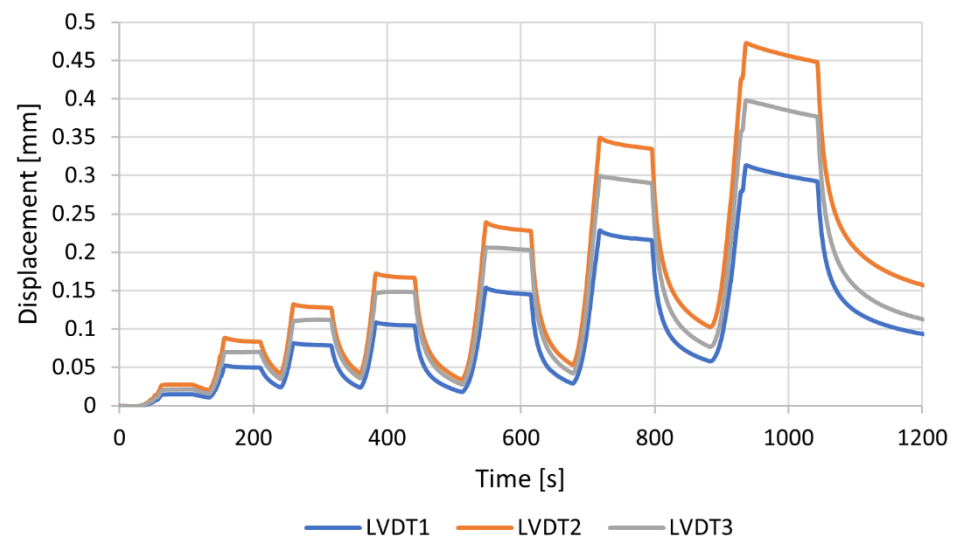
To determine the stress–strain behavior of masonry in compression and the modulus of elasticity of masonry, it is necessary to use another flat-jack placed above the first one (a double flat-jack test). Flat-jacks are inserted into parallel horizontal openings and pressure is applied gradually. In this phase, the displacement gauges (LVDTs) are placed vertically between the flat-jacks, as in Figure 12b. Simultaneously with the application of vertical pressure with the flat-jacks, the displacement is measured (Figure 13), which allows the stress–strain behavior and modulus of elasticity to be determined. For reference, see [27]. The resulting values for the double flat-jack tests are listed in Table 2.

**Figure 13.** Measured displacement during double flat-jack test.

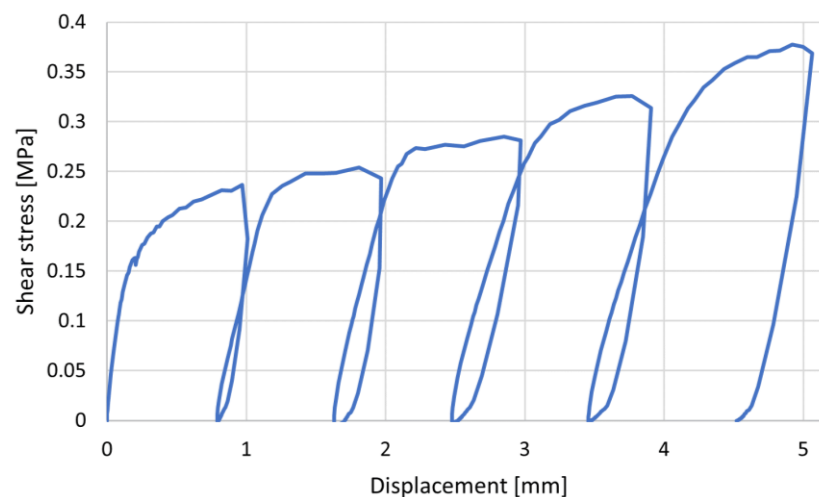
After the double flat-jack test, the shear (shove) test follows in the same location. Both flat-jacks with an additional horizontal hydraulic jack are used for this test (Figure 12c). The displacement gauges used in the previous phases are removed and a horizontal displacement gauge is mounted. In this phase, a horizontal brick (oriented so that a mayor dimension of the brick is parallel to the wall) is pushed until failure, that is, until it slips. This process is repeated for several vertical stress levels (Figure 14). Flat-jacks allow the control of the vertical stress at the test location. As a result, this provides the relationship between the shear stress and the vertical compressive stress. From this relationship, a best-fitting line can be drawn. The angle of this line represents the coefficient of friction, while the intersection with the vertical axis represents the initial shear strength of the masonry. The results of this test phase are shown in Table 3.

**Figure 14.** Change in shear stress during the test (blue line).

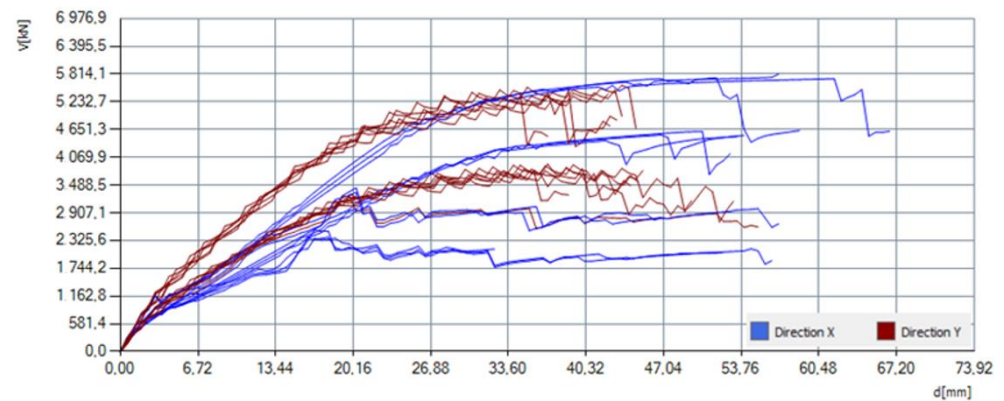
The pushover curves are shown in Figure 15. It is noted that the pushover curves vary within the same direction. The asymmetry of the building (both in plan and height) causes a higher shear capacity for the  $-X$  (negative) orientation versus the  $X$  (positive) orientation. Additionally, it is noted a higher shear capacity is accomplished for the uniform load distribution, in both the  $X$  and  $Y$  direction.

Figure 15. Pushover curves of the existing structure in the current condition.

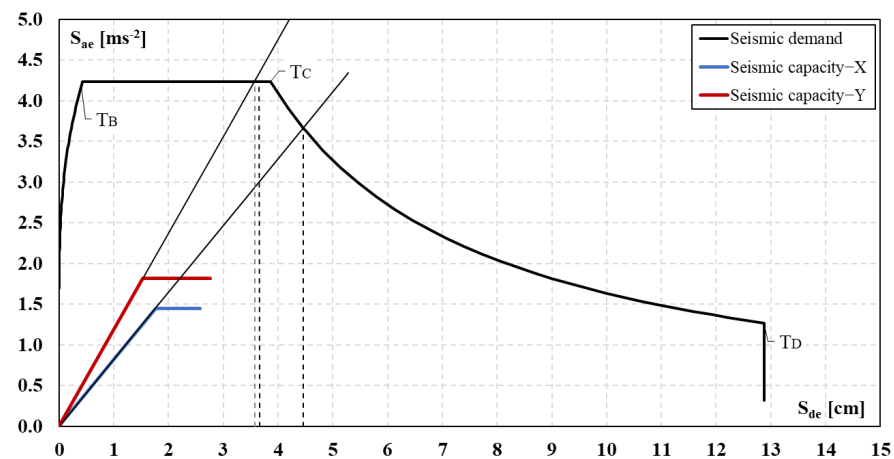
A visualization of the damage from the critical analyses is displayed in Figure 16. The images highlight the critical parts of the structure, which correspond to the actual damage scenarios (damaged spandrels and load-bearing walls in the longitudinal and transversal direction of the central part). Figure 17 displays the capacity curves in the X and Y direction, which are derived from the pushover curves with the lowest risk indices. The radial lines defined by the slope of the first part of the capacity curve represent the elastic structural period  $T^*$ . The intersecting point of the period and the seismic demand is the elastic displacement of the SDoF. It is visible that the seismic capacity is equal in both directions. Still, the seismic demand is lower for the Y direction than the X direction. The latter justifies the higher risk indices in the Y direction, which are shown in Table 6. Accordingly, the structure does not satisfy the seismic requirements.

Figure 17. Seismic demand and capacity of the existing structure.

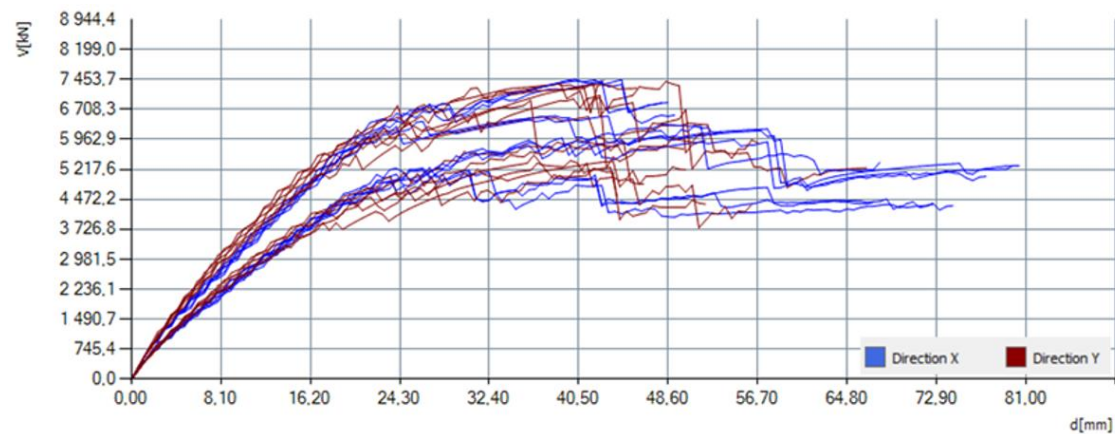
The results are shown in terms of risk indices, pushover curves and capacity curves (Table 8, Figures 21 and 22). In total, 24 analyses were performed. The base shear value

varies depending on the pushover analysis (load distribution, eccentricity load direction, and orientation). The discrepancies are high due to the plan and height irregularities. The aim was to satisfy 24 analyses, so the increase in the capacity also varies. The average increase for the X direction is 23–53%, while for the Y direction, it is 33–40%. The suggested solution caused the increase in seismic capacity to satisfy the level 3,  $\alpha_{225} > 1.0$ . The significant increase in shear capacity in the X direction was noted; this was expected, since the FRCM system was mainly applied to the walls set in the longitudinal X direction. Both displacement capacity and ductility in the X direction increased. The displacement capacity increased in the Y direction, but the ductility remained the same.

**Figure 21.** Pushover curves of the strengthened structure.

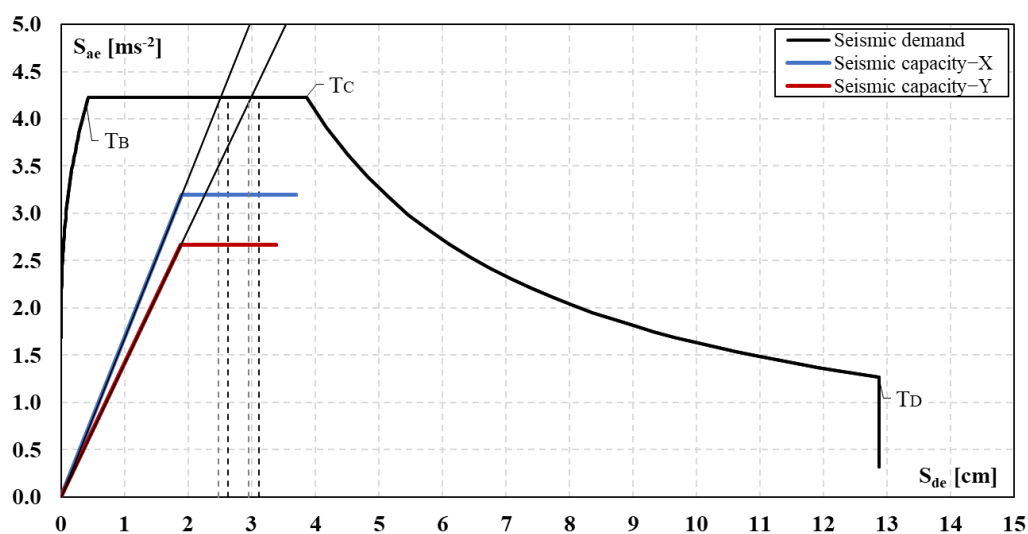
**Figure 22.** Seismic demand and capacity of the strengthened structure.

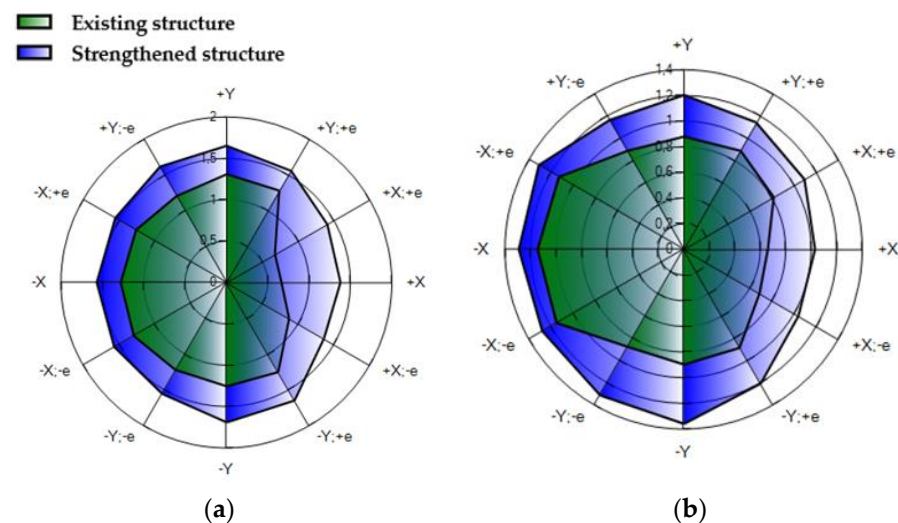
Risk indices vary for each direction, which is displayed in Figure 23. It shows the comparison of risk indices for the limit state “Significant damage”, and the return period of 225 years for the existing and strengthened structures. It is visible that the capacity of the strengthened structure increased overall, regardless of the direction, orientation, and distribution of the forces.

**Figure 23.** Comparison of the risk indices of the models of the existing structure and the structure strengthened using FRCM: (a) uniform distribution; (b) distribution proportionate to the static forces.
