Source / Izvornik: **Buildings**, 2023, 1798 (13)

The Assessment and Retrofitting of Cultural Heritage—A Case Study of a Residential Building in Glina

Abstract: The focus of the study is on the renovation of a specific case study, which is a 19th century building under cultural heritage protection. It highlights the particular challenges faced by civil engineers in the structural renovation of buildings that are under heritage protection. Preserving the identity of these buildings limits the available methods for strengthening their seismic capacity. At the beginning, information about the seismic activity and the different post-earthquake evaluation procedures are presented to identify the damage and take appropriate further steps. Then, basic information about the building is given and supported by graphic attachments. In the following, the methods and materials are explained, focusing on in situ testing with the semi-destructive flat-jack method and the analysis of the structure with the nonlinear method implemented in the software. Subsequently, the obtained results are presented and discussed, accompanied by graphics. An approach for strengthening the structure is presented,

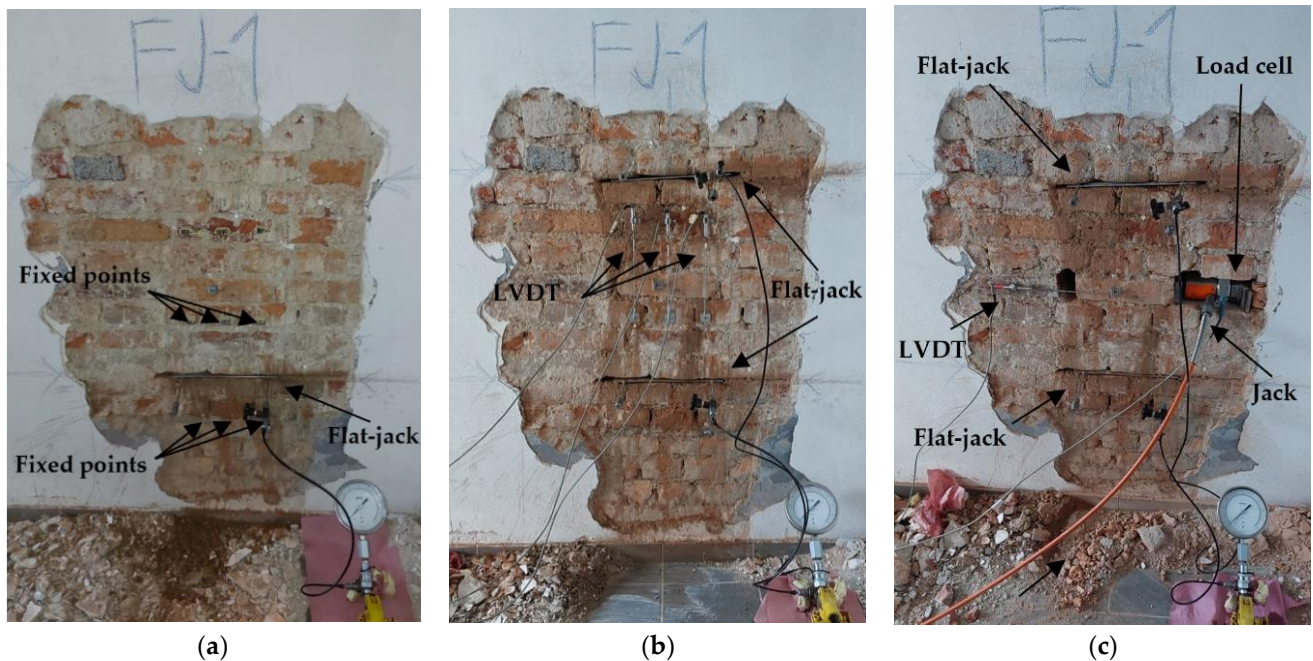
Figure 12. Flat-jack method: (a) single flat-jack test, (b) double flat-jack test, and (c) shear test.

The principle of the single flat-jack test is to partially relieve the compressive stress in the wall by removing the mortar from the horizontal bed joint. This is achieved by making the opening with an eccentric circular saw. The stress is then compensated by means of a flat-jack inserted in the opening. The stress is gradually increased until the original stress and strain state is established, which is verified by measuring the displacements perpendicular to the opening. Measurements are made with a portable extensometer, and fixed measurement points glued to the bricks can be seen in Figure 12a. The results of the single flat-jack tests are shown in Table 1.

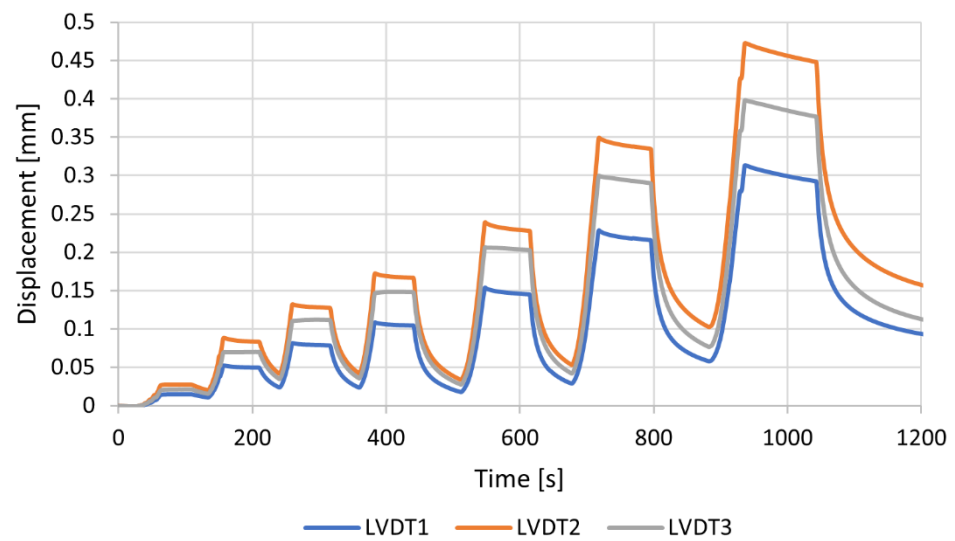
To determine the stress–strain behavior of masonry in compression and the modulus of elasticity of masonry, it is necessary to use another flat-jack placed above the first one (a double flat-jack test). Flat-jacks are inserted into parallel horizontal openings and pressure is applied gradually. In this phase, the displacement gauges (LVDTs) are placed vertically between the flat-jacks, as in Figure 12b. Simultaneously with the application of vertical pressure with the flat-jacks, the displacement is measured (Figure 13), which allows the stress–strain behavior and modulus of elasticity to be determined. For reference, see [27]. The resulting values for the double flat-jack tests are listed in Table 2.

Floor	Mark	E (N/mm ²)
Ground floor	FJ-1	831
First floor	FJ-2	648

Figure 13. Measured displacement during double flat-jack test.

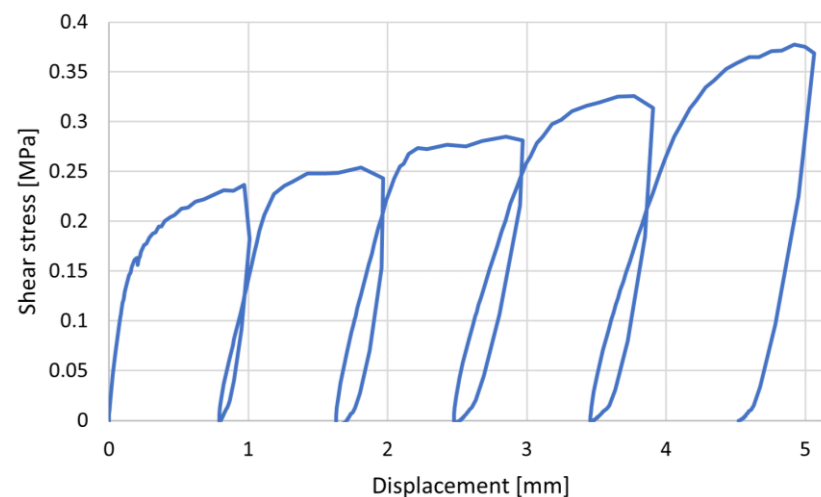
After the double flat-jack test, the shear (shove) test follows in the same location. Both flat-jacks with an additional horizontal hydraulic jack are used for this test (Figure 12c). The displacement gauges used in the previous phases are removed and a horizontal displacement gauge is mounted. In this phase, a horizontal brick (oriented so that a major dimension of the brick is parallel to the wall) is pushed until failure, that is, until it slips. This process is repeated for several vertical stress levels (Figure 14). Flat-jacks allow the control of the vertical stress at the test location. As a result, this provides the relationship between the shear stress and the vertical compressive stress. From this relationship, a best-fitting line can be drawn. The angle of this line represents the coefficient of friction, while the intersection with the vertical axis represents the initial shear strength of the masonry. The results of this test phase are shown in Table 3.

Figure 14. Change in shear stress during the test (blue line).

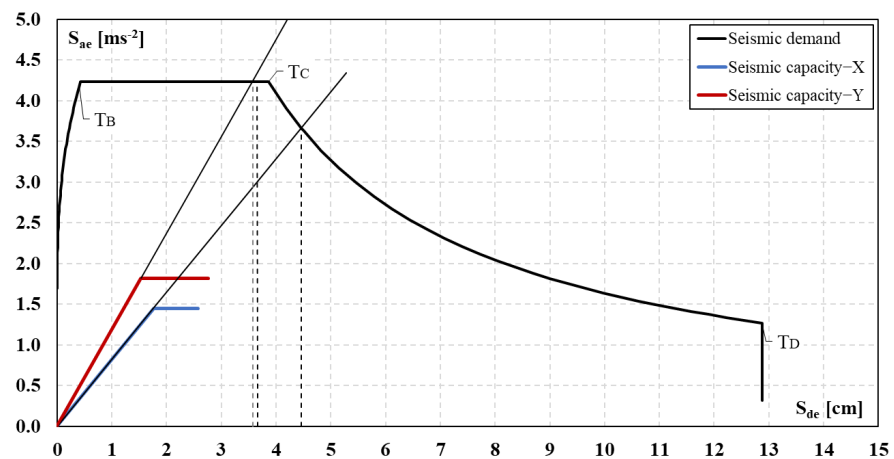
A visualization of the damage from the critical analyses is displayed in Figure 16. The images highlight the critical parts of the structure, which correspond to the actual damage scenarios (damaged spandrels and load-bearing walls in the longitudinal and transversal direction of the central part). Figure 17 displays the capacity curves in the X and Y direction, which are derived from the pushover curves with the lowest risk indices. The radial lines defined by the slope of the first part of the capacity curve represent the elastic structural period T^* . The intersecting point of the period and the seismic demand is the elastic displacement of the SDoF. It is visible that the seismic capacity is equal in both directions. Still, the seismic demand is lower for the Y direction than the X direction. The latter justifies the higher risk indices in the Y direction, which are shown in Table 6. Accordingly, the structure does not satisfy the seismic requirements.

Figure 17. Seismic demand and capacity of the existing structure.

Limit State	Return Period (Years)	α (X Direction)	α (Y Direction)
Significant damage	475	0.424	0.565
Significant damage	225	0.606	0.807
Damage limitation	95	0.819	0.891
