Source / Izvornik: **Buildings, 2023, 1798 (13)**

The Assessment and Retrofitting of Cultural Heritage—A Case Study of a Residential Building in Glina

Karlo Ožić¹, Ivan Markić², Antonela Moretić^{1,*} and Luka Lulić¹

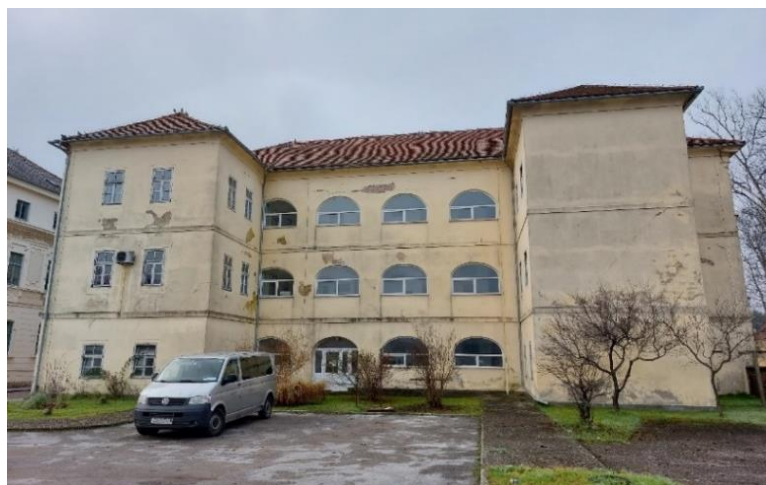
Figure 3. North-east facade of case study building.
