The Assessment and Retrofitting of Cultural Heritage—A Case Study of a Residential Building in Glina

Karlo Ožić¹, Ivan Markić², Antonela Moretić^{1,*} and Luka Lulić¹

Keywords: earthquake; structural strengthening; cultural heritage; nonlinear static analysis; in situ tests

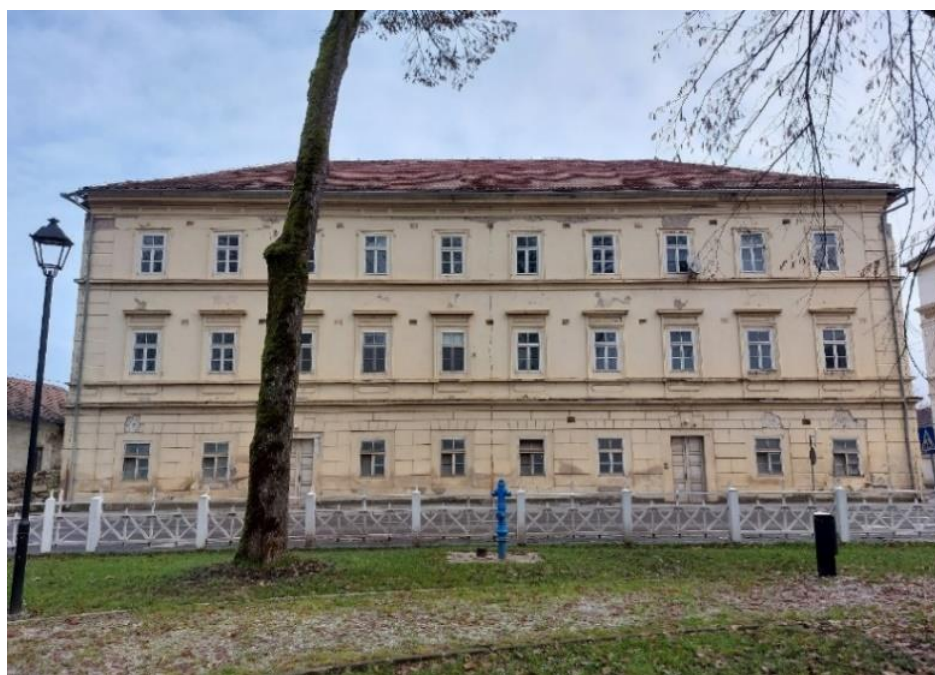
Figure 2. South-west facade of case study building.

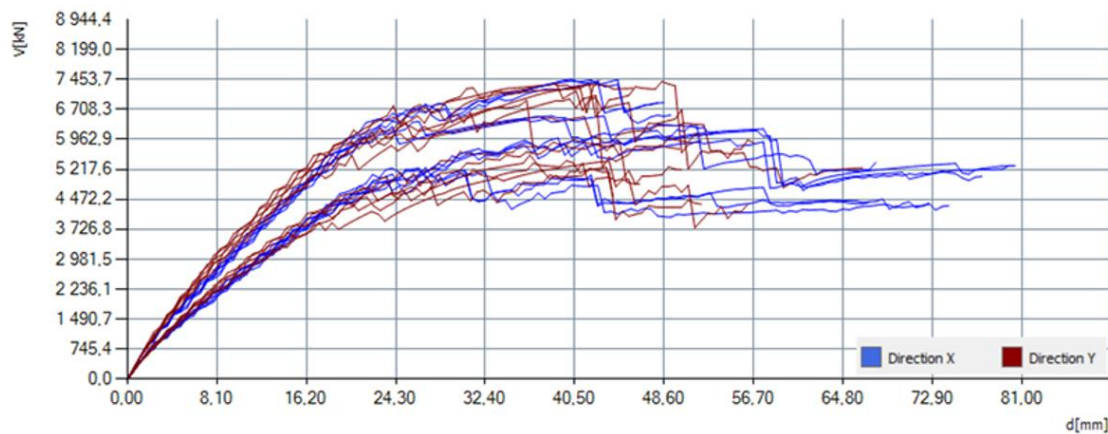
The results are shown in terms of risk indices, pushover curves and capacity curves (Table 8, Figures 21 and 22). In total, 24 analyses were performed. The base shear value

varies depending on the pushover analysis (load distribution, eccentricity load direction, and orientation). The discrepancies are high due to the plan and height irregularities. The aim was to satisfy 24 analyses, so the increase in the capacity also varies. The average increase for the X direction is 23–53%, while for the Y direction, it is 33–40%. The suggested solution caused the increase in seismic capacity to satisfy the level 3, $\alpha_{225} > 1.0$. The significant increase in shear capacity in the X direction was noted; this was expected, since the FRCM system was mainly applied to the walls set in the longitudinal X direction. Both displacement capacity and ductility in the X direction increased. The displacement capacity increased in the Y direction, but the ductility remained the same.

Limit State	Return Period (Years)	α (X Direction)	α (Y Direction)
Significant damage	475	1.099	0.781
Significant damage	225	1.451	1.163
Damage limitation	95	1.563	1.309

Figure 21. Pushover curves of the strengthened structure.
