Seismic Retrofitting of Dual Structural Systems-A Case Study of an Educational Building in Croatia

Seismic Retrofitting of Dual Structural Systems—A Case Study of an Educational Building in Croatia

The building of the higher education institution in Petrinja, Croatia, was built in 1963 and underwent energy renovation in 2018. The building consists of the ground, 1st, and 2nd floors; the area on the ground floor is 1294.3 m² and on the upper floors 603.4 m². The total gross floor area of the building is 2501.1 m², while the useful heated area of the building is approximately 2130 m². The building has an irregular T-shaped layout and consists of three volumes connected into one whole (Figure 3). In the northwest–southeast direction (hereafter X-dir), there are two volumes that have only the ground floor. The volume marked as V1 is 3.84 m high, while the volume V2 in the southeastern part of the building is 5.52 m high and consists of a one large hall. The central volume V3 of the building is arranged in a northeast–southwest direction (hereafter Y-dir) and has three stories with a total height of 11.52 m.

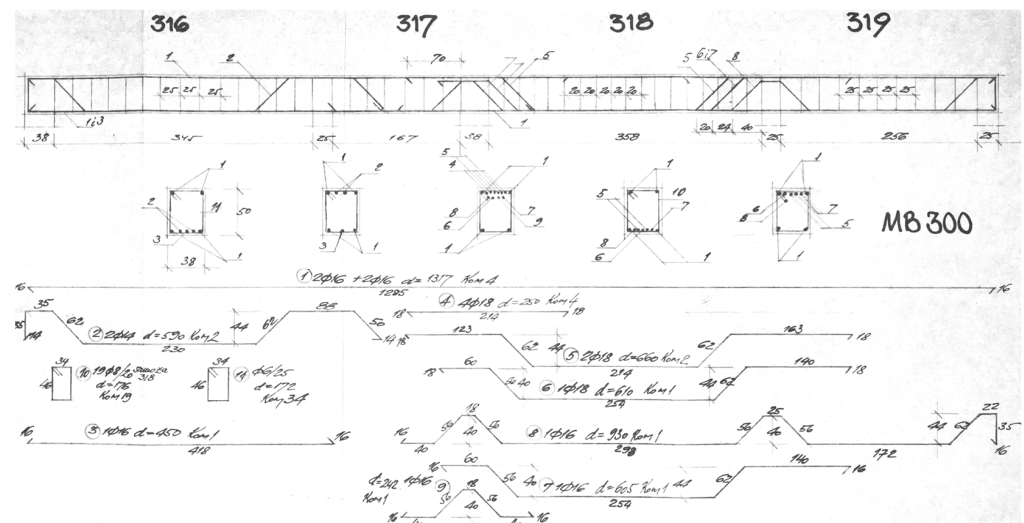
Figure 4. Reinforcement layout form original static design.

The dimensions of the structural elements were obtained from the drawings accompanying the original static design (Figure 4), an architectural drawing of the as-built condition from 2015, the energy retrofit project from 2018, and an on-site survey. A detailed inspection of the load-bearing structure revealed that the building was not built entirely in accordance with the project documentation. The arrangement of columns was altered so that they were not constructed in some locations when a brick wall was present (Figure 5). Other subsequent interventions, alterations, or modernizations carried out over time did not have a significant impact on the load-bearing capacity of the structure. These were mainly offsets of the partition walls.

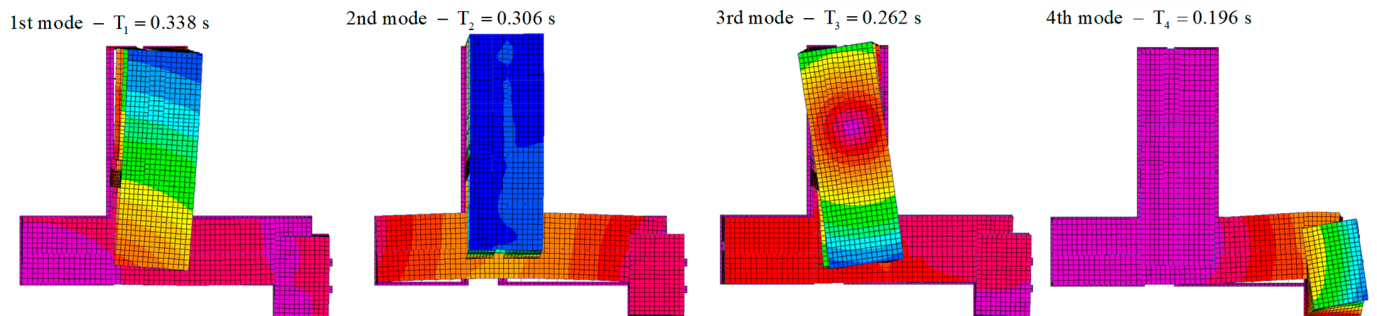
Figure 13. Eigenmodes and corresponding periods values for the as-built state of the building.

Numerical results of the dynamic properties, i.e., eigenperiods and mode shapes, are presented below. Figure 13 shows the results of a model that has a limited crack state since it is loaded only by the weight of the structural elements and other permanent and service loads. Further results for eigenmodes are obtained for the state of the structure near the SD limit state (Figure 14). In this case, the stiffness of the structure is significantly reduced, which is reflected in the prolonged eigenperiods. It should be noted that the irregularity of the building on the ground floor can cause torsional effects that increase the requirements for the relative displacements of the perimeter walls, which could lead to their greater vulnerability during earthquake.

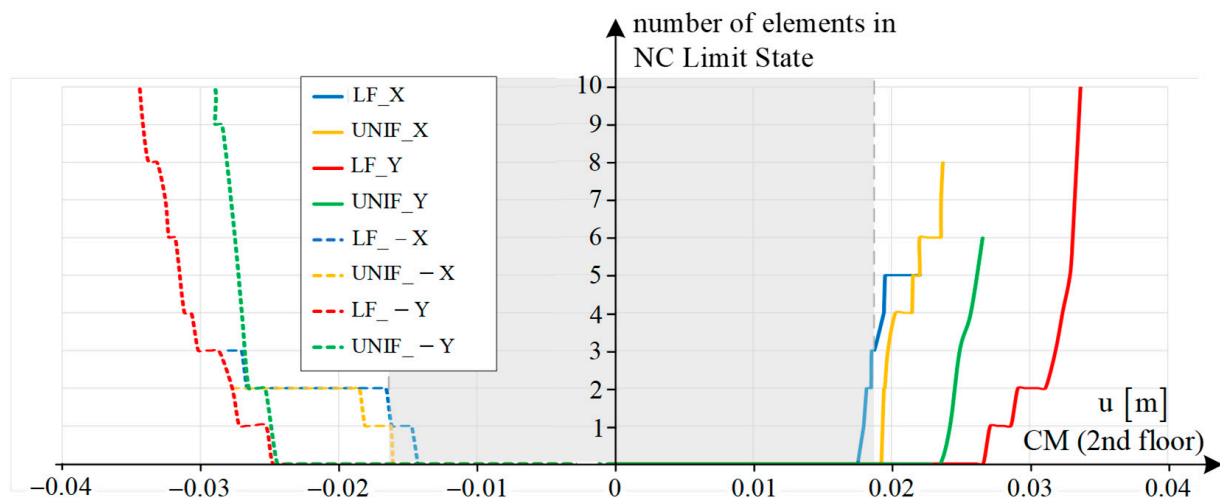
Figure 17. Cumulative number of elements in NC limit state.

Figure 17 shows a diagram that cumulatively represents the number of elements that have reached the limit state of near collapse. For the action in the X-dir, the elements begin to enter this region at a displacement of about 2 cm, while in the Y-dir, this occurs at a value of about 2.5 cm.

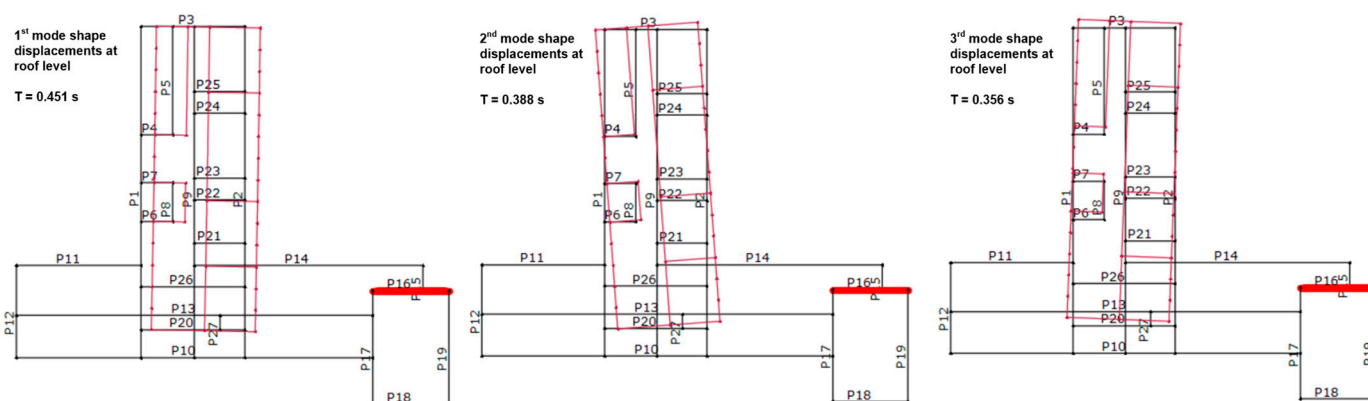
Figure 19. Relevant mode shapes obtained by EFM.

The second model was created with the program 3Muri [39], as mentioned before. First, the eigenmodes and the corresponding periods are determined for the structure, taking into account the crack state of the elements (Table 3 and Figure 19). The first period of the structure is 0.45 s and corresponds to the translation in the X direction, activating 62.5% of the total mass, while the translation mode in the Y direction with a period value

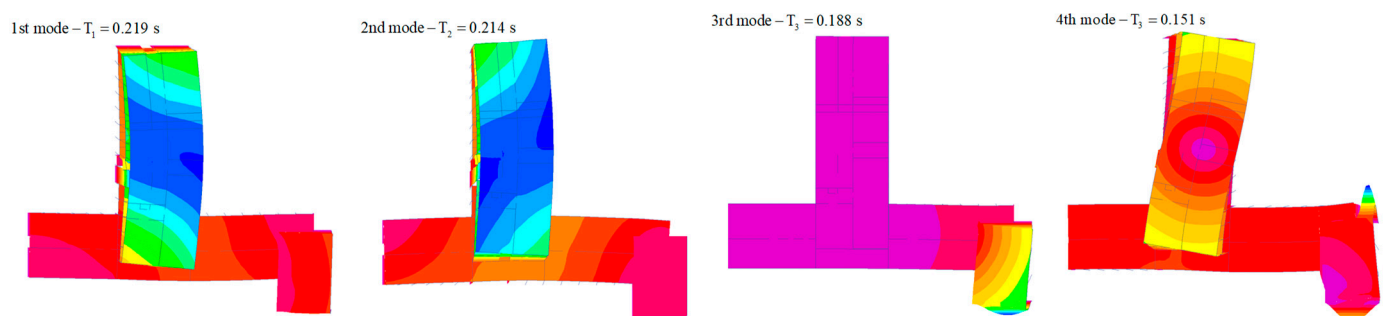
Figure 23. Eigenmodes and corresponding periods values for cracked sections of the retrofitted building.

Due to the presence of new and strengthened elements the dynamic properties of the building have changed, i.e., the period values have reduced notably which is the result of significant increase of structural stiffness mainly due to addition of new RC walls. The Figure 23 shows relevant modes, and it is noticeable that coupling of mode shapes is evident what can be even more emphasized since relevant mode shapes all have near values of periods.

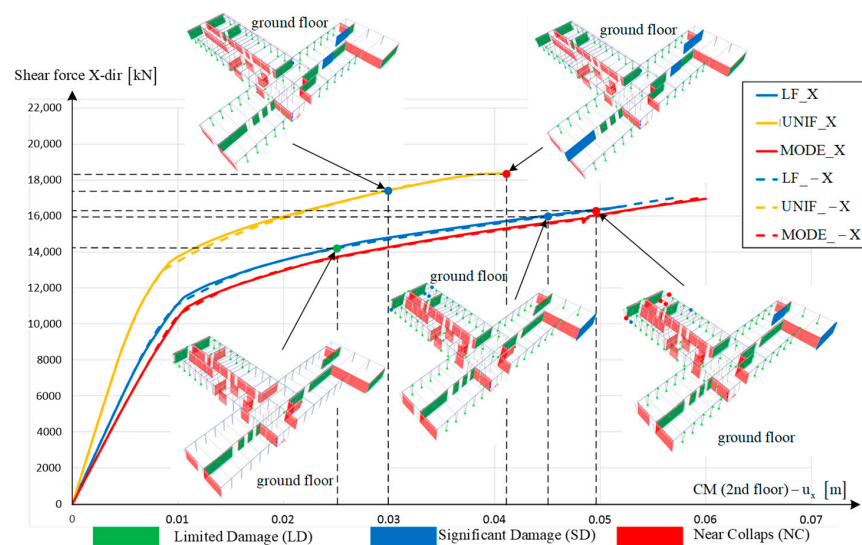
Figure 24. Pushover curves in X-dir for retrofitted structure.

The main results of the pushover analysis for strengthened structure obtained by modelling with ETABS are given below. The limit states of the critical elements and the development of the failure mechanisms are marked on the curves. In Figure 24, it can be seen that some elements of the structure reach a state of limited damage, which is reflected on the curve as a decrease in stiffness, i.e., the slope at a force of 11,000 kN (B.S. = 32%) and a displacement of 9 mm. In addition, there is the initial opening of cracks and a reduction in the stiffness of the individual elements in all floors. These elements still did not utilize bearing capacity and continue to deform. The beginning of the failure of the structural elements occurs at a force of 15,000 kN (B.S. = 44%) and a displacement of 40 mm. The columns on the ground floor on the north side reach the SD limit state due to the exceeding of the shear force capacity. Since such a fracture of the columns is non-ductile, exceeding their ultimate capacity means failure very soon. The walls of the large hall on the ground floor are also in an SD limit state. The next important stage is the failure of these columns (NC limit state) at a force of 16,000 kN and a displacement of 50 mm. At this stage, it can be said that the load-bearing capacity of this part of the building is utilized and a partial failure of the building takes place. As a result, the local failure of the floor slab may occur. It can already be said that the building is in a NC limit state and can be classified as having

the highest degree of damage. However, even in the case of local failure, it is unlikely that the rest of the structure will collapse at this load level. The walls and columns of the 1st and 2nd floors are not critical for action in the X-dir and have not reached the SD limit state.

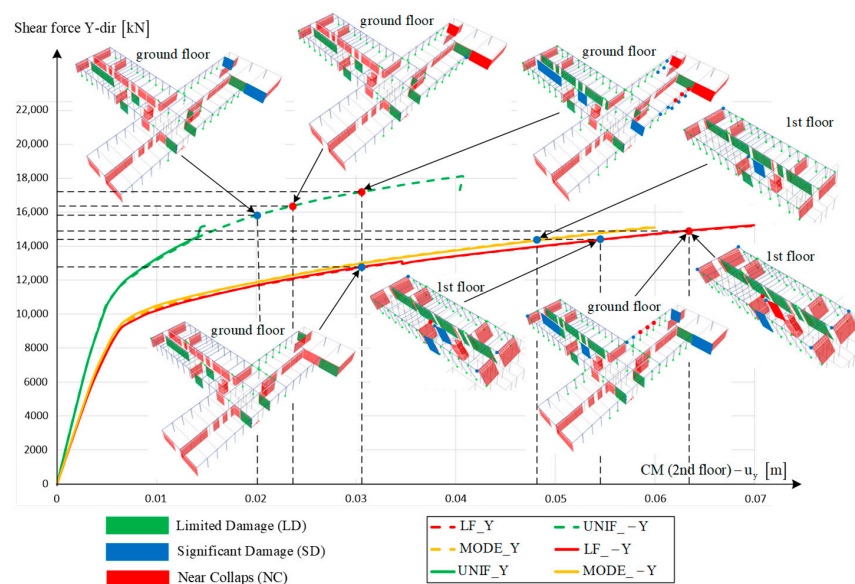
Figure 25. Pushover curves in Y-dir for retrofitted structure.

Figure 25 shows the relevant pushover curves for the Y-dir. Individual elements reach a state of limited damage at a force value of 3900 kN (B.S. = 12%) and a displacement of 5 mm. The diagram shows the elements on the ground floor where the cracks appear first, but the limited damage of elements is present on all floors.

The beginning of the failure of the structural elements occurs at a force of 14,000 kN (B.S. = 41%) and a displacement of 50 mm. The critical elements that first reach the SD limit state are the walls next to the staircase on the 1st floor, followed by the exceeding of the SD limit state for the adjacent walls and for the walls of the large hall on the ground floor. The final result is the failure of these walls and the drop of the bearing capacity in the pushover curve. However, it should be mentioned that the walls on the ground and on the 2nd floor were not found to be critical in the Y-dir for the lateral force.

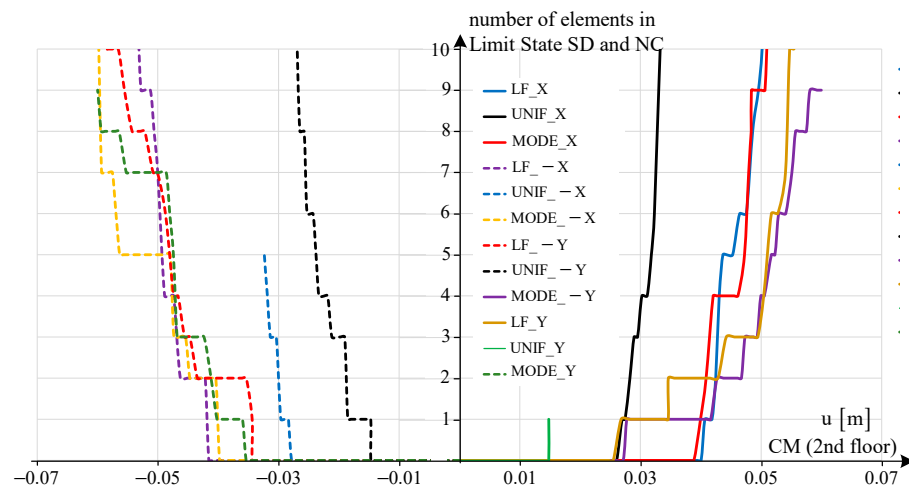
Figure 26. Cumulative number of elements in SD and NC limit state.

The diagrams that cumulatively show the number of elements that have reached the SD and NC limit state for different lateral load patterns are displayed in the Figure 26.

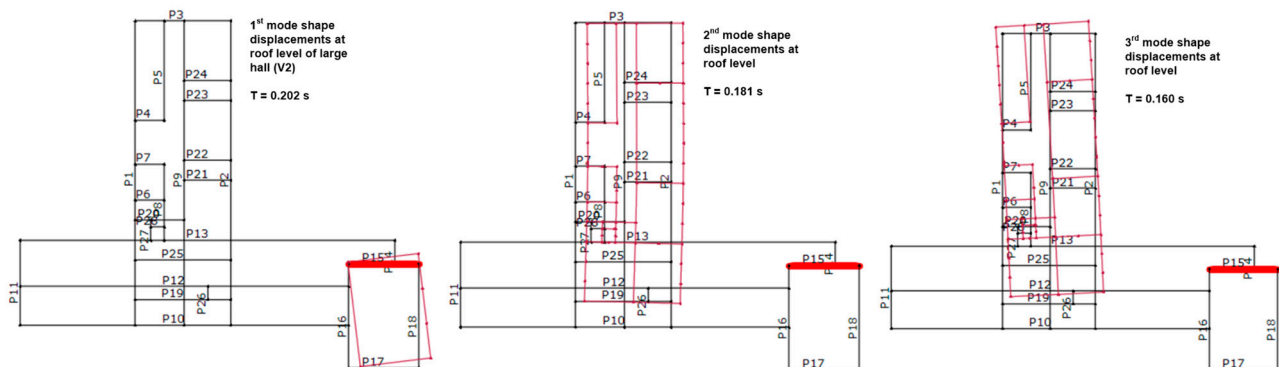
Figure 28. Relevant mode shapes obtained by EFM for the retrofitted structure.

The results of the EFM with the program 3Muri also demonstrate that the reinforcements caused a significant change in the dynamic properties of the structure, which is a consequence of the stiffening of the structural system (Table 4). In this model for the state of cracked sections (Figure 28), the first mode of vibration with a period of 0.204 s is a local one and affects the deformation of the elements of the large hall with a participation of 2.1% of the mass in the Y-dir and a visible torsional influence. The translation mode in the X-dir appears in the second period with a value of 0.181 s and a mass participation of 70.2%, while the translation in the Y-dir direction maintains the influence of torsion and has a period value of 0.16 s with a mass participation of 58.5%. In the fourth oscillation mode, the torsion is noticeable, and the value of the period is 0.145 s.
