Seismic Retrofitting of Dual Structural Systems-A Case Study of an Educational Building in Croatia

Seismic Retrofitting of Dual Structural Systems—A Case Study of an Educational Building in Croatia

Abstract: On 29 December 2020, a devastating Mw6.4 earthquake struck near the town of Petrinja, Croatia. The main earthquake was preceded by a Mw4.9 foreshock the day before. The earthquakes caused extensive damage to buildings, especially historic buildings made of unreinforced masonry but also to buildings of other typologies and to critical infrastructure. Today, recovery efforts in Croatia focus primarily on reconstruction and seismic retrofitting. Family homes and public, cultural, educational, and other facilities are top priorities. In this paper, a comprehensive study of existing building in the educational sector is presented as a case study. The seismic performance of the building is evaluated using numerical methods, first for the as-built condition and then for the retrofitted building. For each condition, the collapse mechanisms of the building were determined and critical structural elements were identified. The presented retrofit strategy of the dual structural system co

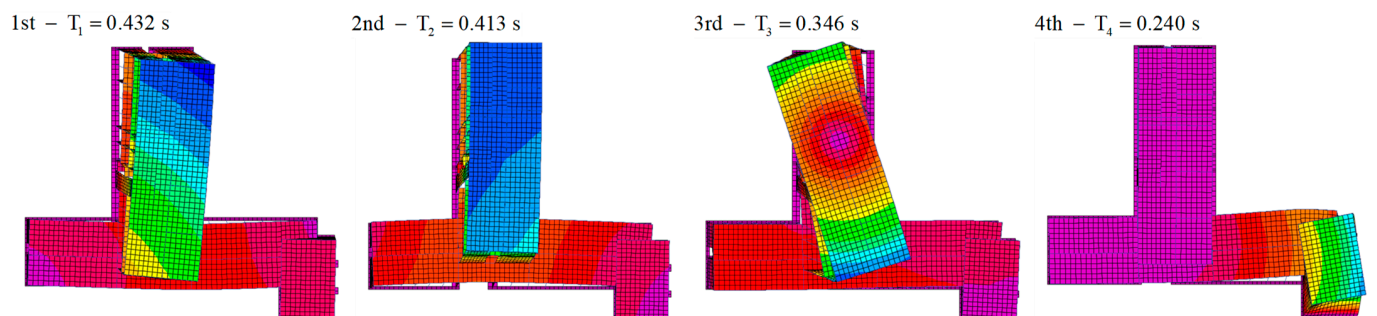
Figure 14. Eigenmodes and corresponding periods values for cracked sections of the as-built state of the building.

Numerical results of the dynamic properties, i.e., eigenperiods and mode shapes, are presented below. Figure 13 shows the results of a model that has a limited crack state since it is loaded only by the weight of the structural elements and other permanent and service loads. Further results for eigenmodes are obtained for the state of the structure near the SD limit state (Figure 14). In this case, the stiffness of the structure is significantly reduced, which is reflected in the prolonged eigenperiods. It should be noted that the irregularity of the building on the ground floor can cause torsional effects that increase the requirements for the relative displacements of the perimeter walls, which could lead to their greater vulnerability during earthquake.

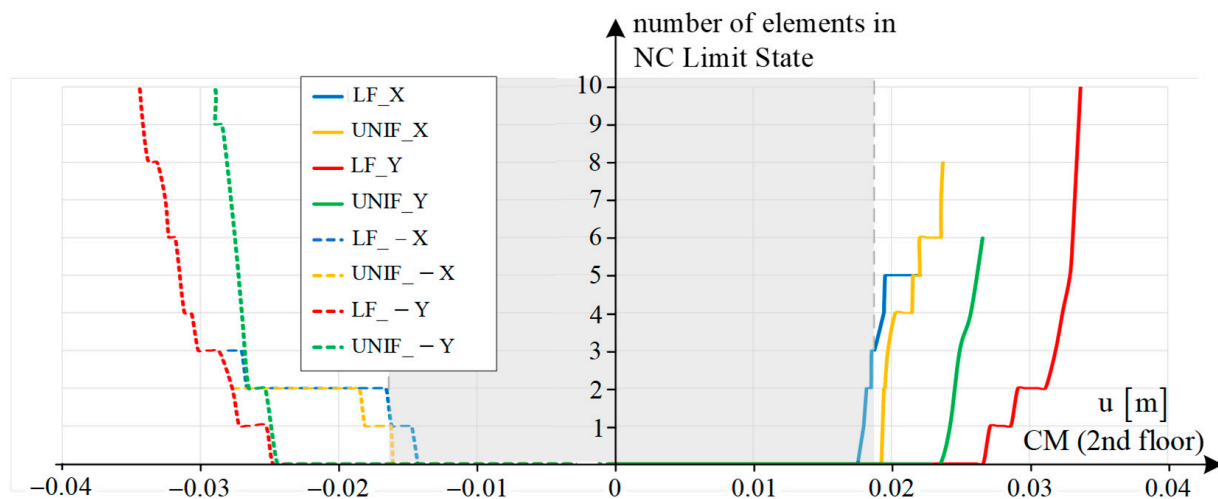
Figure 17. Cumulative number of elements in NC limit state.

Figure 17 shows a diagram that cumulatively represents the number of elements that have reached the limit state of near collapse. For the action in the X-dir, the elements begin to enter this region at a displacement of about 2 cm, while in the Y-dir, this occurs at a value of about 2.5 cm.

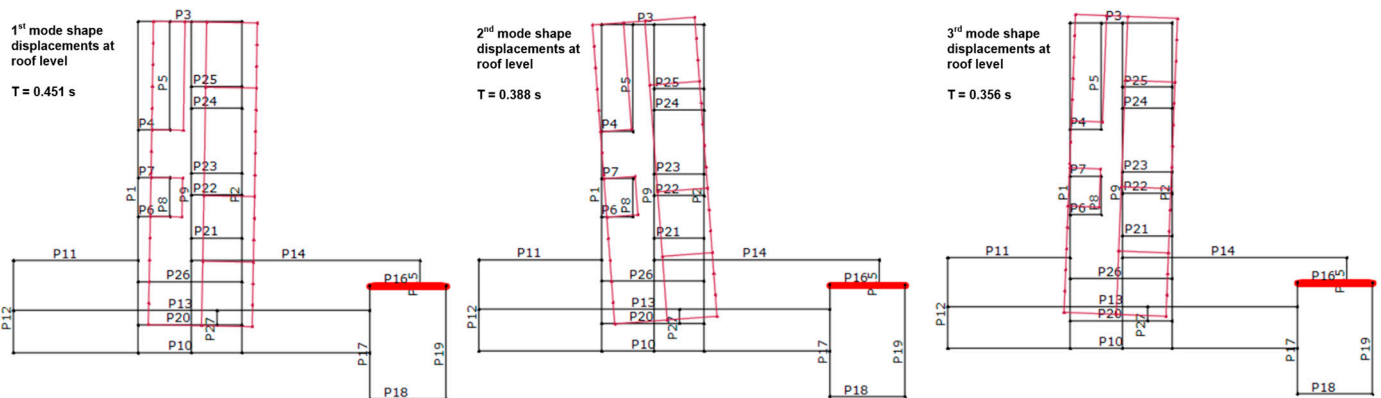
Figure 19. Relevant mode shapes obtained by EFM.

The second model was created with the program 3Muri [39], as mentioned before. First, the eigenmodes and the corresponding periods are determined for the structure, taking into account the crack state of the elements (Table 3 and Figure 19). The first period of the structure is 0.45 s and corresponds to the translation in the X direction, activating 62.5% of the total mass, while the translation mode in the Y direction with a period value

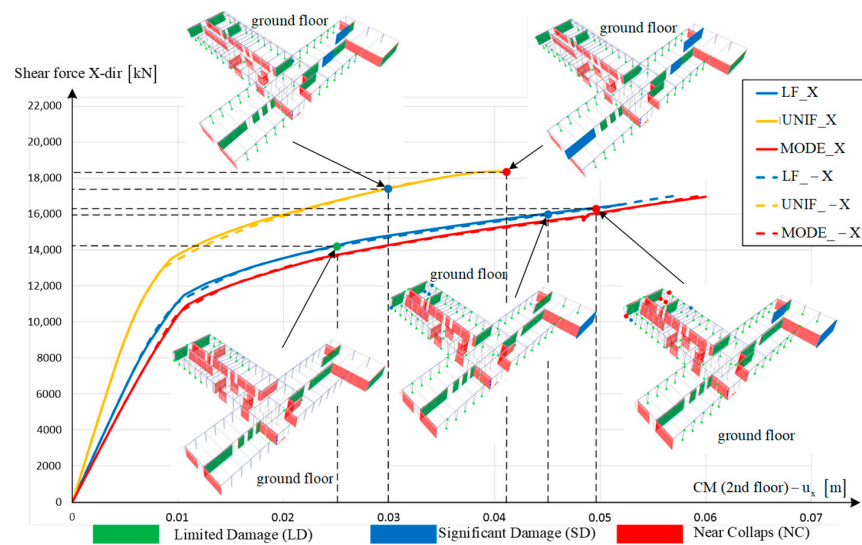
Figure 24. Pushover curves in X-dir for retrofitted structure.

The main results of the pushover analysis for strengthened structure obtained by modelling with ETABS are given below. The limit states of the critical elements and the development of the failure mechanisms are marked on the curves. In Figure 24, it can be seen that some elements of the structure reach a state of limited damage, which is reflected on the curve as a decrease in stiffness, i.e., the slope at a force of 11,000 kN (B.S. = 32%) and a displacement of 9 mm. In addition, there is the initial opening of cracks and a reduction in the stiffness of the individual elements in all floors. These elements still did not utilize bearing capacity and continue to deform. The beginning of the failure of the structural elements occurs at a force of 15,000 kN (B.S. = 44%) and a displacement of 40 mm. The columns on the ground floor on the north side reach the SD limit state due to the exceeding of the shear force capacity. Since such a fracture of the columns is non-ductile, exceeding their ultimate capacity means failure very soon. The walls of the large hall on the ground floor are also in an SD limit state. The next important stage is the failure of these columns (NC limit state) at a force of 16,000 kN and a displacement of 50 mm. At this stage, it can be said that the load-bearing capacity of this part of the building is utilized and a partial failure of the building takes place. As a result, the local failure of the floor slab may occur. It can already be said that the building is in a NC limit state and can be classified as having

the highest degree of damage. However, even in the case of local failure, it is unlikely that the rest of the structure will collapse at this load level. The walls and columns of the 1st and 2nd floors are not critical for action in the X-dir and have not reached the SD limit state.

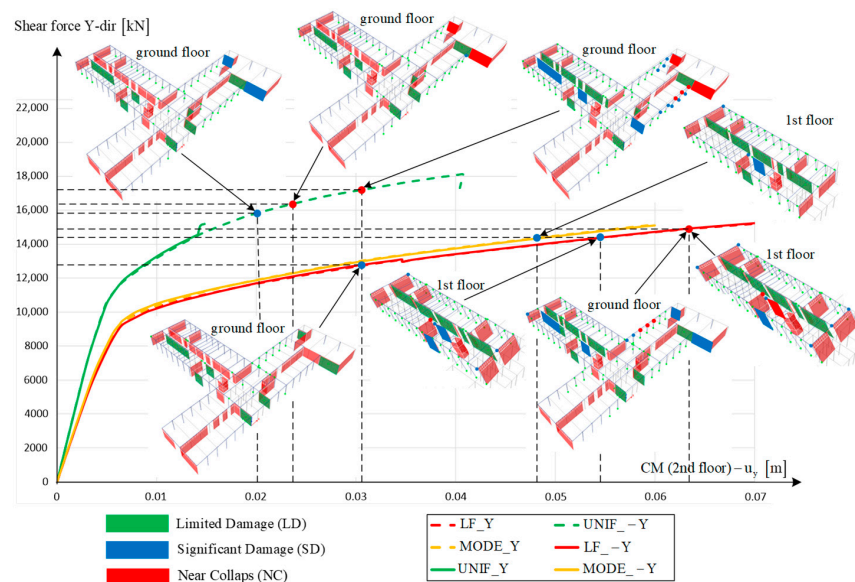
Figure 25. Pushover curves in Y-dir for retrofitted structure.

Figure 25 shows the relevant pushover curves for the Y-dir. Individual elements reach a state of limited damage at a force value of 3900 kN (B.S. = 12%) and a displacement of 5 mm. The diagram shows the elements on the ground floor where the cracks appear first, but the limited damage of elements is present on all floors.

The beginning of the failure of the structural elements occurs at a force of 14,000 kN (B.S. = 41%) and a displacement of 50 mm. The critical elements that first reach the SD limit state are the walls next to the staircase on the 1st floor, followed by the exceeding of the SD limit state for the adjacent walls and for the walls of the large hall on the ground floor. The final result is the failure of these walls and the drop of the bearing capacity in the pushover curve. However, it should be mentioned that the walls on the ground and on the 2nd floor were not found to be critical in the Y-dir for the lateral force.
