The December 2020 magnitude (Mw) 6.4 Petrinja earthquake, Croatia: seismological aspects, emergency response and impacts

Source / Izvornik: **Bulletin of earthquake engineering, 2023, 21, 5767 - 5808**

Josip Atalić¹ · Marija Demšić¹ · Maja Baniček² · Mario Uroš¹ · Iva Dasović³ · Snježan Prevolnik³ · Alen Kadić² · Marta Šavor Novak¹ · Miroslav Nastev⁴

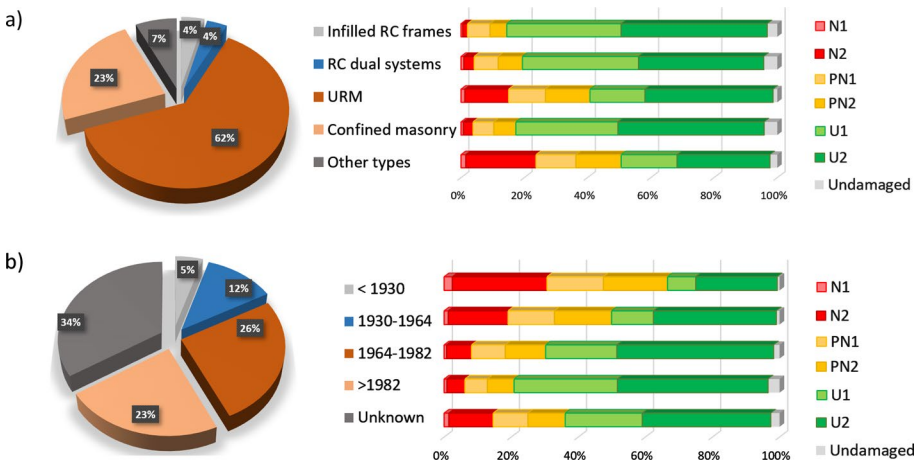
Extensive damage to buildings was widespread in Petrinja, the nearby towns of Glina and Sisak, as well as throughout the rural settlements of the Sisak-Moslavina County. Based on the inspection results, the most damaged buildings were of unreinforced masonry (URM), followed by confined masonry (CM), while the reinforced concrete (RC) structures (consisting of approximately equal parts of infilled frames and dual systems) sustained much lesser damage (Fig. 6a). The building category referred to as “other types”, which accounts for 7% of damaged buildings in this figure, includes traditional wooden houses as well as mixed structural systems, e.g., wood and URM or partially confined masonry (Fig. 25). However, it was observed that the latter building category was frequently classified as the more resistant CM in the inspection forms. The confusion resulted because the inspection form did not provide explicit option for this peculiar typology, however, specific to a relatively large number of buildings. Due to the insufficient time and accelerated training, only a part of the experts managed to recognize these buildings as “other types”. As mentioned in Chapter 2, the partially confined masonry buildings disregard standard engineering practices and seismic regulations resulting in critical structural deficiencies. Furthermore, it should be mentioned that no damage to steel structures was reported, also the inspection of the industrial steel structures of the oil refinery in nearby town Sisak and the industrial plant in Kutina, located about 40 km from Petrinja, did not reveal any significant structural damage caused by this earthquake.

Another important statistical indicator correlated to the usability of buildings is the year (period) of construction. The graphs shown in Fig. 6b clearly indicate that buildings built before 1930 have sustained the most significant structural damage. The damage percentage decreases gradually for more recent structures due to the improvement of the construction practices with the introduction of the new and improved construction standards and seismic regulations.

Fig. 6 Data on building usability assessments in the affected area with respect to: **a** most common structural systems, and **b** period of construction (CCEE 2022)
