The December 2020 magnitude (Mw) 6.4 Petrinja earthquake, Croatia: seismological aspects, emergency response and impacts

Atalić, Josip; Demšić, Marija; Baniček, Maja; Uroš, Mario; Dasović, Iva; Prevolnik, Snježan; Kadić, Alen; Šavor Novak, Marta; Nastev, Miroslav

Source / Izvornik: **Bulletin of earthquake engineering, 2023, 21, 5767 - 5808**

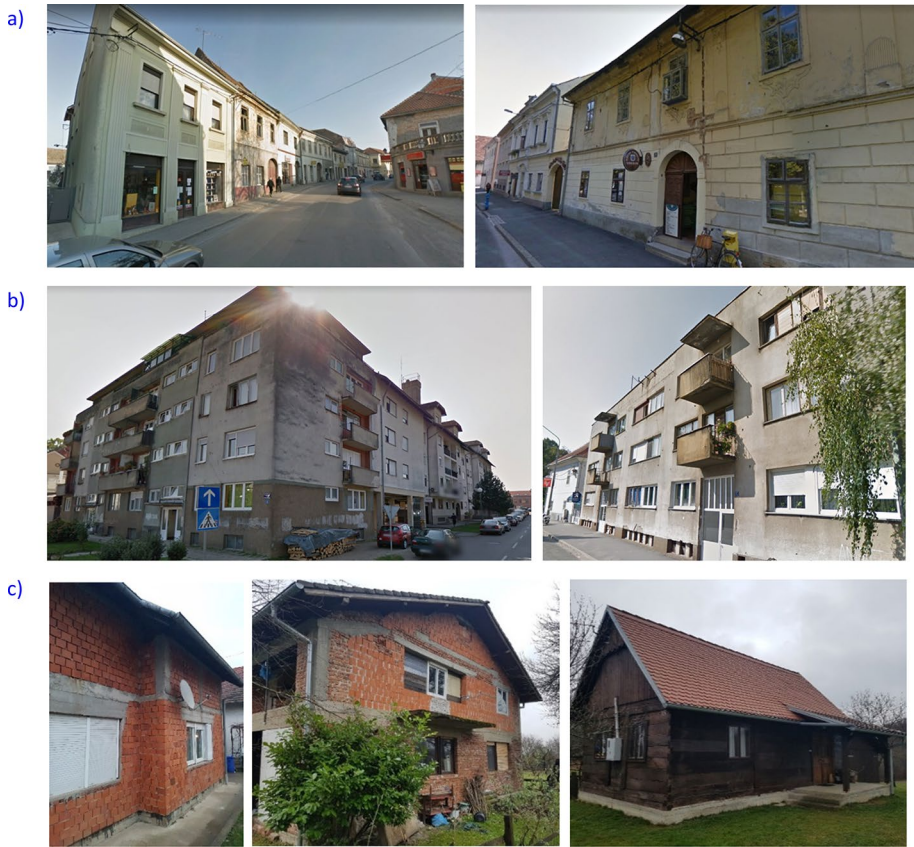
Traditional URM buildings are dominant in both urban centers of Petrinja, Glina and Sisak and in the rural areas. Most of the masonry buildings in the historic city centers are built in the late 18th and early nineteenth centuries of solid brick and lime mortar. They are classified either as individual cultural heritage or are protected being a part of the cultural and historic ensemble. The load bearing walls are continuous from the foundation to the attic and support the weight of the floor and roof structures without any confinement (Fig. 2a). They are typically up to two stories high with attic and are positioned in aggregates or as freestanding. The floor structure is made of timber joists oriented in the direction transverse to the longitudinal bearing walls. In some cases, the ground floor consists of brick cross and barrel vaults. The partition walls are also made of solid brick, whereas the roof structure is made of timber beams and rafters often without adequate stabilizing elements. The tall and massive chimneys are usually free standing from the attic floor level. Not adequately anchored to the main structure are also the traditional non-structural elements such as cornices, plasters and other decorations. As well, most of the buildings have been poorly maintained, contributing to significant deterioration of the materials and compromising the safety of the occupants and pedestrians.

The older URM multi-apartment buildings, frequent in the urban areas, have a semi-precast floor structures of reinforced concrete and masonry with girders and ring beams, the so-called "fert" structure slabs (Fig. 2b). The number of stories varies from two to four. The roof structure in these buildings is made of timber trusses without stabilizing elements. On the other hand, the confined masonry buildings with vertical and horizontal confining elements and semi-precast floor structures started appearing mostly after 1995, as part of the post-war reconstruction. According to the seismic regulations at the time (SFRY 1981), valid until the introduction of Eurocode for the design of masonry structures in 2007, it was not mandatory for low-rise buildings to use confined masonry instead of unreinforced masonry. In other words, masonry structures without vertical confinement elements were allowed for up to G + 2, ground floor plus two storey buildings, in seismic zone VIII and up

Fig. 2 City of Petrinja **a** URM buildings in the historic centre, **b** Multi-apartment masonry buildings, and **c** Single masonry and wooden residential buildings (Google Maps 2021, CCEE 2022)

In addition to URM and confined masonry buildings, in rural areas are typical the traditional wooden single-family residential buildings with one and rarely with two stories (Fig. 2c). They have a simple rectangular foot-print and the connection of the wooden walls is usually done with hardwood dowels. Often, they are accompanied by outbuildings, which are usually made of poorer material and structural quality.

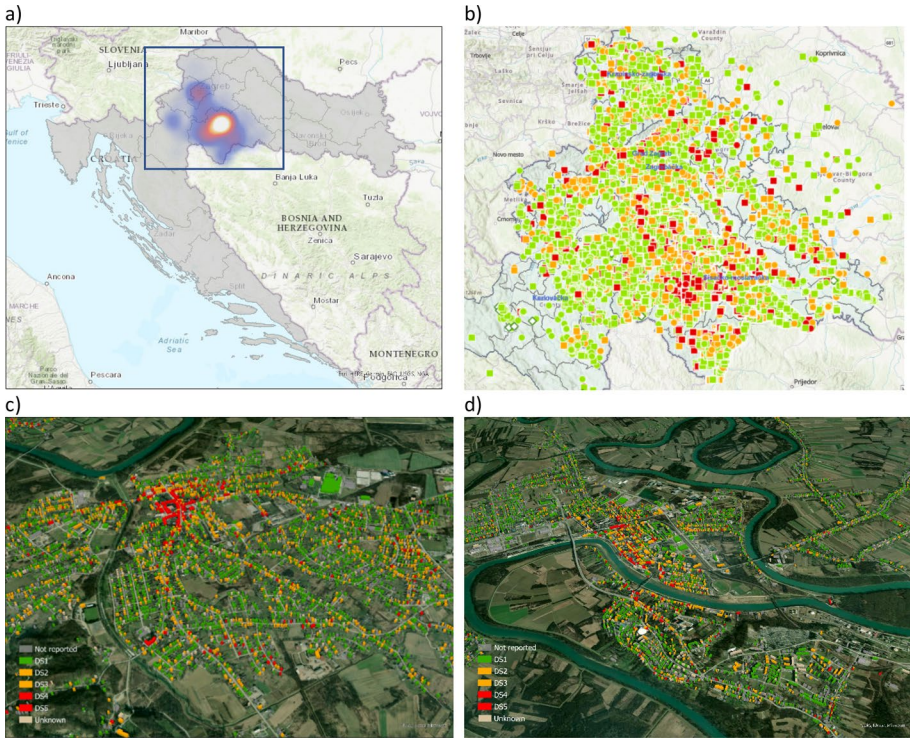
Fig. 7 Building inspection results: **a** heatmap of the affected area, **b** usability assessments in the central Croatia, **c** spatial distribution of structural damage in Petrinja according to EMS-98 scale, **d** spatial distribution of structural damage in Sisak according to EMS-98 scale. The usability states in **(b)** are indicated with: green—usable, yellow—temporarily unusable, red—unusable. The damage states in **(c)** and **(d)** are negligible damage DS1, slight to moderate damage DS2 and DS3, and heavy to very heavy damage DS4 and DS5. (CCEE 2022)

Figure 7a presents the heatmap of the affected area, while the usability assessments for the most affected region of the Central Croatia (marked with blue rectangle in Fig. 8a) are given in Fig. 7b. The spatial distribution of damage in the towns of Petrinja and Sisak

according to the inspection results is shown in Fig. 7c and d. It clearly points out the concentration of damage in the historical centers where mostly URM buildings built in the late 18th and first half of the nineteenth century are located.

By the end of March 2022, a total of 50,000 inspections were conducted in all affected counties, covering approximately 13,000 km² what is more than a fourth of the country's territory (Fig. 7a and 7b). According to Table 1, overall, 5,373 buildings were red-tagged (N1 1% and N2 10%), 10,736 yellow-tagged (PN1 10% and PN2 11%), 33,062 green-tagged (U1 22% and U2 44%), while in 829 inspected buildings no structural damage was observed (U0 2%). Regarding the damage according to EMS-98 scale presented in Table 2, there were 29,078 buildings graded DS1, 9,741 DS2, 4,371 DS3, 2,759 DS4, 685 DS5, and 3,366 inspections that did not provide damage assessment according to the EMS-98 scale.

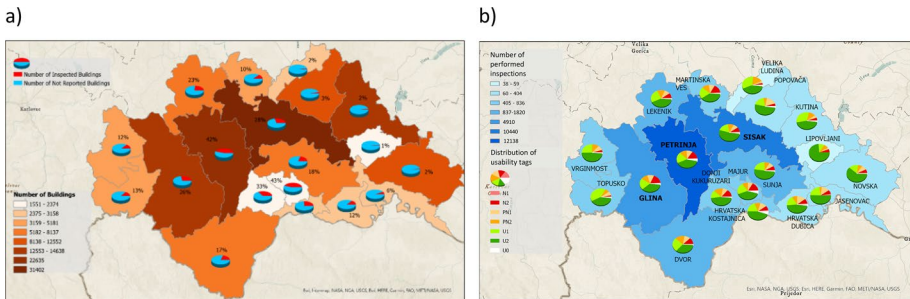
Fig. 8 Building inspection results for Sisak-Moslavina County: **a** percentage of inspected buildings; **b** usability assessment results by municipalities (CCEE 2022)

In the Sisak-Moslavina County only (Fig. 8), 38,320 inspections were conducted with 4,745 red-tagged buildings (N1 1% and N2 11%), 8,397 yellow-tagged (PN1 10% and PN2

12%), 24,475 green-tagged (U1 19% and U2 45%), while 703 inspected buildings showed no damage (U0 1%). In Fig. 8a, the pie chart shows the ratio of inspected buildings to all buildings in the municipalities of Sisak-Moslavina County, while the total number of buildings in a municipality is indicated by shades of brown. In Fig. 8b, the pie chart presents the distribution of the usability assessment results in performed inspections, while the total number of performed inspections in the municipalities is indicated by shades of blue. Obviously, due to its proximity to the epicenter, the municipality of Petrinja was the most affected. Out of the 12,138 buildings inspected there, 15% were red-tagged, 24% yellow-tagged, and 59% green-tagged.
