Post-Earthquake Dynamic Performance of Intact Masonry Building Based on Finite Element Model Updating

As a case study, a building of a high school in Sisak (Figure 1) built in 1935 was taken. The building has four floors: basement, ground floor, and two upper floors. In the central part of the building there is a three-legged staircase with a landing. The foundations are constructed as a reinforced concrete slab. The load-bearing part of structure consists of walls made of solid bricks of 29(39) cm × 15 cm × 6.5 cm, floor slabs and reinforced concrete ribbed floor slabs. The thickness of the load-bearing walls in the basement is 60 cm and 75 cm, and 50 cm and 60 cm on the ground floor and upper floors. The partition walls are 15 cm, 18 cm, 25 cm or 30 cm thick and are made of hollow blocks. The floor slab is 25 cm thick and the reinforced concrete ribbed floor slab has a total height of 33 cm. The clear distance between the ribs is 60 cm, the width of the ribs is 13 cm, and the height is 23 cm. At the entrance of the building on the first and second floors, there is a load-bearing part of the structure that rests on columns with the square section of 75 cm × 75 cm and a height of

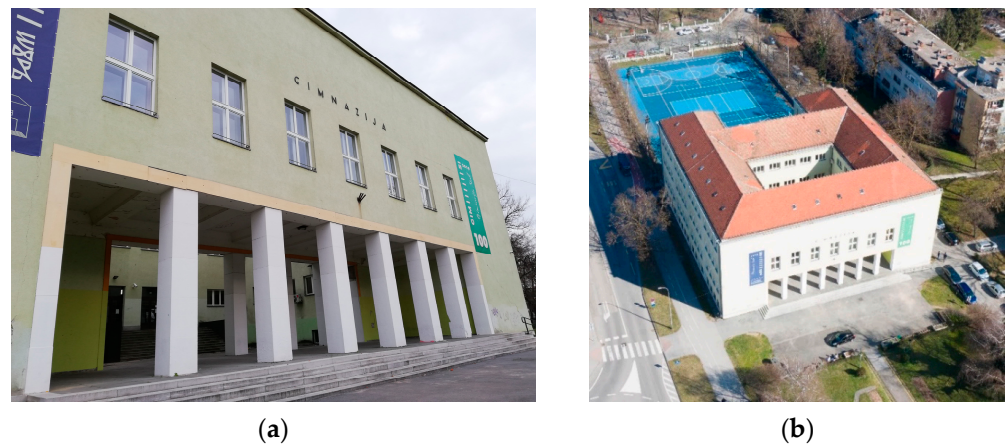
Figure 1. High school building in Sisak (a) entrance in school (b) bird view.

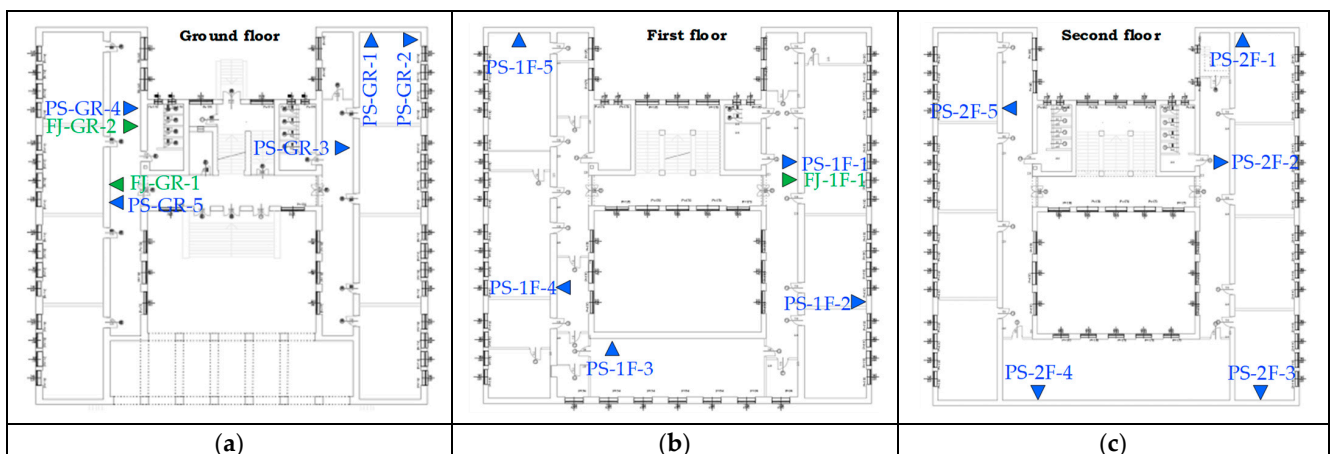
Figure 2. Measurement points for determination of mechanical properties of walls on the (a) Ground Floor (b) First Floor (c) Second Floor.

To determine the mechanical properties of bearing walls, a shear test and flat jack test were performed. As a result of conducted shear test [8], the shear strength, f_v^{exp} , with the contribution of normal compressive stress, σ_0^{exp} , is obtained. On the observed structure, a total of 15 measurement locations were selected (Figure 2), 5 at each floor in which the shear strength test was performed. The obtained test results are shown in Table 1.

In addition to existing compressive stress, using the flat jack, the modulus of elasticity (E^{exp}) is also determined (Table 2). The obtained value is significantly higher than the expected value and the one recommended by the literature [8]. The obtained value of shear strength without compressive stress (f_{V0}^{exp}), using the flat jack test, within one floor varies significantly (test results on the ground floor). The above can be supported by the assumption that the wall at the measurement location FJ-GR-2 is perhaps one of the walls on which rehabilitation work was carried out in a previous period.

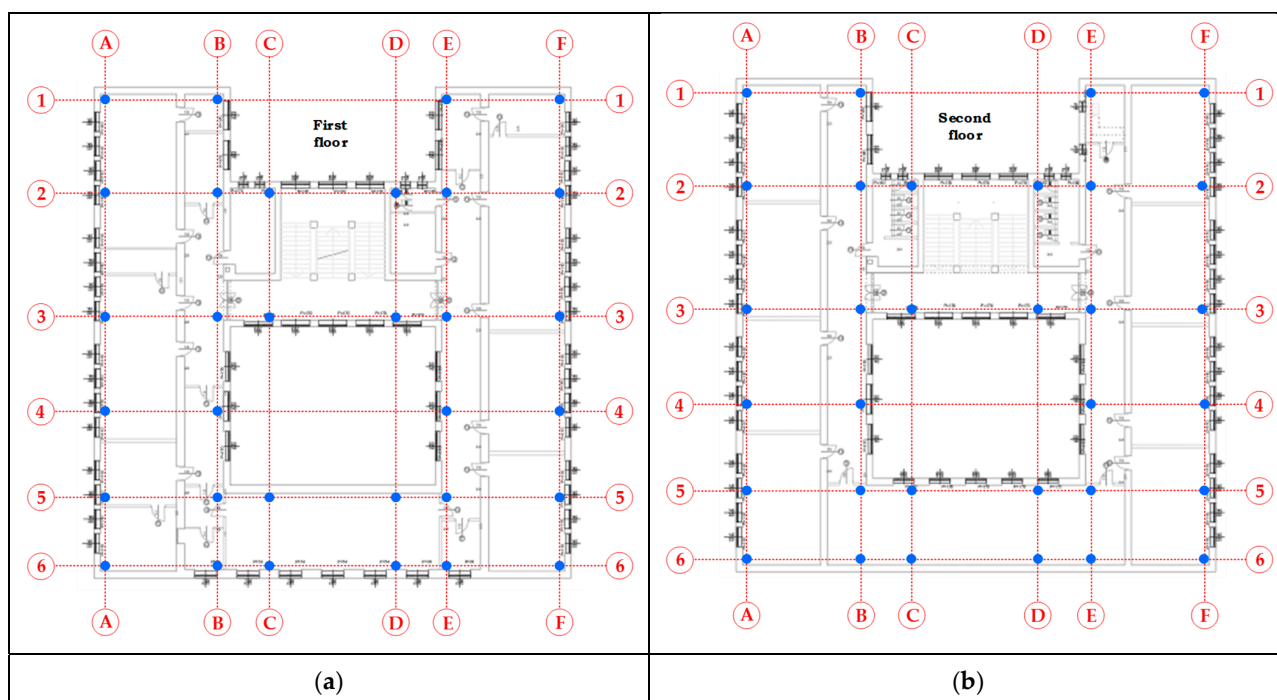
Figure 5. Arrangement of measurement points for determination of the structural dynamic properties at the (a) first and (b) second floor.

The structural response was measured during the ambient excitation. The reference point was located at the measurement point C3 on the second floor. Classical frequency domain decomposition (FDD) and enhanced frequency domain decomposition (EFDD) methods were used for estimation of structural dynamic properties, natural frequencies (Table 3, Figure 6), and mode shapes (Figure 7). The values of experimentally obtained frequencies for the concerned mode shapes were read from the characteristic record (Figure 6).

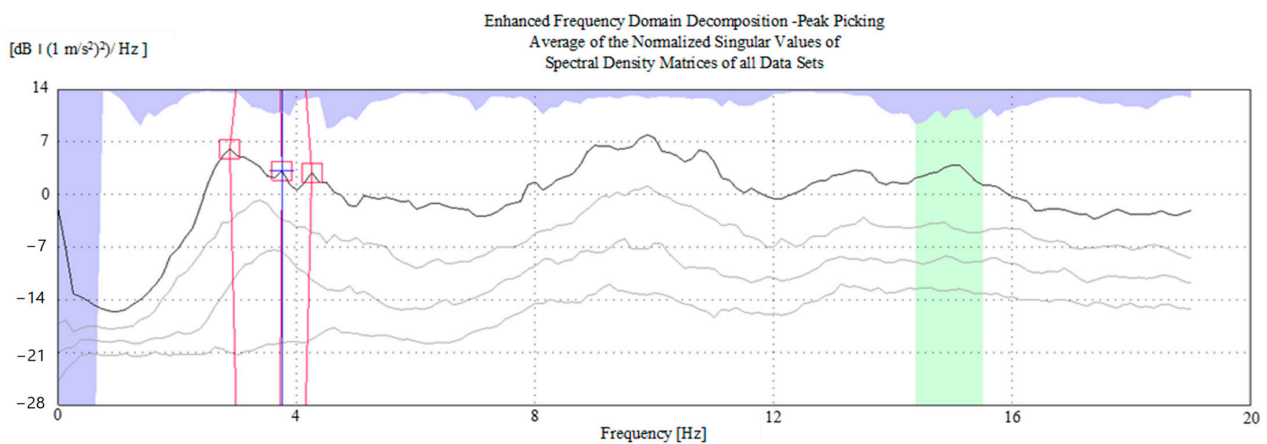
Mode <i>i</i>	$f_i^{exp} \pm st.dev.$
1	2.972 ± 0.10
2	3.742 ± 0.09
3	4.275 ± 0.27

Figure 6. Characteristic record of frequency domain decomposition (FDD) for the determination of natural frequencies.

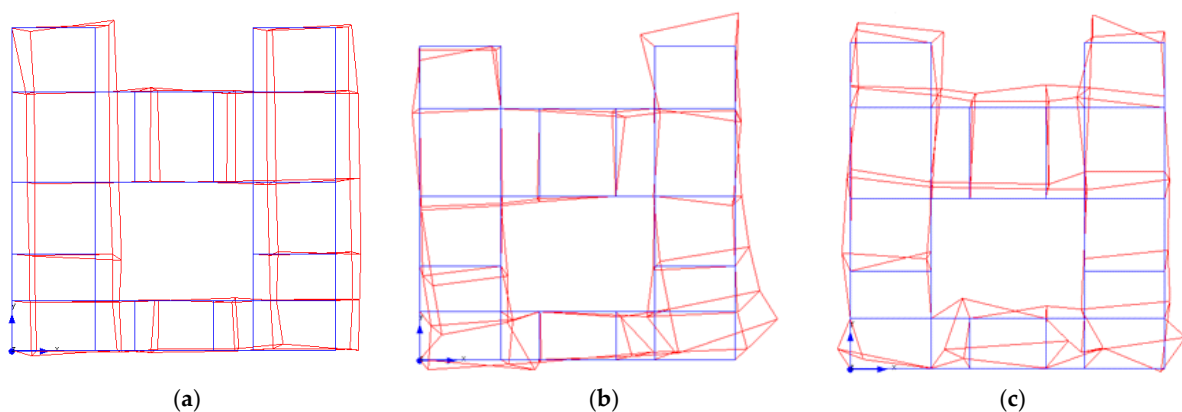
Figure 7. Experimentally determined (a) first (b) second and (c) third mode shape. The blue lines represent the undeformed shape, while the red line represent deformed shape.

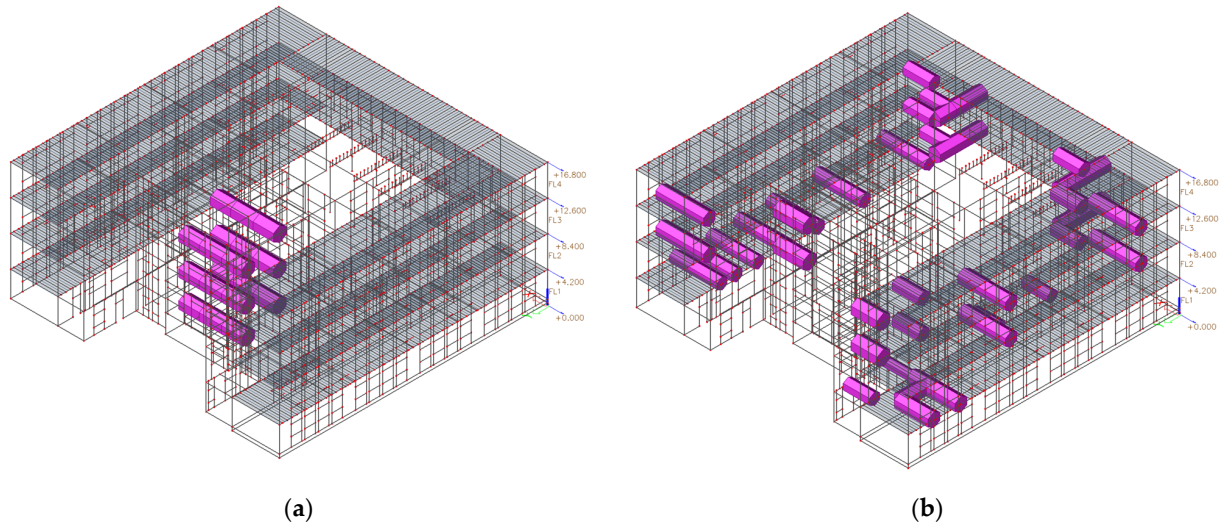
reactions from the self-weight were obtained, which were transferred to the 3D model of the structure. Staircases are entered into the 3D model of the structure in the same way (Figure 9a). Since all partition walls were damaged in the earthquake, it was assumed that they did not contribute to the structural stiffness and are introduced to numerical model as additional mass (Figure 9b). The mezzanine structure is modeled as a ribbed slab with additional layers.

Figure 9. Initial numerical model of the case study: (a) mass of the staircase and (b) representation of the mass of partition walls in the numerical model.

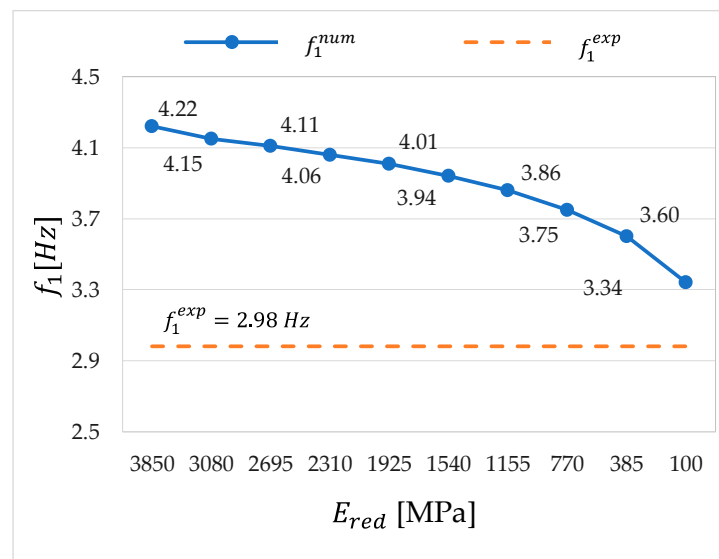
Based on the analysis (Figure 12) of the elasticity modulus reduction for the damage construction elements (E_{red}), a decrease in the first natural frequency (f_1^{num}) can be noticed. However, by imitating the damaged parts of the structure with finite elements with a reduced modulus of elasticity, satisfactory results were not achieved. Regardless of the fact that the previous iteration and analysis did not provide satisfactory results (matching values of numerically predicted and experimentally measured natural frequencies), in the next iteration, the simulation of damages in the specified load-bearing walls is retained.

Figure 12. Changes of the first natural frequency of the numerical Model 3 (f_1^{num}) for different levels of modulus of elasticity reduction (E_{red}) with the comparison of the experimentally obtained natural frequency (f_1^{exp}).

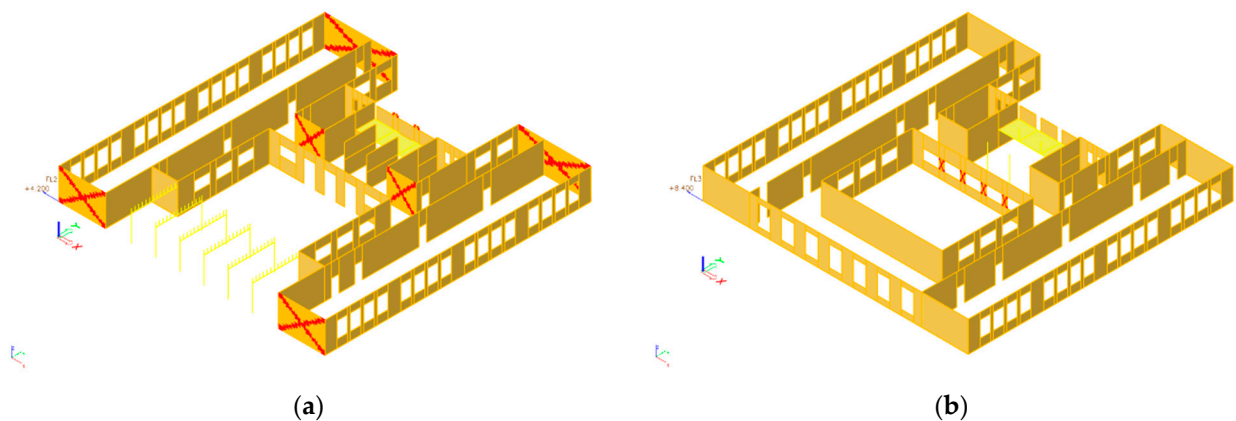
Since the behavior of the structure obtained by experimental testing was not achieved with the previously analyzed updated numerical models, the numerical analysis was carried out on the new model (Model 4). The new model is developed in such a way that the finite elements of the initial numerical model, whose locations correspond to the location of the diagonal cracks determined by visual inspection (Figure 13), were associated with a modulus of elasticity close to 0 (in order to avoid errors in calculation).

Figure 13. The finite elements of the model with a reduced modulus of elasticity at the (a) ground and (b) first floor.

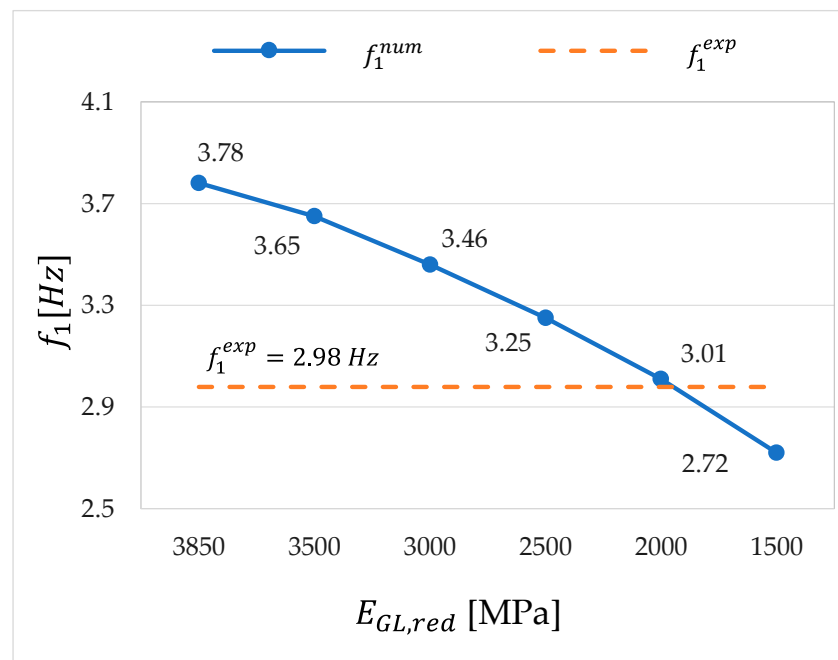
Figure 14. Changes of the first natural frequency of the numerical Model 5 (f_1^{num}) for different levels of global modulus of elasticity reduction ($E_{GL,red}$) with the comparison of the experimentally obtained natural frequency (f_1^{exp}).

The changes in the natural frequency values obtained by numerical modal analysis with respect to the experimental values are visible. The modulus of elasticity around the 2000 MPa gives a very small difference compared to the experimentally obtained results. The next table (Table 8) shows a comparison of the experimentally determined values of the natural frequencies with the frequencies obtained by the numerical modal analysis of Model 5, to which the global modulus of elasticity in the amount of 2000 MPa is assigned.

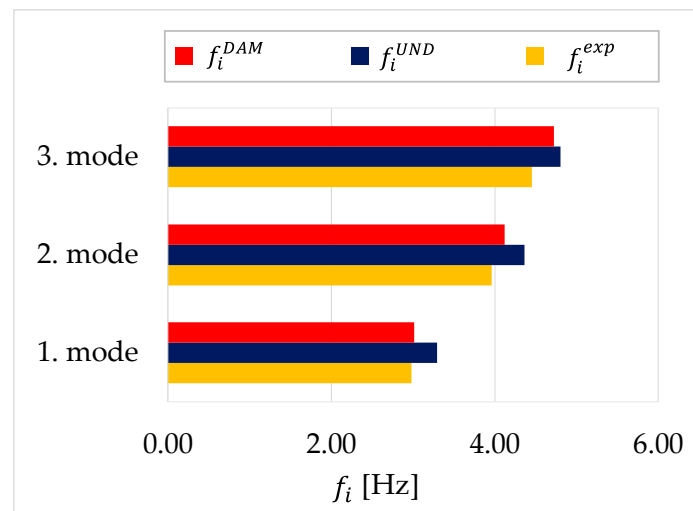
The comparison shows approximately equal results of the undamaged numerical model compared to the experimental results for the first three experimentally determined mode shapes, Figure 16. The difference in the natural frequency of the damaged and undamaged state is 9% for the first, 6% for the second, and 2% for the third mode shape. The ratio between the frequency of the numerical model before the earthquake and the frequency of the final numerical model shows the greatest difference in frequency results for the first mode, so it can be assumed that the greatest damage occurred in the first mode shape.

Figure 16. Comparison of experimentally obtained (f_i^{exp}) and natural frequencies of numerical models for damage (f_i^{DAM}) and undamaged state (f_i^{UND}).
