Case studies of structural natural frequencies assessment and application in SHM and the calibration of FEM models

Davor Uglešić¹, Ante Uglešić²

Abstract

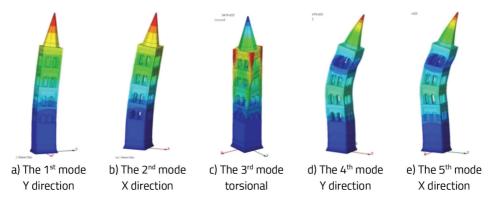
Figure 1. Modes

We used the results for the calibration of the FEM model. During the multi-step calibration process of the FEM model, it is necessary to change and adapt boundary conditions, geometric properties, material properties. The model was calibrated in more than a few steps and modal analyses were performed (Fig. 1) whereby we have well matching between measured and calculated frequencies, differences from 0 to 10.7 % (Table 2). The same table compares our measurements with those performed by Herak et al which also match well, with differences ranging from 2.9 to 4.7 %. The monitoring of the cracks in the bell tower is ongoing. Upon completion of the monitoring, we plan to repeat the measurements to determine whether there are differences in relation to the first results of natural frequencies.
