# Analysis of Tram Traffic-Induced Vibration Influence on Earthquake Damaged Buildings

**Abstract:** The Zagreb 2020 earthquake severely damaged the historic centre of the city. Most of the damage occurred on historic masonry residential buildings, many of which are situated very close to the tram track. Although traffic-induced vibrations generally do not affect surrounding buildings, they can be harmful to buildings damaged by a previous earthquake. Vibrations could contribute to the further propagation of existing cracks. The effect of vibrations depends on many factors, one of the most important being the distance between the track and the building. The vibrations are highest at the source, and the energy loss occurs due to transfer through the soil to the recipients. The impact of tram-induced vibrations on earthquake-damaged buildings in the city of Zagreb is investigated in this paper. The analysis is conducted on a tramway network scale to identify critical locations by performing continuous monitoring on the tramway network and risk analysis based on the distance of buildings from the track, vibration amplitude at source, and building damage. Further investigation is base

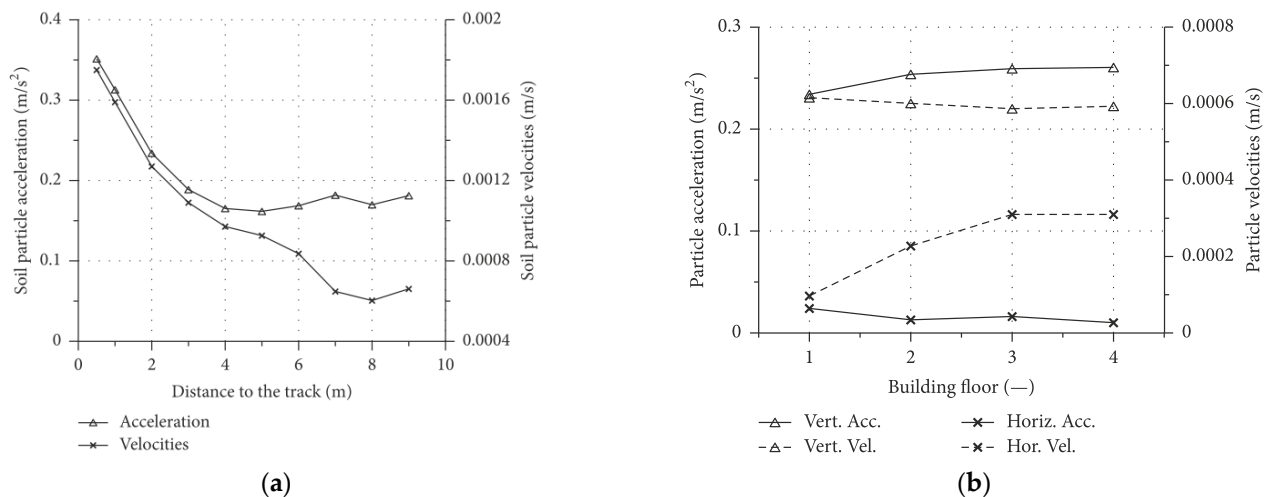
**Figure 2.** (a) Soil particle acceleration and velocities at different distances from the track; (b) maximum particle velocities and acceleration at different floors of the building [10].

transmitted to other parts of the structure, causing the floors, ceilings, and walls to vibrate. As shown in [4], the velocities of horizontal particles increase upwards in the building, while vertical velocities and accelerations are constant (Figure 2b). It can be concluded that vibrations are consistently higher on the upper floors of buildings. Measurements conducted in [7] show that vertical velocity levels are larger than horizontal vibration components for foundation slabs, which corresponds to the diagram given in Figure 2. Therefore, vertical vibrations are more important in the design aimed at reducing the transmission of vibrations to the upper floors [7].

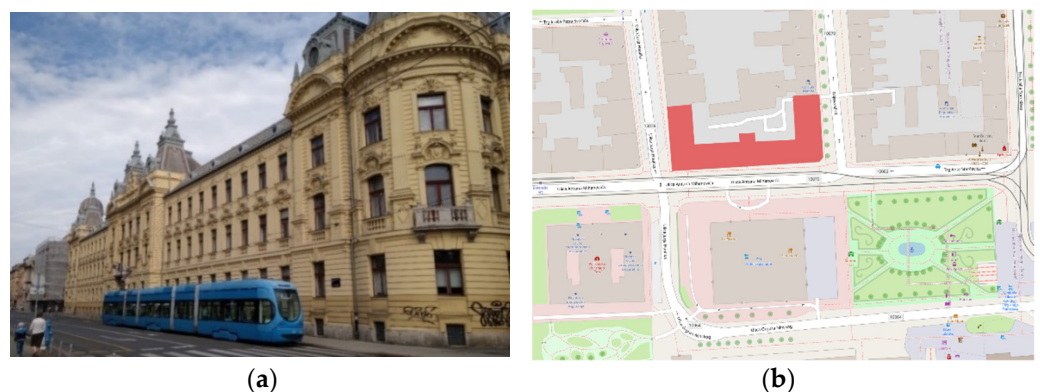
**Figure 3.** (a) Tram type 2200 passing on the northern track in front of the HŽI head-office building (south wing), (b) with building orientation (red) and tram centreline (black) © OpenStreetMap contributors.

The testing was conducted in the Croatian Railways Infrastructure (HŽI) head-office building, situated in the historic centre of Zagreb at Mihanovićeveva 12. The building was built in 1903 as a head office building for railway authority MAV, which is a predecessor of HŽI. It is a typical example of a masonry structure situated in the historic Zagreb downtown complex, with a basement, ground floor, first floor, and second floor. The first reconstruction followed in the 1930s when side wings (east and west) were widened. In 1964, a third floor was upgraded and constructed under the existing wooden roof structure. After the roof fire in 1977, the wooden roof was replaced with the steel frame roof structure. In this renovation, the third floor was constructed as a reinforced concrete structure. The last renovation included an upgrade of the building façade in the 1990s. In its current form, the building consists of three wings (east, south, and west), five floors, each with a gross area of 2200 m<sup>2</sup>, Figure 3.

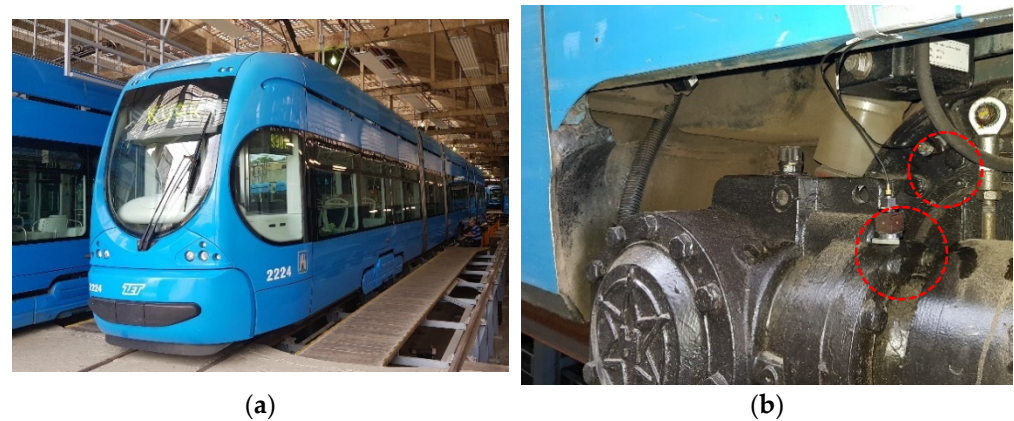
**Figure 5.** (a) Tram TMK2224 in the position for accelerometer mounting; (b) vertical and transverse accelerometers at the central bogie.

Measurements on tram bogie were conducted to acquire the best insight into vibration characteristics at the source (wheel–rail interface) and to prepare the ground for the long-term monitoring of vibrations on an instrumented in-service vehicle. For the initial testing, measurement was conducted using tram TMK 2224 (low-floor tram constructed by Končar KEV that is the main tram type with a fleet of 140 running within the Zagreb tram network), further referred to as the reference tram, Figure 5. The tram is 70 m long and features 5 modular compartments. It runs on 3 bogies (Bo'Bo'Bo' arrangement), out of which the central bogie was instrumented with accelerometers on the left and right sides of the bogie in both vertical and transverse direction as described below:

Acceleration data were acquired using 10 mV/g accelerometers synchronized in time, and the data were recorded at a sampling rate of 4096 Hz.

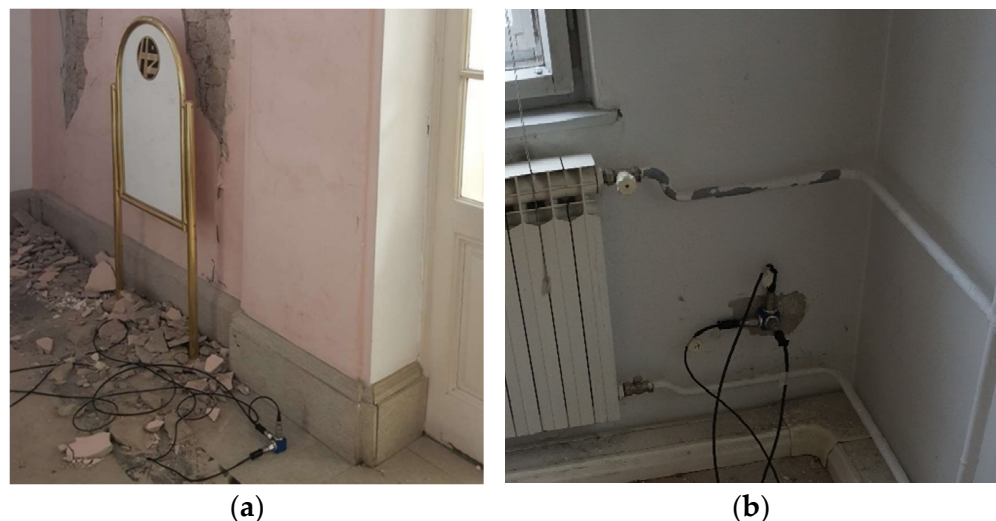
**Figure 7.** Accelerometer placement on the (a) rigid floor surface and (b) masonry wall structure.

Accelerometers were attached to steel cubes (measuring  $40 \times 40 \times 40$  mm) in three perpendicular directions by means of magnets. The cubes were then attached with industrial glue to the solid floor or wall structure, Figure 7. Acceleration data were acquired and processed using 500 mV/g accelerometers synchronized in time, and the data were recorded at a sampling rate of 1024 Hz.
