Rapid post-earthquake damage assessment platform based on UAV and GIS

Source / Izvornik: **1st Croatian Conference on Earthquake Engineering, 2021, 405 - 410**

Key words: damage assessment, damage detection, UAV, GIS, on-line platform

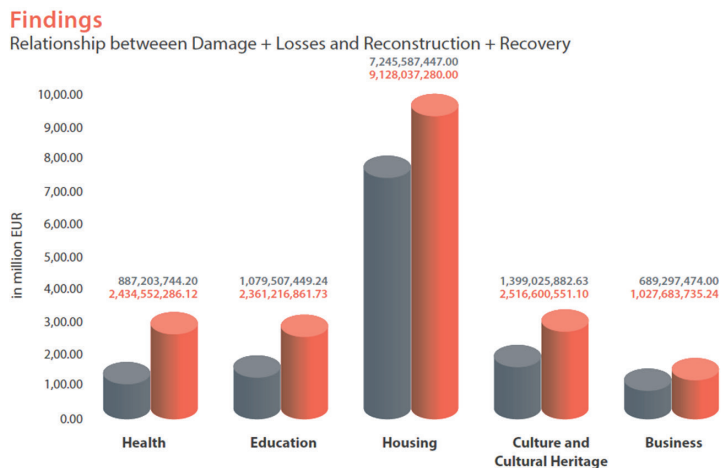
Figure 1. World Bank – Rapid Damage and Needs Assessment after the Zagreb earthquake [2]

On the 22nd of March, 2020, at 6 hours and 24 minutes, the area of the City of Zagreb and its surroundings were hit by an earthquake with magnitude of 5.5 (M_L) and intensity VII according to the EMS-98 scale. It is estimated that 791,038 people were directly exposed to earthquake conditions of level-VII intensity. The total affected area was about 22.2 million square meters, with 82 % of the affected area in residential parts of the city. According to the World Bank methodology, the assets' damage was around 20% of Croatian GDP for 2020. More information can be found in Figure 1.
