# Rapid post-earthquake damage assessment platform based on UAV and GIS

## Rapid post-earthquake damage assessment platform based on UAV and GIS

**Key words:** damage assessment, damage detection, UAV, GIS, on-line platform

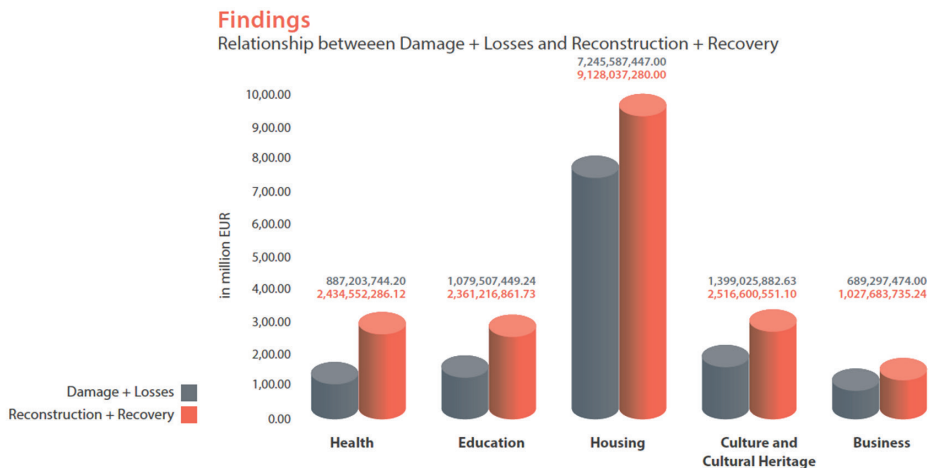
Figure 1. World Bank – Rapid Damage and Needs Assessment after the Zagreb earthquake [2]

On the 22<sup>nd</sup> of March, 2020, at 6 hours and 24 minutes, the area of the City of Zagreb and its surroundings were hit by an earthquake with magnitude of 5.5 ( $M_L$ ) and intensity VII according to the EMS-98 scale. It is estimated that 791,038 people were directly exposed to earthquake conditions of level-VII intensity. The total affected area was about 22.2 million square meters, with 82 % of the affected area in residential parts of the city. According to the World Bank methodology, the assets' damage was around 20% of Croatian GDP for 2020. More information can be found in Figure 1.

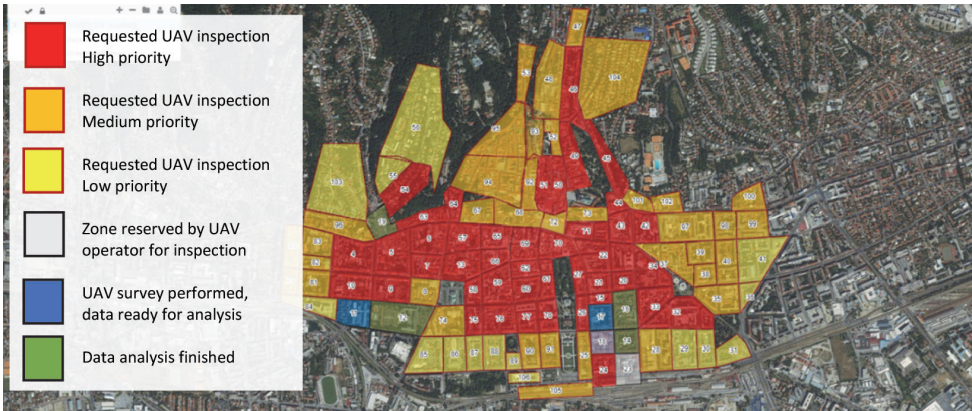
**Figure 2. Zone definition and classification for UAV inspection**

Developed on-line platform minimizes engineers' risk and improves detection of structural damage on hard-to-reach and dangerous locations. It also allows remote assessment of on-site acquired aerial photography increasing the potential workforce involved. The framework has been developed in cloud-based GIS platform GISCloud already used in different civil engineering applications [4, 5] which provided free access to all interested engineers and UAV operators for this specific task. Developed GIS application included modules for UAV operators (overview and reservation of zones for coordination of UAV missions, figure 2) and for civil engineering professionals (damage detection and

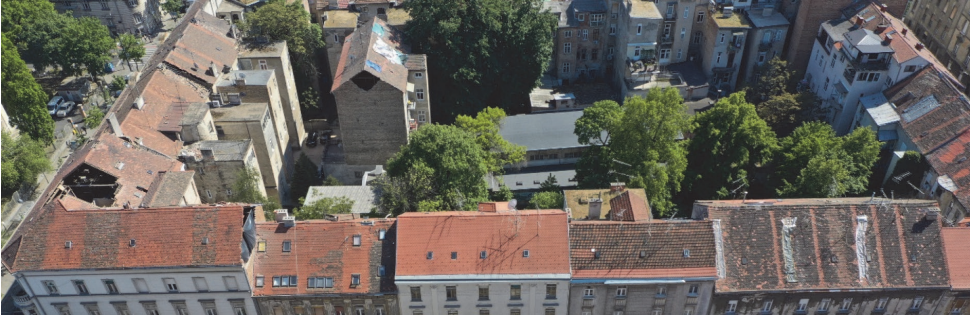
Figure 4. Typical UAV photography that was later on analysed
