# Post-Earthquake Dynamic Performance of Intact Masonry Building Based on Finite Element Model Updating

Source / Izvornik: Applied sciences (Basel), 2023, 13, 1 - 19

# Article Post-Earthquake Dynamic Performance of Intact Masonry Building Based on Finite Element Model Updating

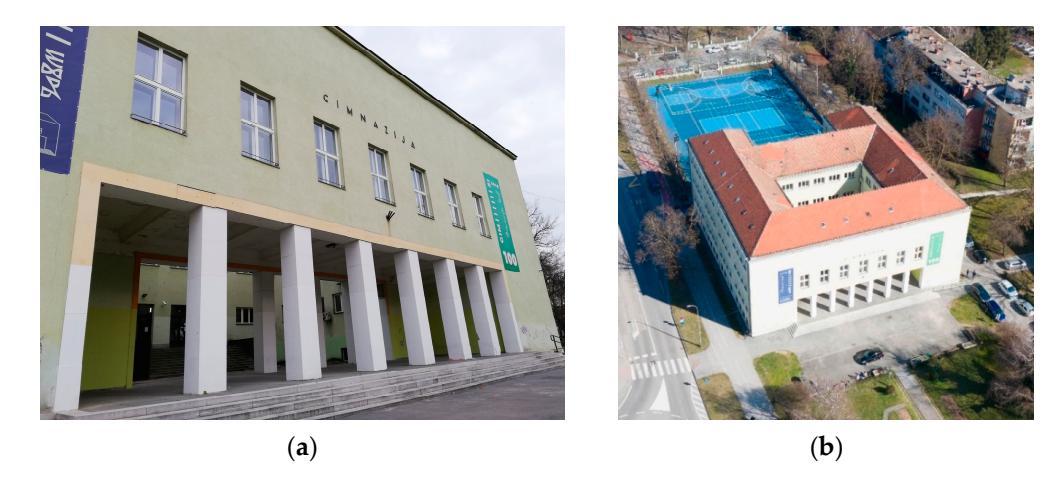
As a case study, a building of a high school in Sisak (Figure 1) built in 1935 was taken. The building has four floors: basement, ground floor, and two upper floors. In the central part of the building there is a three-legged staircase with a landing. The foundations are constructed as a reinforced concrete slab. The load-bearing part of structure consists of walls made of solid bricks of 29(39) cm  $\times$  15 cm  $\times$  6.5 cm, floor slabs and reinforced concrete ribbed floor slabs. The thickness of the load-bearing walls in the basement is 60 cm and 75 cm, and 50 cm and 60 cm on the ground floor and upper floors. The partition walls are 15 cm, 18 cm, 25 cm or 30 cm thick and are made of hollow blocks. The floor slab is 25 cm thick and the reinforced concrete ribbed floor slab has a total height of 33 cm. The clear distance between the ribs is 60 cm, the width of the ribs is 13 cm, and the height is 23 cm. At the entrance of the building on the first and second floors, there is a load-bearing part of the structure that rests on columns with the square section of 75 cm  $\times$  75 cm and a height of 470 cm. The columns are arranged in two rows of four or six columns at equal centre distance of 330 cm. The mezzanine structure in this part is reinforced with beams of 75 cm imes 123 cm, placed at an axial distance of 330 cm above the columns. The supporting structure of the roof is made of wood and is 418 cm high. The geometrical dimensions of the building are  $37 \text{ m} \times 37 \text{ m}$ .

Figure 1. High school building in Sisak (a) entrance in school (b) bird view.

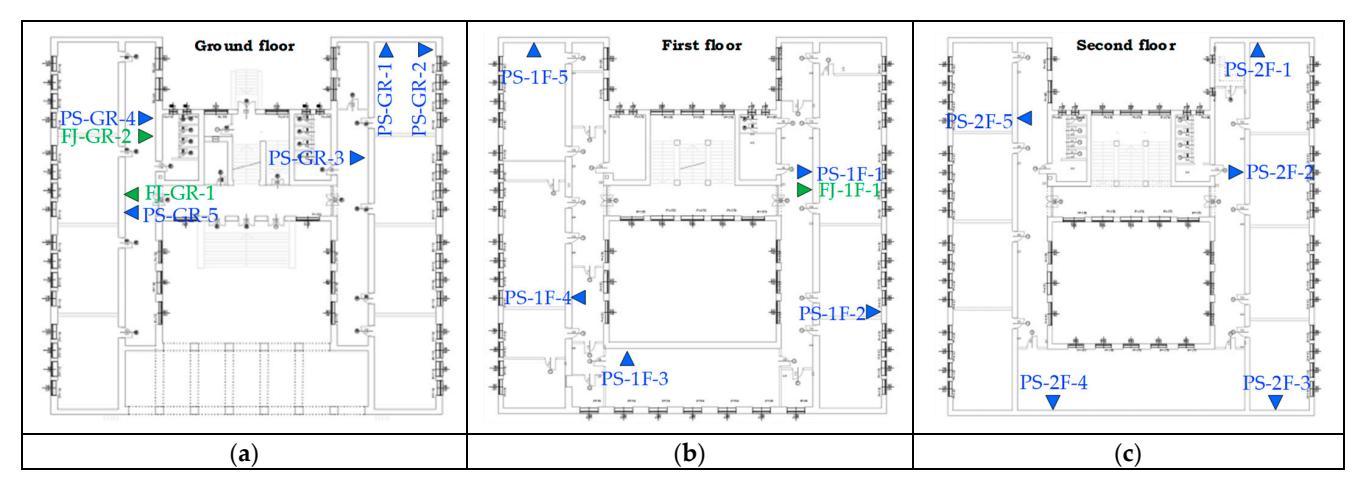
Within the experimental investigation of case study determination of mechanical properties (Figure 2) of the masonry walls and operational modal analysis (OMA) were considered in addition to visual inspection (Figure 3).

**Figure 2.** Measurement points for determination of mechanical properties of walls on the (**a**) Ground Floor (**b**) First Floor (**c**) Second Floor.

To determine the mechanical properties of bearing walls, a shear test and flat jack test were performed. As a result of conducted shear test [8], the shear strength,  $f_v^{exp}$ , with the contribution of normal compressive stress,  $\sigma_0^{exp}$ , is obtained. On the observed structure, a total of 15 measurement locations were selected (Figure 2), 5 at each floor in which the shear strength test was performed. The obtained test results are shown in Table 1.

In the subjected structure, a total of three flat jack tests were performed: two on the first floor and one on the second floor. The obtained values of the existing compressive stress  $(f_0^{exp})$ , in the wall are shown in Table 2.

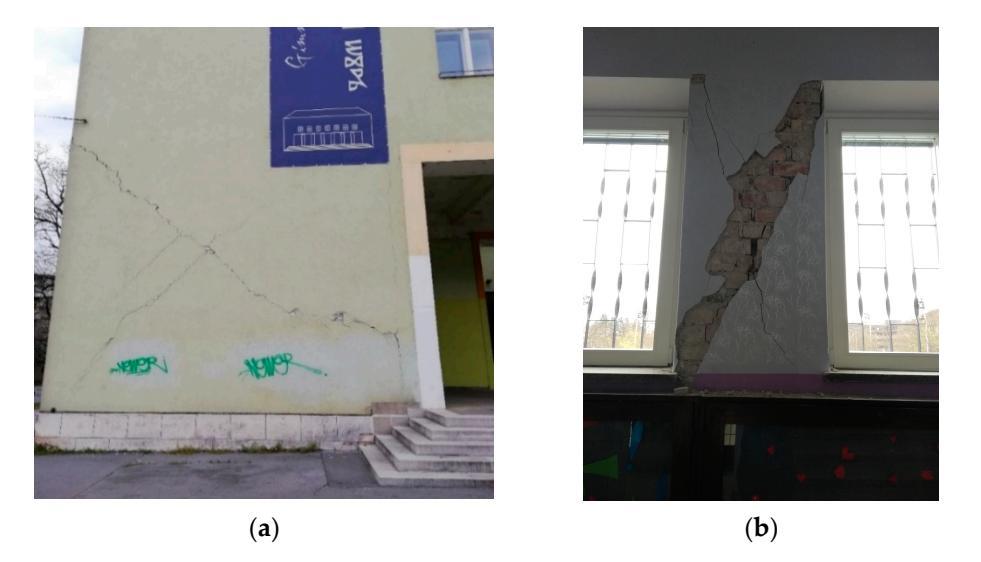
Figure 3. Observed characteristic damages on (a) the load bearing walls (b) the walls between the openings.

A detailed visual inspection was performed to visually evaluate the structure. During the inspection, some guidelines of the RVS (Rapid Visual Screening) method were applied [36]. The building was inspected by a team of four engineers. The inspection lasted approximately six hours. During the inspection, damage on load bearing and partition walls was observed on the ground floor and first floor. Special attention was paid to crack widths on structural and non-structural elements, separation between structural elements, and displacement of structural components. The cracks were generally diagonal and occurred both in the mortar joints and in the masonry units themselves. Some characteristic and specific damage can be seen in Figure 3. There was frequent evidence of crushing and spalling on many non-structural elements, seen in Figure 4a. Extensive detachment of the surface layer was evident on some parts of the ceiling, seen in Figure 4b. Considering the observation during the visual inspection, the finite element model of the structure in the updating phase is adapted to the found state.

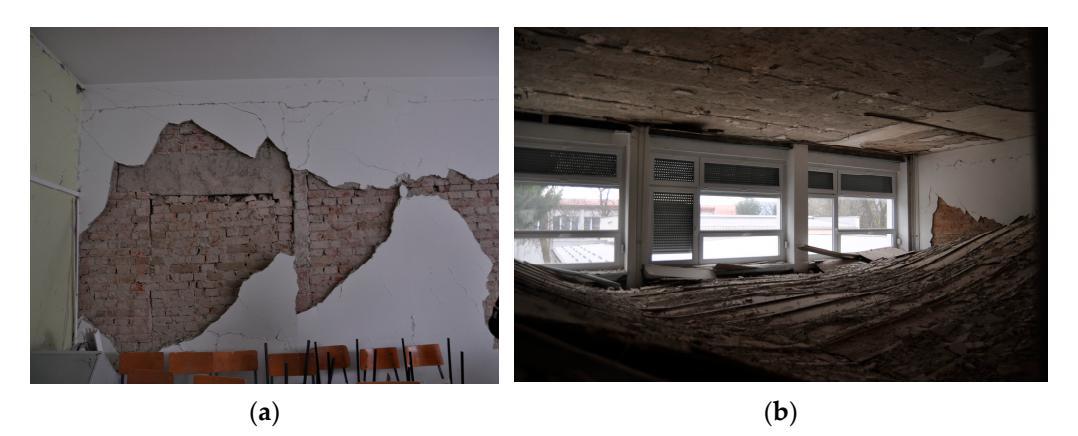
Figure 4. Observed damage on (a) the partition wall and (b) the ceiling.

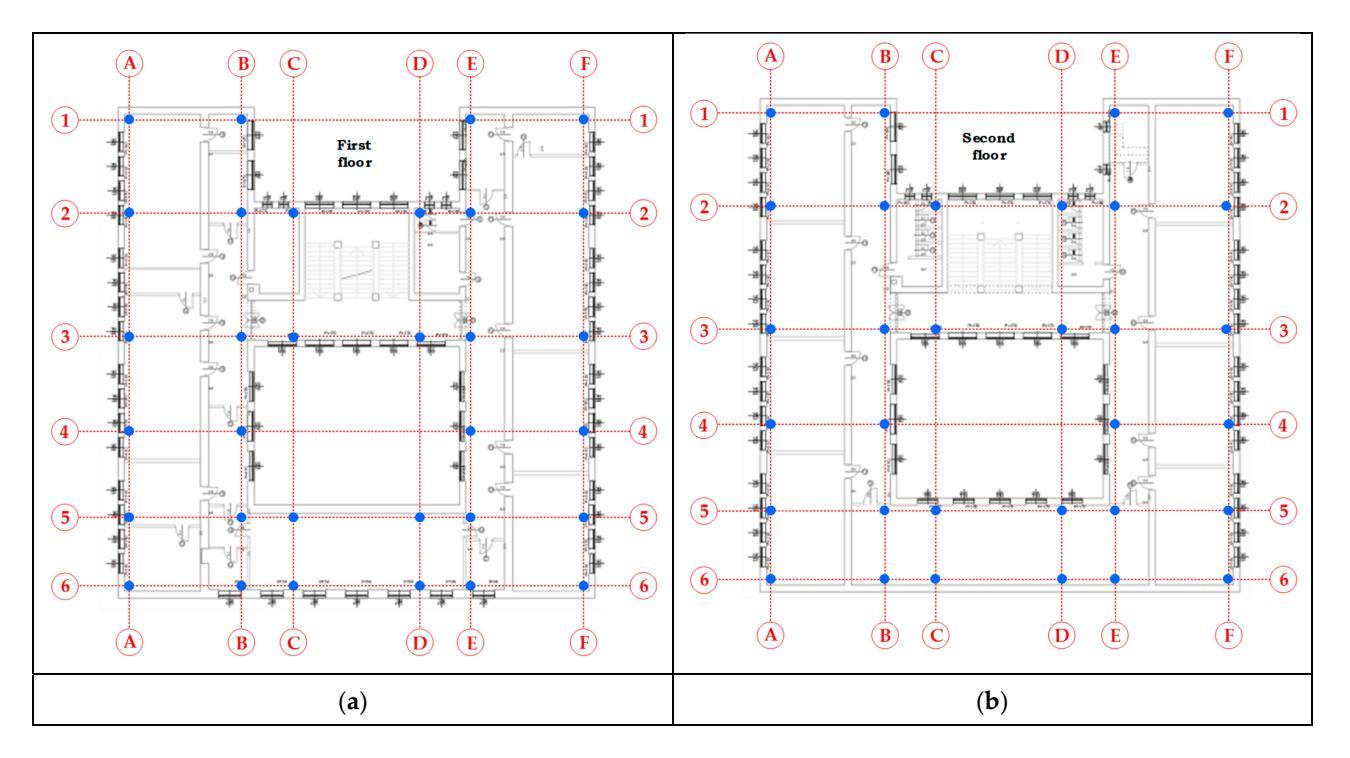
As a part of OMA, structural dynamic properties were obtained. In the following section, each test is described in detail. Operational modal analysis was performed by using piezoelectric accelerometer (PCB Piezotronics, type 393B31) with the nominal sensitivity of 10 V/g (PCB Piezotronics, Depew, NY, USA) an analyzer (Brüell&Kjaer, type 3560C, Brüell&Kjaer, Naerum, Denmark) and associated software. The measurement was performed in total 64 points, 32 points per floor (1st and 2nd) in two perpendicular, x and y, directions (Figure 5) during 128 s in each point. In this way, 128 degrees of freedom were obtained, the sum of which corresponds to two horizontal directions.

**Figure 5.** Arrangement of measurement points for determination of the structural dynamic properties at the (**a**) first and (**b**) second floor.

The structural response was measured during the ambient excitation. The reference point was located at the measurement point C3 on the second floor. Classical frequency domain decomposition (FDD) and enhanced frequency domain decomposition (EFDD) methods were used for estimation of structural dynamic properties, natural frequencies (Table 3, Figure 6), and mode shapes (Figure 7). The values of experimentally obtained frequencies for the concerned mode shapes were read from the characteristic record (Figure 6).

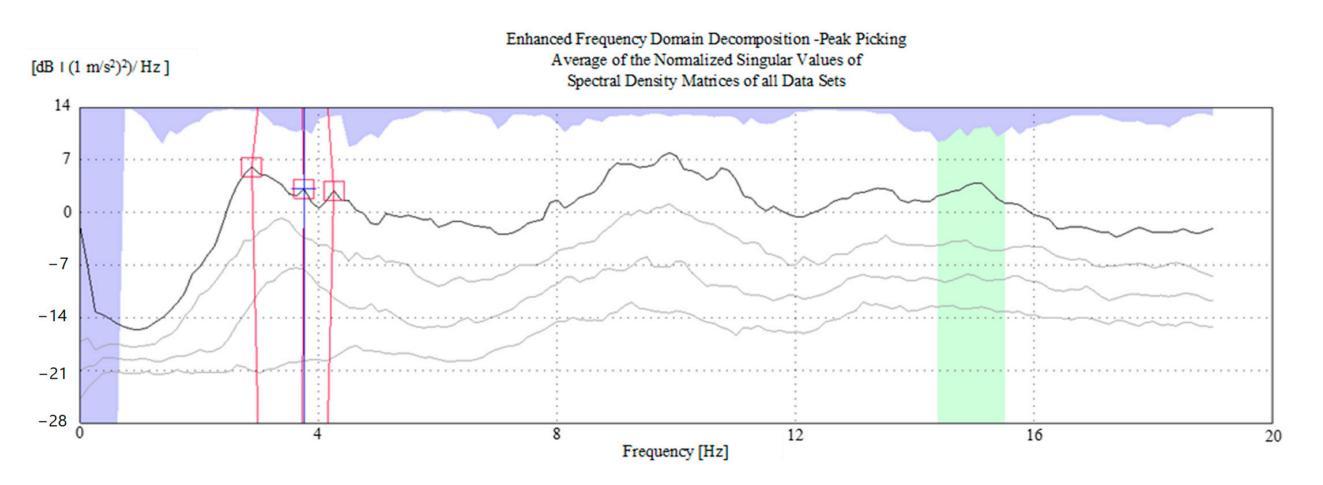
**Figure 6.** Characteristic record of frequency domain decomposition (FDD) for the determination of natural frequencies.

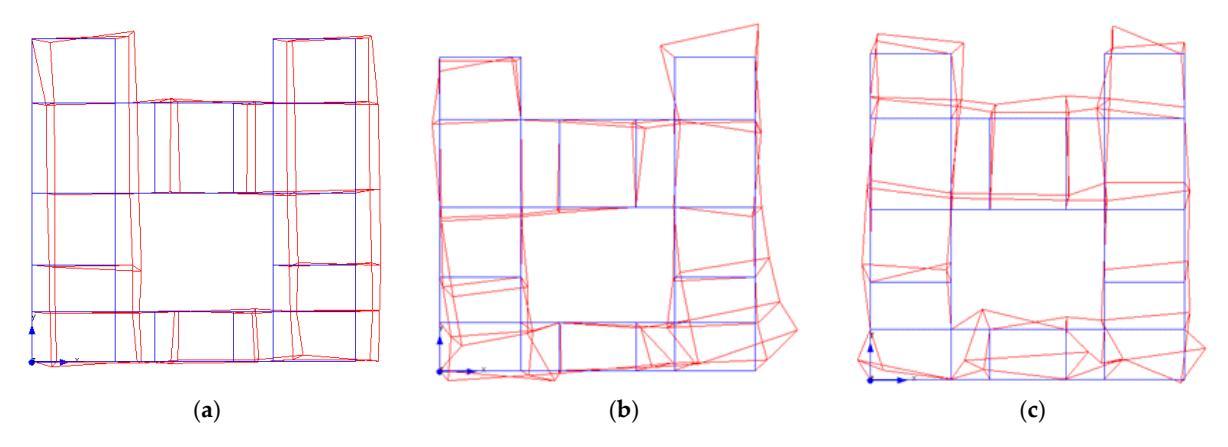
**Figure 7.** Experimentally determined (**a**) first (**b**) second and (**c**) third mode shape. The blue lines represent the undeformed shape, while the red line represent deformed shape.

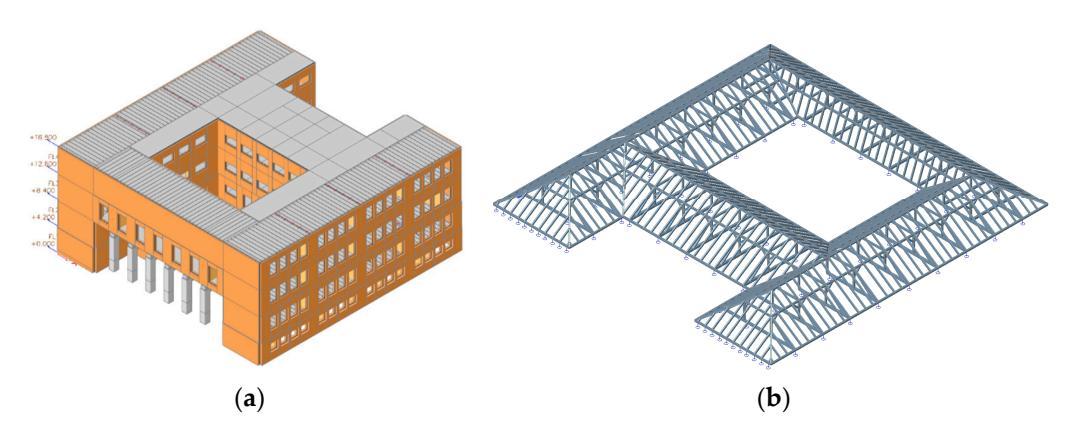
Experimentally obtained results were used to update the numerical model of the high school (Figure 8a). The model was developed in the commercial software SCIA Engineering 22 [19]. Considering the fact that the determination of the dynamic parameters is based on the ambient excitation in the vicinity of the real structure, with respect to a very low (hardly measurable) vibration level, it is sufficient for the comparison of the experimentally

and numerically determined dynamic parameters to create and analyze a linear numerical model. Walls and slabs were modelled with shell elements, slabs reinforced with ribs are modelled using coupled shell elements, and a slab reinforced with beams is modelled with a shell element that is connected with a beam using rigid elements. Columns and beams are modelled using beam elements. Boundary conditions under the load bearing walls are assumed to be fixed, while for the columns it is proposed that they are clamped. The dimensions of the elements are taken from the drawings. Material properties assigned to the modelled elements are listed in Table 4.

Figure 8. Numerical model of the case study: (a) 3D model and (b) 3D sub-model of the roof.

To consider the effect of the roof, i.e., its weight, a sub-model was created (Figure 8b). The basic mechanical properties of the material are taken from the experimental investigation, while the dimensions are defined according to the available drawings. The elements of the roof are modelled using the beam elements. By calculating the sub-model of the roof, reactions from the self-weight were obtained, which were transferred to the 3D model of the structure. Staircases are entered into the 3D model of the structure in the same way (Figure 9a). Since all partition walls were damaged in the earthquake, it was assumed that they did not contribute to the structural stiffness and are introduced to numerical model as additional mass (Figure 9b). The mezzanine structure is modeled as a ribbed slab with additional layers.

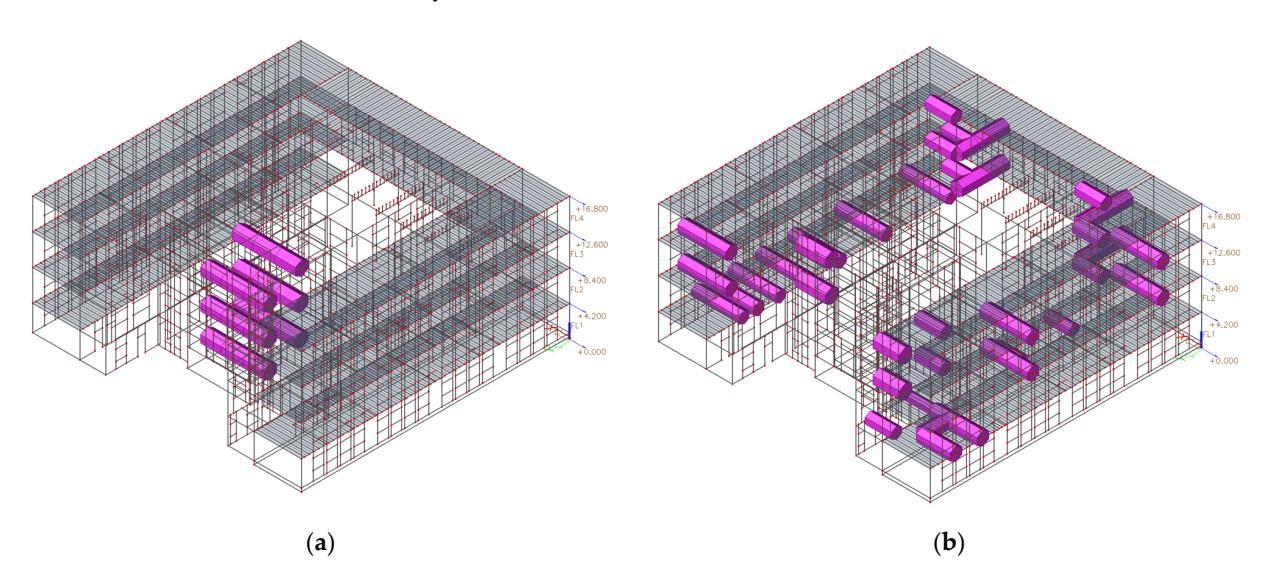
**Figure 9.** Initial numerical model of the case study: (**a**) mass of the staircase and (**b**) representation of the mass of partition walls in the numerical model.

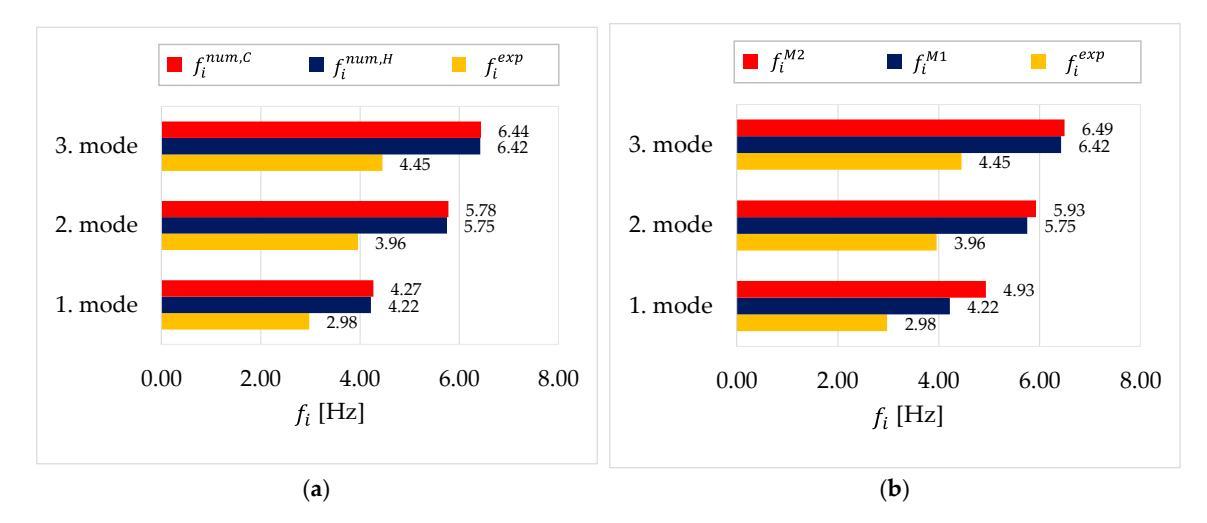
To determine the influence of the boundary conditions on the change in the value of the natural frequencies of the structure, a model with fixed and clamped boundary conditions was developed. In the numerical model, the values of the entered masses of partition walls, roofs, and staircases were retained. A graphical comparison of the experimentally obtained natural frequency values with the frequencies obtained for both clamped  $\begin{pmatrix} f_1^{num,C} \end{pmatrix}$  and hinge  $\begin{pmatrix} f_1^{num,H} \end{pmatrix}$  boundary conditions is given in the Figure 10.

**Figure 10.** Graphical comparison of the experimentally obtained natural frequency values  $(f_1^{exp})$  with the frequencies obtained for hinge  $(f_1^{num,C})$  and clamped  $(f_1^{num,H})$  boundary conditions for (a) Model 1 and (b) Model 2.

Based on the analysis of the influence of the boundary conditions on the first natural frequency values, it can be seen and concluded from the graphical representation (Figure 10a) that there are no differences between the natural frequency values for the hinge  $(f_1^{num,H})$  and clamped  $(f_1^{num,C})$  boundary conditions, i.e., boundary conditions do not affect the natural frequency values. A clamped boundary condition, also known as fixed or fully restrained boundary condition, means that a structure is completely fixed or immobilized at a particular boundary. A hinge boundary condition, also referred to as a pinned or simply supported boundary condition, allows rotation at a specific boundary while preventing translation. Based on this observation and conclusion, for the further analysis and updating steps, the numerical model with hinge boundary conditions is considered. For the sake of simplicity, the selected model is referred to as M1 in the following text.

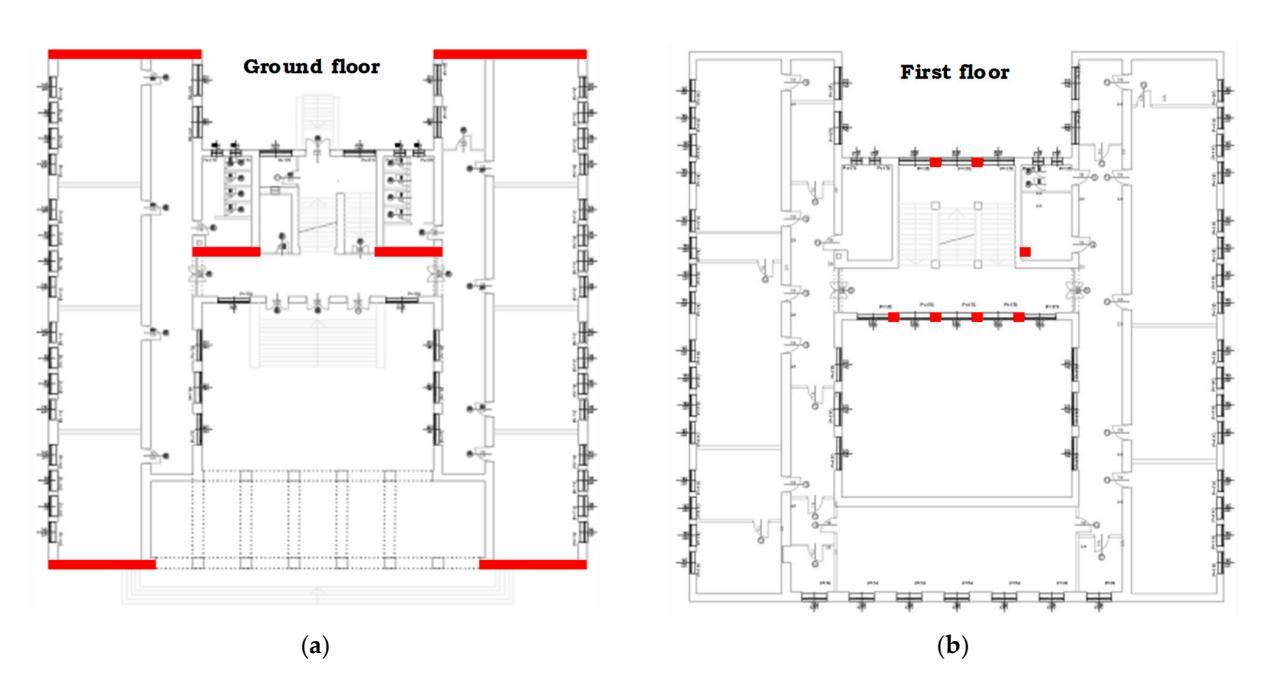
To be able to numerically predict the real structural behavior, the damaged structural elements in this step of analysis are modelled with reduced elasticity modulus. These elements were selected based on a visual inspection and their positions are marked in Figure 11.

**Figure 11.** The elements of the model with a reduced modulus of elasticity (red bars) at the (**a**) ground and (**b**) first floor.

In the numerical model, the damaged elements were modelled by finite elements with associated material with changed characteristics, i.e., reduced modulus of elasticity. Within a few steps, the reduction in the modulus of elasticity was performed.

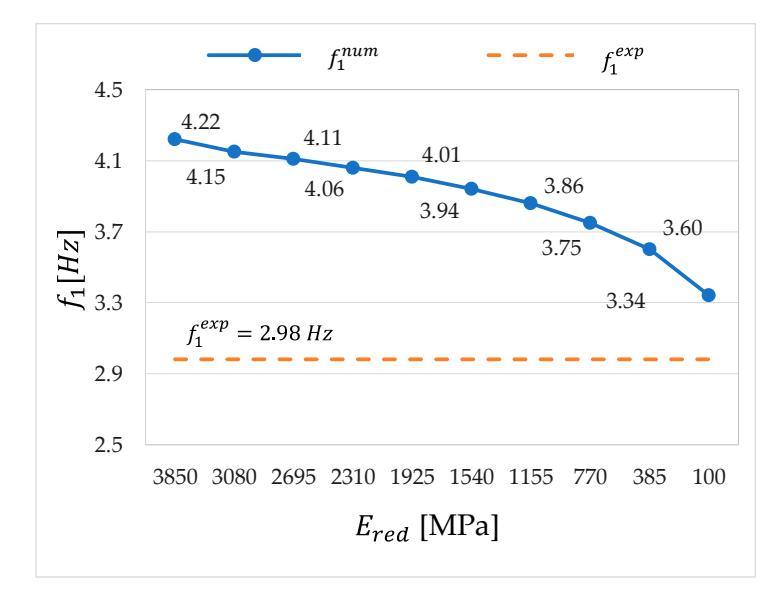
Based on the analysis (Figure 12) of the elasticity modulus reduction for the damage construction elements ( $E_{red}$ ), a decrease in the first natural frequency ( $f_1^{num}$ ) can be noticed. However, by imitating the damaged parts of the structure with finite elements with a reduced modulus of elasticity, satisfactory results were not achieved. Regardless of the fact that the previous iteration and analysis did not provide satisfactory results (matching values of numerically predicted and experimentally measured natural frequencies), in the next iteration, the simulation of damages in the specified load-bearing walls is retained.

**Figure 12.** Changes of the first natural frequency of the numerical Model 3  $(f_1^{num})$  for different levels of modulus of elasticity reduction  $(E_{red})$  with the comparison of the experimentally obtained natural frequency  $(f_1^{exp})$ .

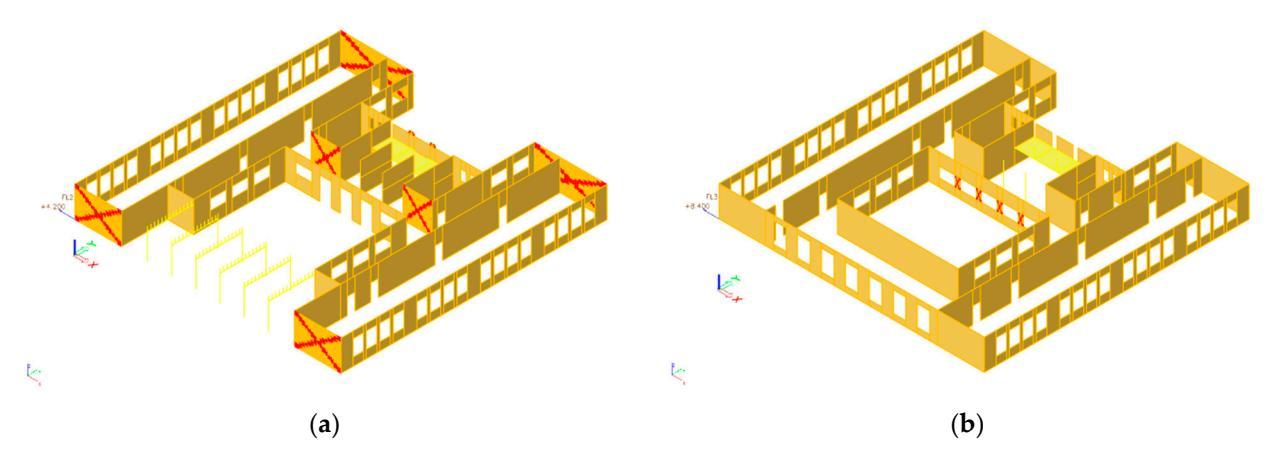
Since the behavior of the structure obtained by experimental testing was not achieved with the previously analyzed updated numerical models, the numerical analysis was carried out on the new model (Model 4). The new model is developed in such a way that the finite elements of the initial numerical model, whose locations correspond to the location of the diagonal cracks determined by visual inspection (Figure 13), were associated with a modulus of elasticity close to 0 (in order to avoid errors in calculation).

**Figure 13.** The finite elements of the model with a reduced modulus of elasticity at the (**a**) ground and (**b**) first floor.

The introduction of the assumption of a decrease in the modulus of elasticity of the finite elements corresponding to the location of the cracks resulted in a decrease in the frequency values. However, the frequency obtained by numerical modal analysis is still significantly higher than the one obtained by experimental investigation. For this reason, in the next section, the effect of reducing the global modulus of elasticity of walls is analyzed. Since the results of the analysis of the numerical model with introduced diagonal damage (Model 4) and that with a reduced modulus of elasticity of load-bearing walls where damage was observed (Model 3) are similar, according to the recommendations from the literature [24], a model with introduced diagonal damage (Model 5) was adopted to check the effect of the reduction in the global modulus of elasticity ( $E_{GL,red}$ ).

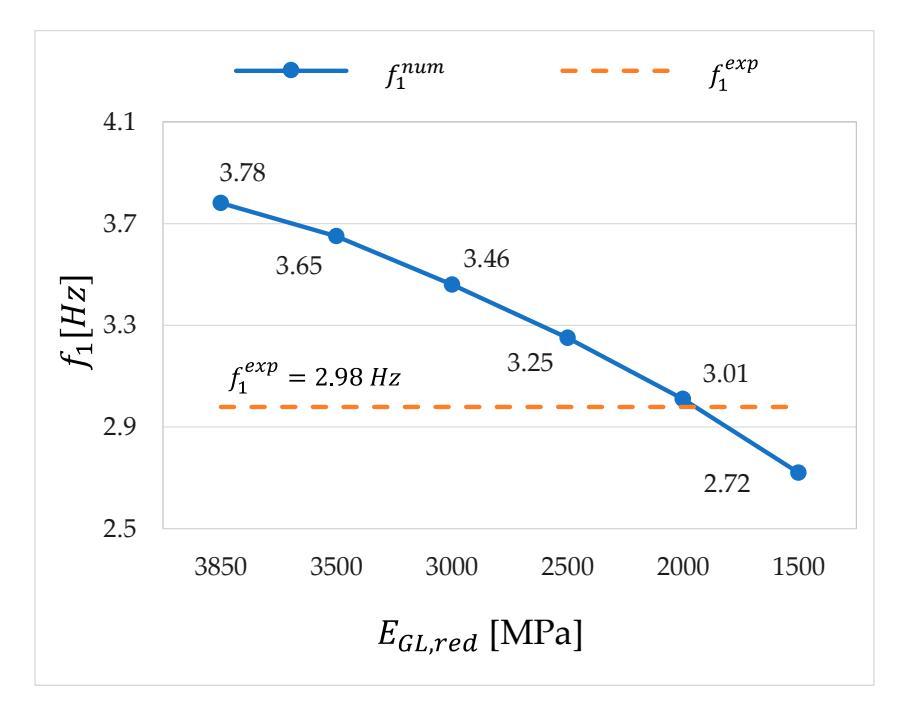
**Figure 14.** Changes of the first natural frequency of the numerical Model 5  $(f_1^{num})$  for different levels of global modulus of elasticity reduction  $(E_{GL,red})$  with the comparison of the experimentally obtained natural frequency  $(f_1^{exp})$ .

The changes in the natural frequency values obtained by numerical modal analysis with respect to the experimental values are visible. The modulus of elasticity around the 2000 MPa gives a very small difference compared to the experimentally obtained results. The next table (Table 8) shows a comparison of the experimentally determined values of the natural frequencies with the frequencies obtained by the numerical modal analysis of Model 5, to which the global modulus of elasticity in the amount of 2000 MPa is assigned.

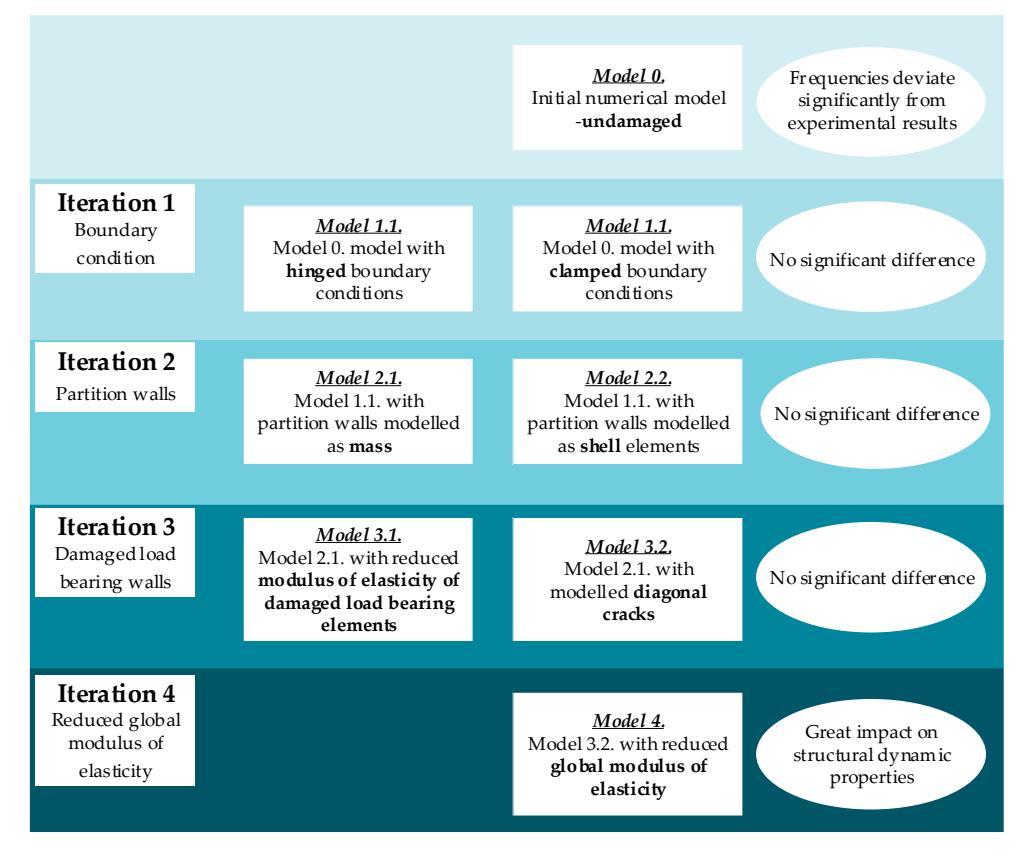
jack method also has a value that is not specific for this type of construction. Considering the overall picture of the determination of the mechanical properties of masonry walls, it is necessary to be extremely careful in the interpretation of the results, and the obtained values should be additionally controlled by numerical analysis (Figure 15).

Figure 15. Flowchart of numerical model iteration.

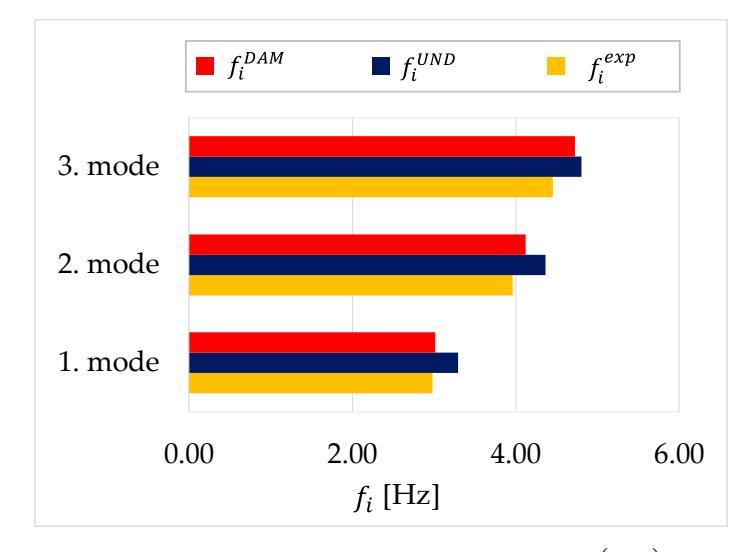
The comparison shows approximately equal results of the undamaged numerical model compared to the experimental results for the first three experimentally determined mode shapes, Figure 16. The difference in the natural frequency of the damaged and undamaged state is 9% for the first, 6% for the second, and 2% for the third mode shape. The ratio between the frequency of the numerical model before the earthquake and the frequency of the final numerical model shows the greatest difference in frequency results for the first mode, so it can be assumed that the greatest damage occurred in the first mode shape.

**Figure 16.** Comparison of experimentally obtained  $(f_i^{exp})$  and natural frequencies of numerical models for damage  $(f_i^{DAM})$  and undamaged state  $(f_i^{DAM})$ .
