Earthquake resilience at district level hospital in bangladesh. tactic of non- structural elements and social awareness

Source / Izvornik: **1st Croatian Conference on Earthquake Engineering 1CroCEE, 2021, 187 - 198**

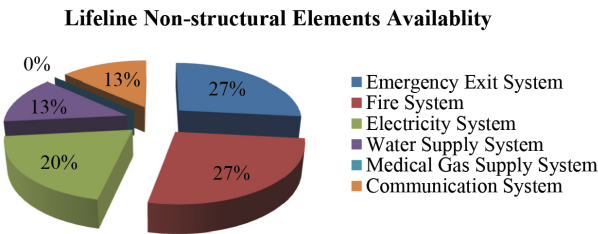
Figure 2. Present Lifeline Non-structural Elements Availability (Source. Field Survey, 2019)

The following figure 2 shows the lifeline non-structural elements available in the Lalmonirhat Sadar Hospital. From the lifeline non-structural elements the emergency exit and fire system contains the more percentage of available system and both of them are 27 %.

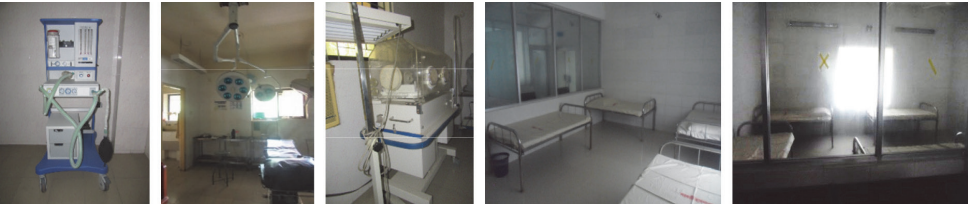
Figure 3. Medical Facilities (Anesthesia, Operating Room and Incubator) and Architectural Elements (Laminated glass panel in pediatric ward), Source. Field Survey, 2019

As the hospital established in 1981 and the building renewed in 2006 the Architectural Elements poses a little risk compared to other system. About 100 sq. feet's of total glass paneled partition found. 60 sq. feet of them are required modification.

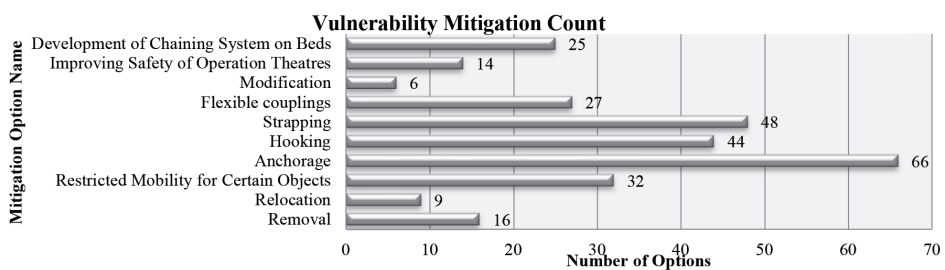
**Figure 4. Vulnerability Mitigation Option Counts (Source. Field Survey, 2019)**

The following figure 4 shows the mitigation options stated in the WHO guideline to increase systems performance and here are the total mitigation option for the hospital nonstructural elements.
