Damage Assessment of Reinforced Concrete Elements Due to Corrosion Effect Using Dynamic Parameters: A Review

Source / Izvornik: **Buildings, 2021, 11(10)**

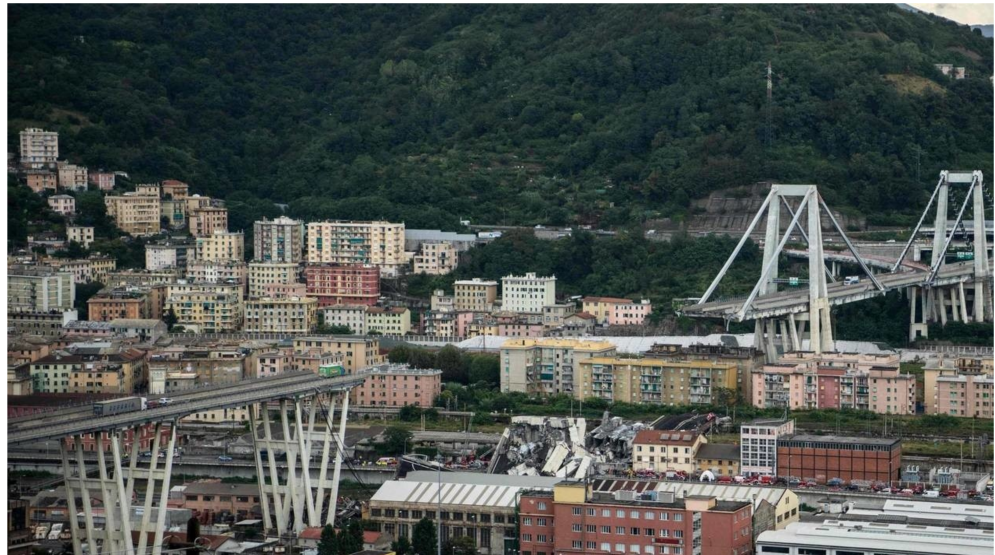
Figure 1. View of the collapsed part of the Polcever viaduct in Genoa, August 2018. (AP Photo, Antonio Calanni, 2018).

One of the last cases of collapse occurred in Italy in August 2018, on the busy A10 traffic route connecting the seaport of Genoa with the rest of Europe (Figure 1).

As a result of the collapse of part of the Polcever viaduct, built in 1967 according to a project by Riccardo Morandi, forty-three people were killed that day. The viaduct is 2.4 km away from the sea, so it was directly exposed to the aggressive action of seawater salt throughout its use. Analysis concluded that the failure of the hanger, made of prestressed concrete, was due to a combination of fatigue of the material and damage caused by corrosion, whose progressiveness was high due to the proximity of the sea and the industrial zone [5]. In order to minimize such catastrophic events in the future, it is necessary to emphasize detailed assessments of the condition of existing bridge structures and apply appropriate modern maintenance measures, or consider the removal of those that are not worth repairing [6].

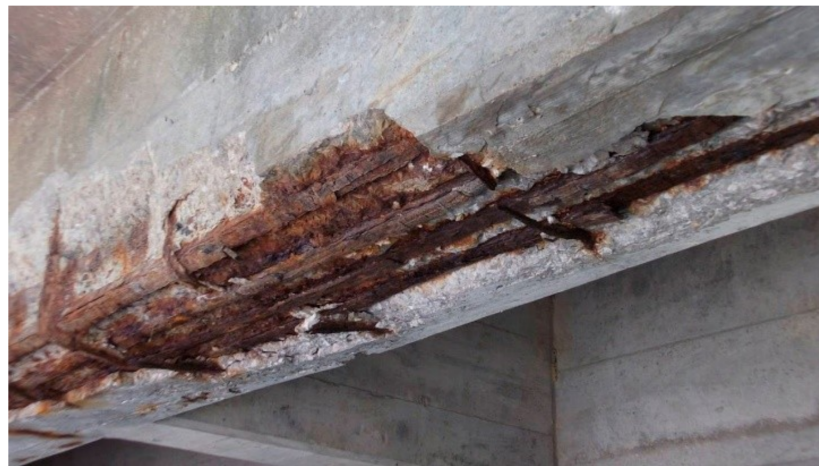
Figure 2. Display of reinforcement corrosion effects in reinforced concrete beam.

The impact of reinforcement corrosion is one of the most significant problems related to the durability of concrete structures [7]. Corrosion of reinforced concrete elements is always a coupling phenomenon between steel cross section reduction and loss of bond strength [8]. Either uniform or local corrosion can have important effects on the mechanical behavior of the steel reinforcement bars [9] and has previously led to a decrease in the strength and stiffness of reinforced concrete structures [10]. The consequent action of corrosion causes initial cracks in the concrete and separation of the protective layer (Figure 2).
