# Mechanical and Fire Performance of Innovative Hollow Glue-Laminated Timber Beams

*Source / Izvornik:* **Polymers, 2022, 14(16)**

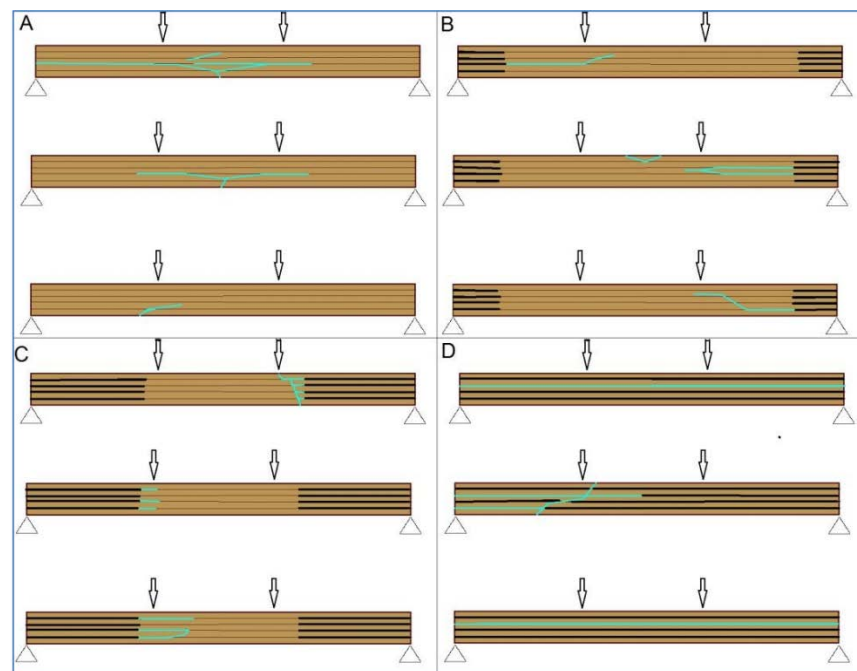
Figure 1 shows possible failures, where the blue lines represent the failure lines, the black lines represent delamination, and the dark brown lines represent the glue lines.

**Figure 1.** Possible failures of GL timber beam in fire event: (A) failure without delamination; (B) delamination occurs at the supports; (C) partially developed delamination (D) delamination occurs along the entire GL timber beam.

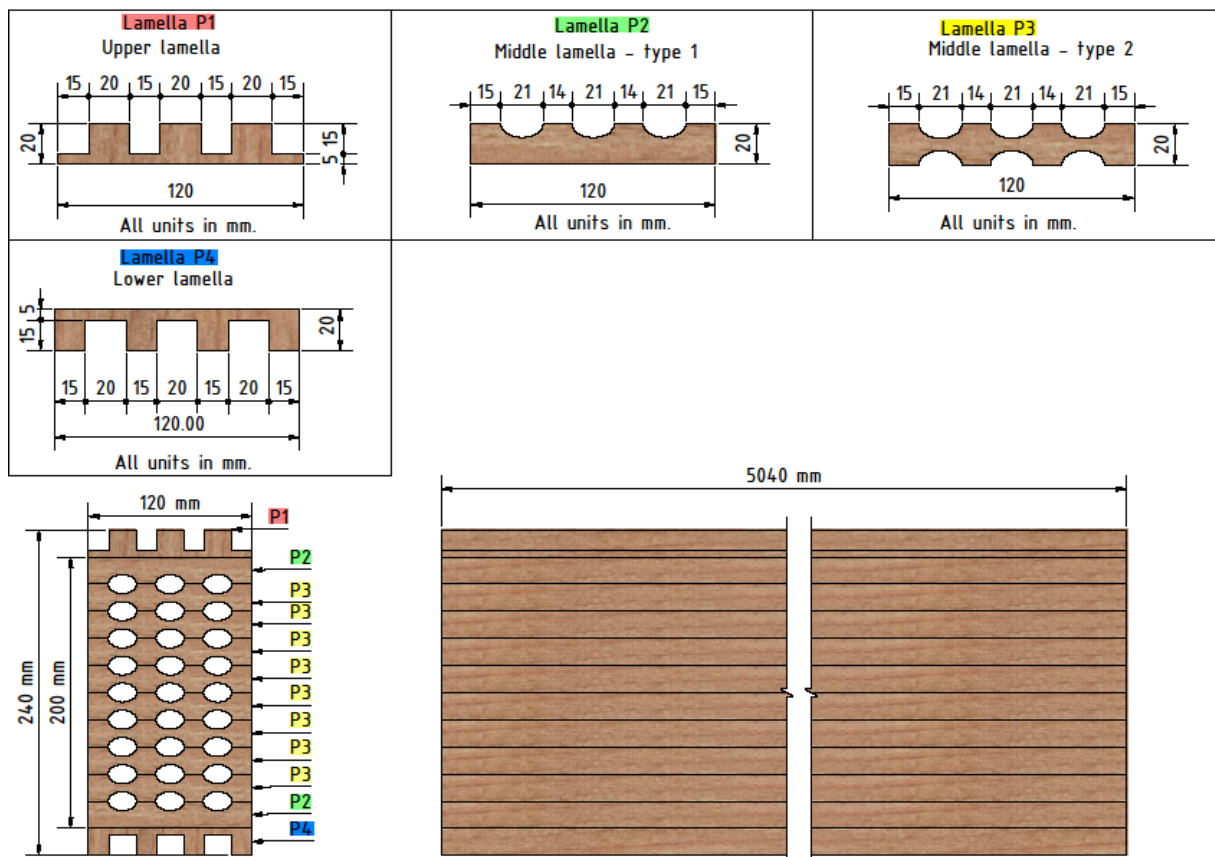
Figure 2. Innovative glue-laminated hollow timber beam.

and finally, the adhesive used in joining the lamellae. Consequently, the conclusion was that samples with elliptical holes have higher and satisfactory load capacity. Furthermore, moisture-curing 1-component polyurethane adhesive PUR Kleiberit 510.0 with reinforced fibers [24] was used for the research, and the edge lamellas were made without holes, to avoid stress concentration in the edge zones. According to DIN EN 14,080 and DIN EN 15,497, this is a one-component certified PUR adhesive for load-carrying wood construction. It is approved according to SANS 10183-2 as a wood adhesive for load-carrying wood components in service class S3 (service class S3), which means that is suitable for long-term outdoor use, even with direct contact with the ground. New, improved timber elements used in this paper can be seen in Figure 2.

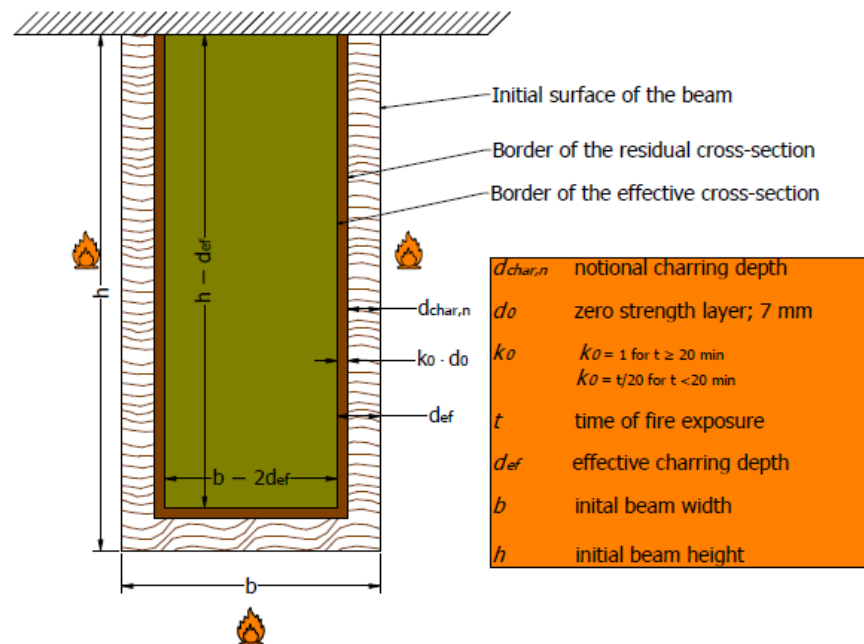
The fire resistance time for a normal GL timber beam can be estimated by defining the ideal residual cross-section (Figure 3) according to EN 1995-1-2 [25], and comparing the actual bending stress, which depends on the residual cross-section values at a given time:

**Figure 3.** Definition of ideal residual cross-section (EN 1995-1-2, 2004 [25]).

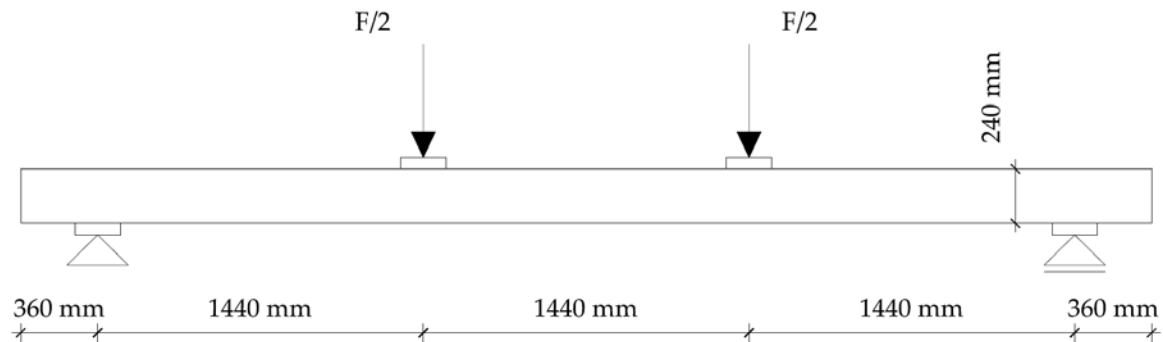
**Figure 4.** Test setup—4-point bending.

To determine the load level for the fire test, four-point bending tests on timber elements were carried out according to EN 408 [27]. The tests were carried out on a simply supported beam with a span of  $18h$ , where  $h$  is the height of the sample. The distance of the load input from the support and the distance between the forces themselves was  $6h$  (Figure 4). To avoid local stresses, additional steel plates were placed at the point of load application. In this way, the correct load distribution on the sample was obtained.

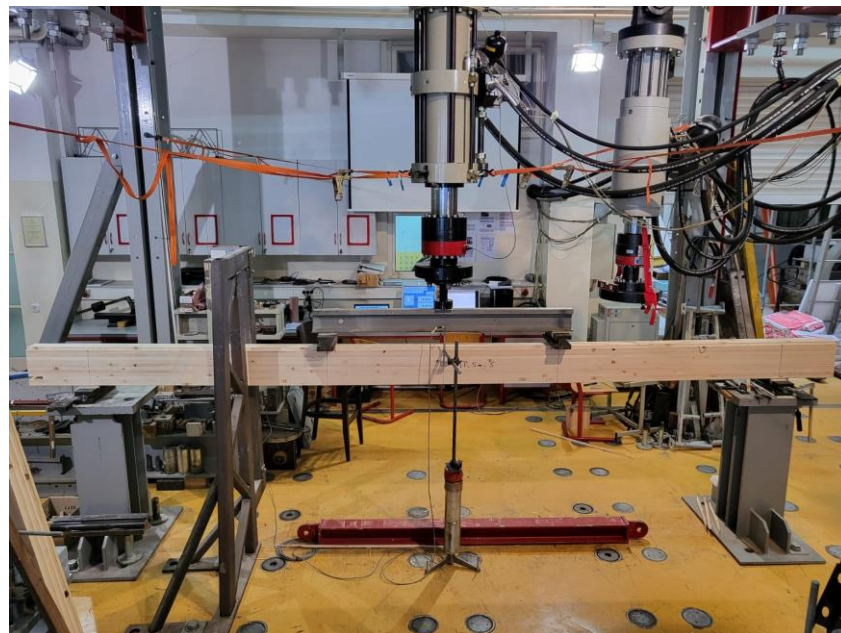
**Figure 5.** Experimental work—4-point bending at ambient temperature.

the fact that the end lamellae were shaped in such a way that there were notches, it was necessary to introduce additional auxiliary elements in the form of caps, over which the load was applied. For this purpose, additional timber elements were made and positioned at the load input area. These additional elements were made of a more solid material to prevent local embossing. The clamps were installed at the support in order to simulate lateral restraints. The experimental work and setup are shown in Figure 5.

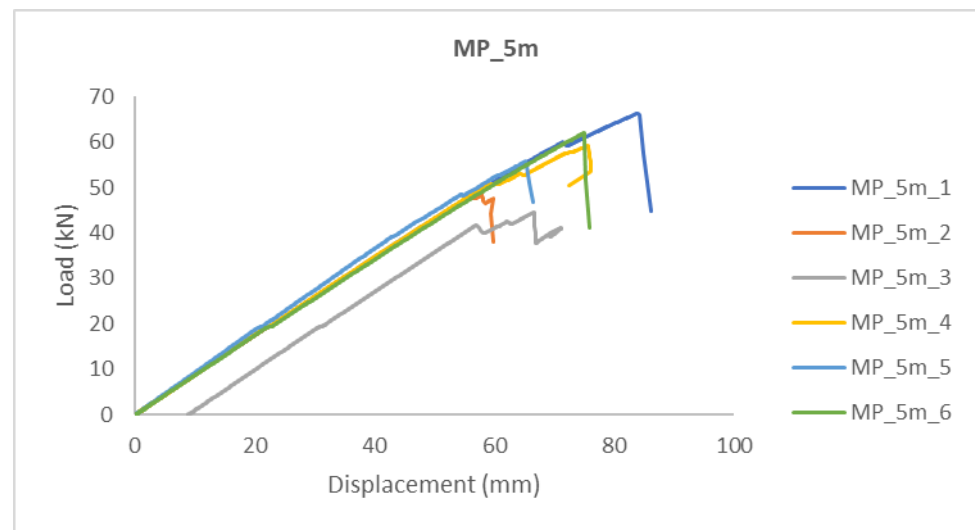
**Figure 6.** Load-displacement—normal (non-perforated) samples.

In the diagrams shown below (Figures 6 and 7), it can be seen that the beams (in the same sample group), up to a certain load level showed similar behavior, i.e., stiffness. For higher load levels, their stiffness was significantly reduced due to local wood imperfections, cracking, and adhesive behavior. The failure occurred after reaching the tensile strength of the timber.

The higher slope of the force-displacement curve for normal MP-n specimens can be seen in Figure 6, which indicates their greater stiffness, which is natural considering the perforation of the ME-n specimens, i.e., the smaller cross-sectional area.

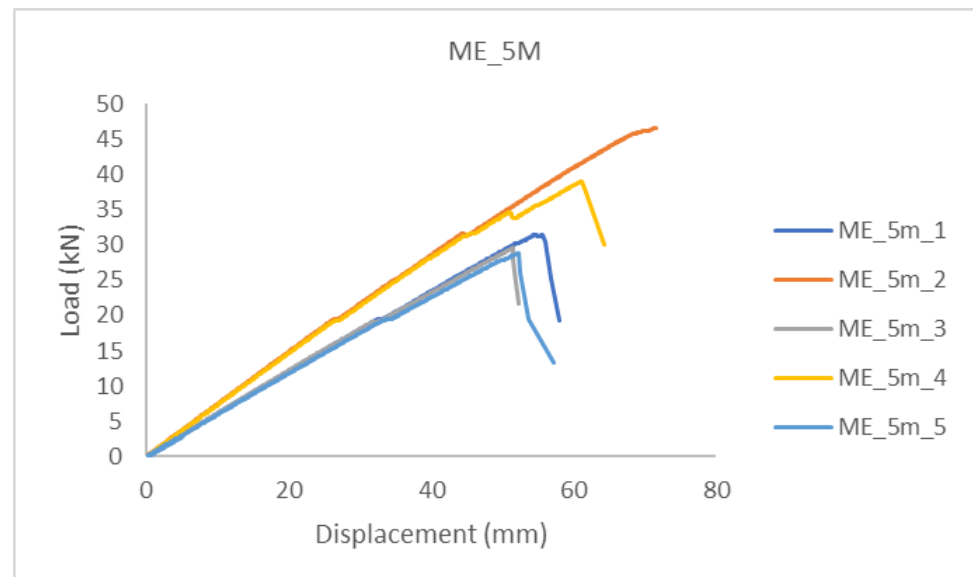
**Figure 7.** Load-displacement—hollow glued laminated samples.

In Figure 7, it can be seen that the failure of samples with the same type of cavities did not occur at the same load value. The cause was mostly natural wood defects, such as knots, shakes, cross-grain, crookedness, rind galls, burrs, and curls.

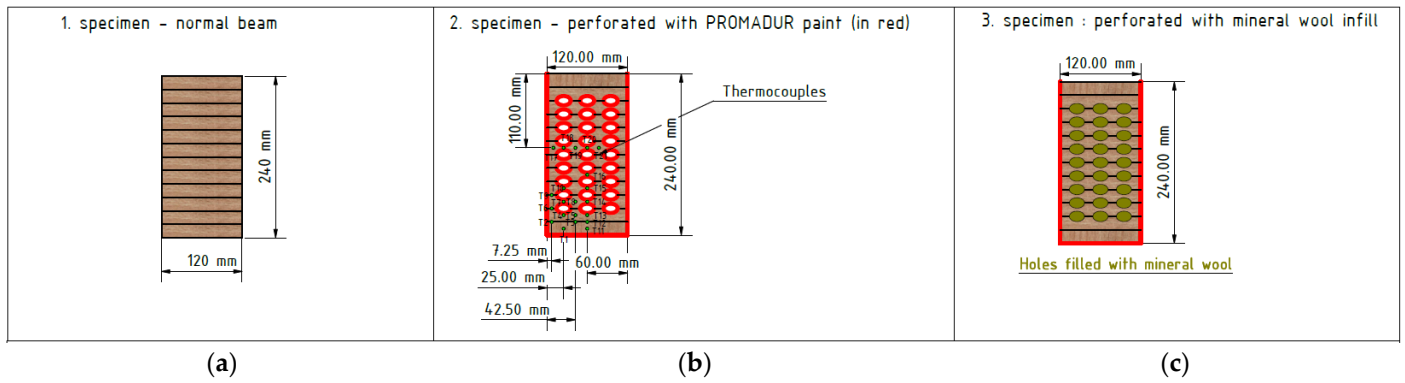
Figure 8. Specimen cross-section: (a) normal beam; (b) hollow with intumescent paint; (c) hollow with mineral wool infill.

The dimensions of the samples were the same as in the mechanical tests, as follows: 120 × 240 × 5040 mm (width × height × length). Moisture was measured in each sample and the average moisture was 10% for all samples. The laminated timber sample consisted of a total of twelve lamellae glued together. The slats were made of soft timber (fir) 20 mm thick and made in such a way that the fibers inside the timber were directed in the direction of the length of the beam (see Figures 8 and 9). The lamellas were glued using Kleiberit 510.0 glue, manufactured by Klebchemie-M.G. Becker GmbH [24]. This is a PUR adhesive for load-bearing wood construction certified in accordance with DIN 1052 [30]. An advantage and difference compared to previous research [23] was that this adhesive has a very high bond strength due to specially reinforced fibers. Three different types of timber beams were tested to compare innovative hollow glue-laminated timber elements with standard and most used timber products. Therefore, the first sample was a standard GL timber beam, and the other two were hollow GL beams with fire protection. In the first hollow beam, the protection was an intumescent paint coating, Promadur [31], along the perimeter of the beam and inside the cavity, while in the second the mineral wool was placed in cavities and intumescent paint was also applied on the outer surface of the sample. In this research, PROMADUR [31] intumescent paint was used. It is a single-pack water-borne, solvent-free transparent intumescent coating for fire protection of timber structures. In the case of fire, PROMADUR expands, creating a protective insulating foam that protects the substrate from contact with air (oxygen), decreasing the combustibility, and slowing down the transfer of energy (heat) from the fire to the timber elements, increasing the fire resistance. The general idea was to use cavities in such a way as to partially stop the penetration of fire and temperature towards the interior of the beam. Figure 8 shows different types of cross-sections of investigated timber beams.

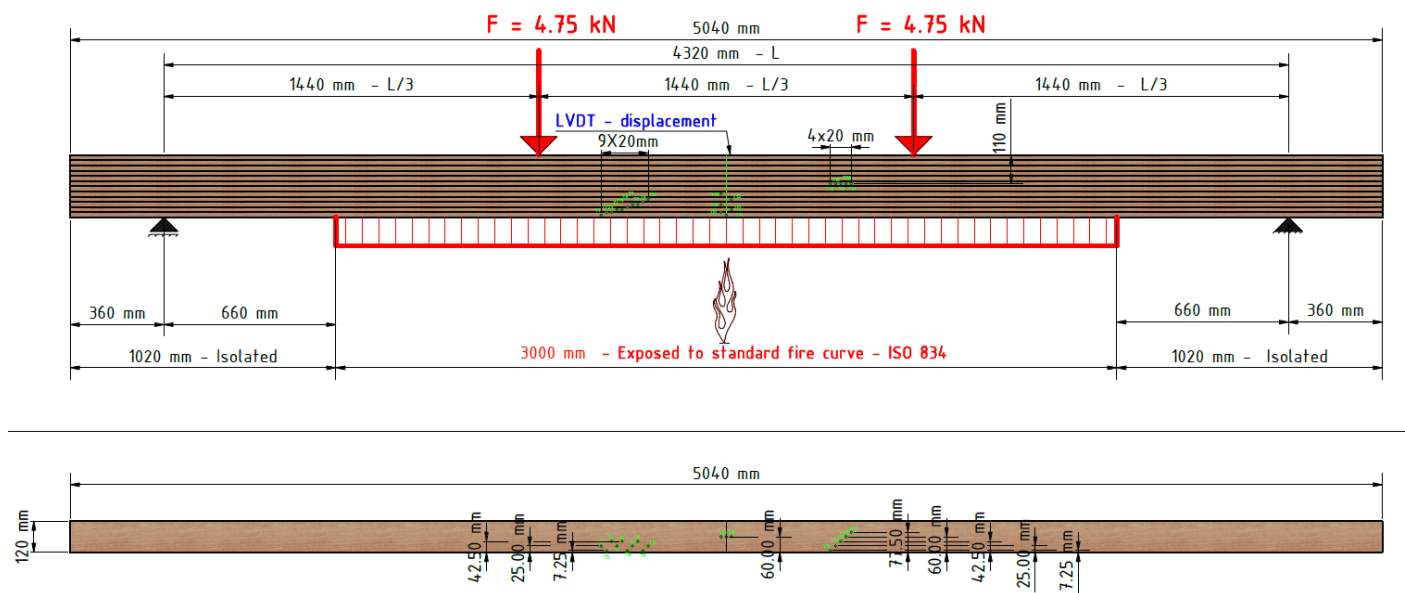
Figure 9. Fire test-experiment setup.

The samples were exposed to fire on three sides (bottom and sides). The load-bearing beam specimen was mounted on a vertical load-bearing structure equipped with a hydraulic system for applying the load. The load-bearing structure was placed on the horizontal test furnace in such a way that only a part of the beam 3000 mm long was exposed to fire. The beam was oriented so that the longer side of the section (240 mm) was placed vertically. The beam supports were located outside the test furnace at a distance of 4320 mm from each other. On one side of the beam, one support was fixed, and on the other side, it was sliding in the longitudinal direction. All the above described can be seen in Figure 9.

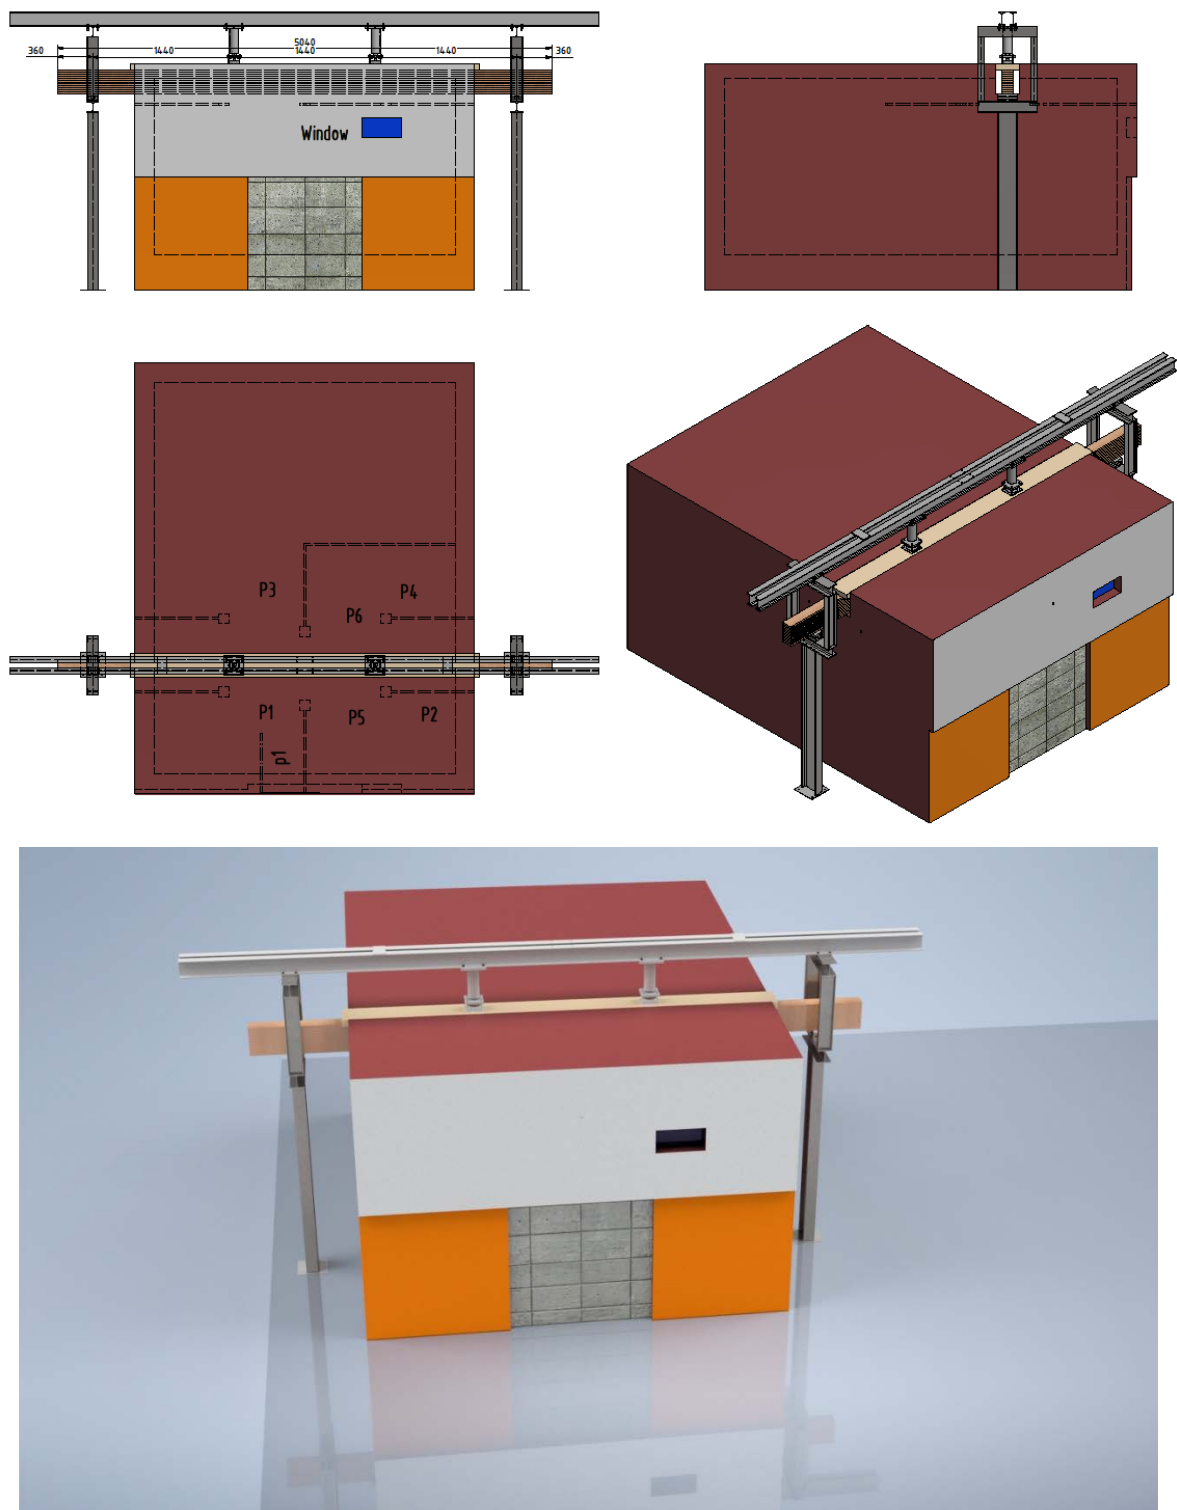
**Figure 10.** Furnace and general fire test scheme.

The construction, composition, and orientation of the sample as well as the type of sample supports on the load-bearing structure, are shown in Figure 10.

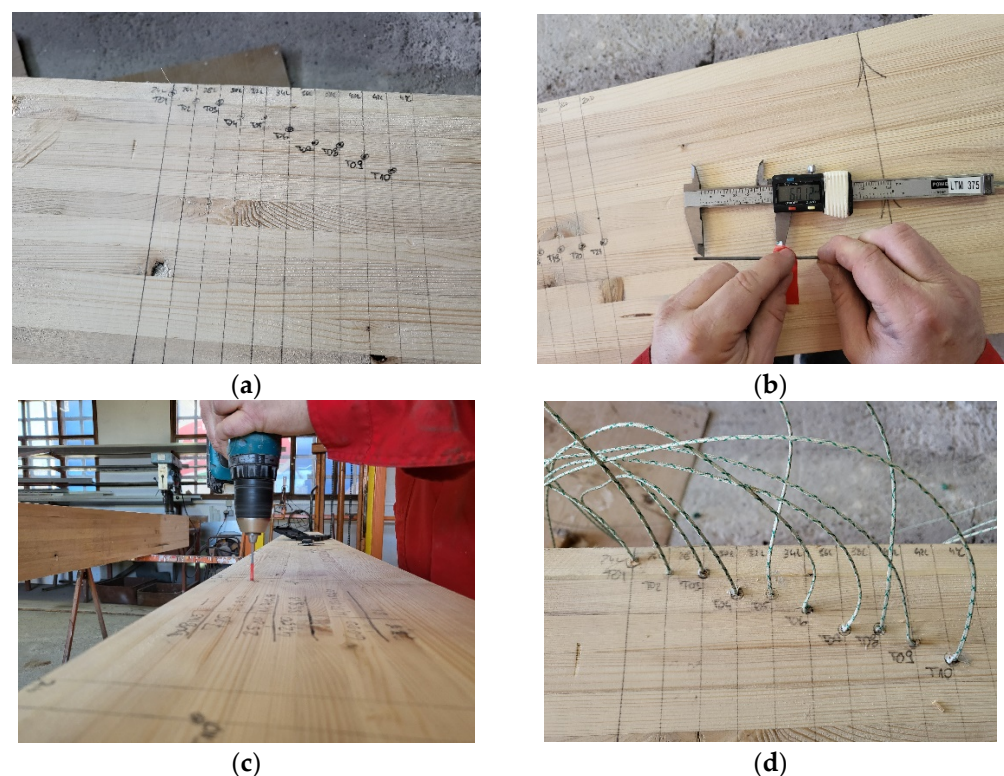
**Figure 11.** Thermocouple installation process: (a) marking the beam; (b) measuring and marking the drill; (c) hole drilling; (d) installation of the thermocouples.

Temperatures through the sample cross-section were measured with 21 NiCr-Ni thermocouples, (type K) wire  $\varnothing$  0.5 mm. The installation process of thermocouples can be seen in Figure 11. After insertion, the thermocouples were additionally fixed with wooden wedges, while the holes were filled with fireproof silicone. In this way, the position and depth of the thermocouples were fully ensured.

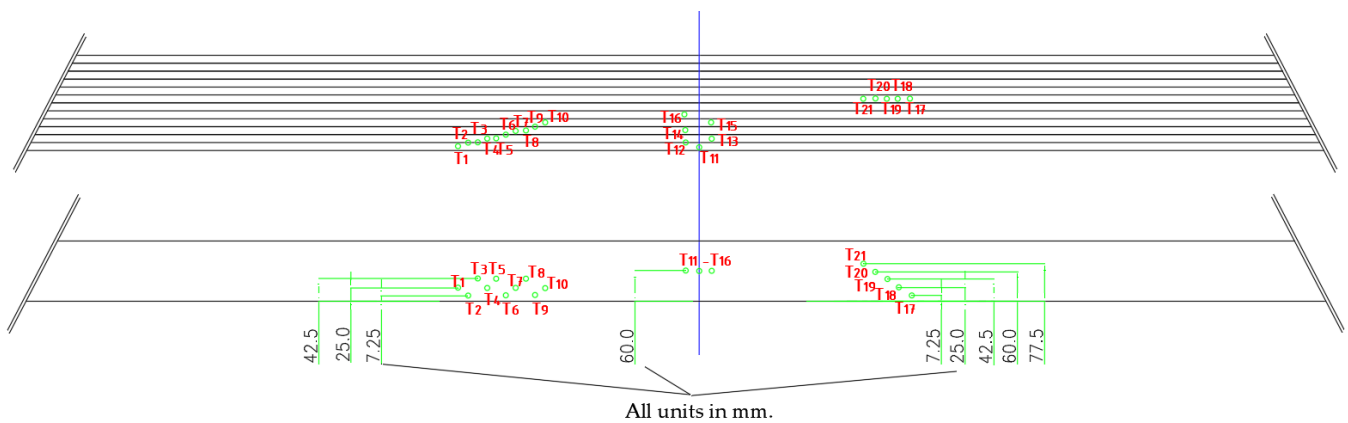
**Figure 12.** Thermocouple layout.

The thermocouple layout is shown in Table 3 and Figure 12, while thermocouple installation depth is shown in Table 4.

The layout of the thermoelements was chosen to cover temperature measurements from all exposed sides. The thermocouples were divided into three groups with seven thermocouples in each series depending on their placement in the beam. The group of thermoelements T11–T16 measured the development of temperature due to the influence of fire exposure from the bottom side, the group T17–T21 measured the temperatures assumed to mainly depend on the fire exposure from the side of the beam, while the group of thermoelements T1–T10 measured the notional charring rate and development of temperature.

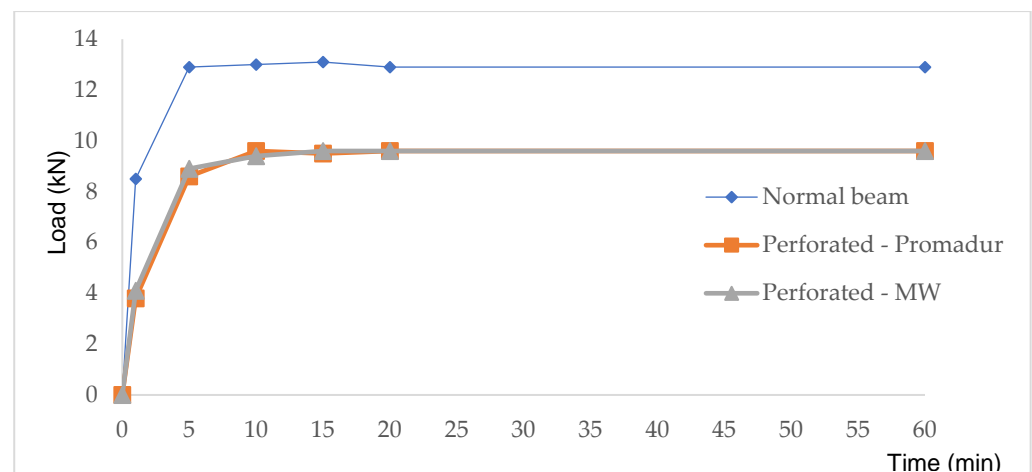
Figure 13. Loading protocol.

The sample was gradually loaded before the test. The required total load was reached 15 min before the start and was maintained throughout the test (see Figure 13).

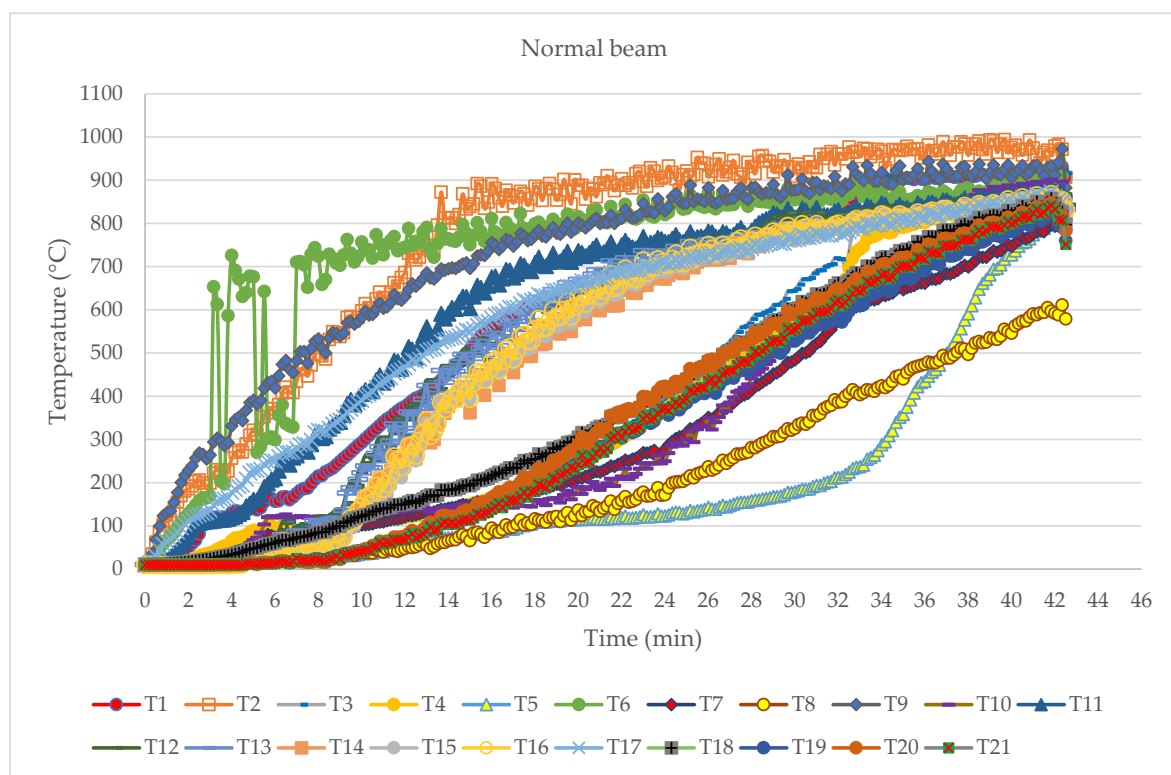
**Figure 14.** Temperature development diagram.

In addition to the observation of physical changes in the samples, the development of temperature towards the interior of the timber beams was monitored. The arrangement and selection of thermocouples made it possible to monitor the development of temperature for all three exposed sides of the samples. The following are the results of testing, i.e., the development of temperature over time (Figure 14).

The development of the temperature inside the sample was visible according to the groups of thermocouples. It could be seen that the group of thermocouples that was installed the deepest had a gentle slope of the curve, which told us about the natural resistance of wood as a material, i.e., the creation of a carbon layer. One important aspect was that all thermocouples in the thermocouple series were exposed to temperatures over 300 °C, which is where the isotherm charring line occurred. When thermocouples were directly exposed to fire they were affected by convection and radiation which can explain the temperature fluctuations in the diagrams (see T6 in Figure 14). From that point on, measurements of those thermocouples could be ignored.

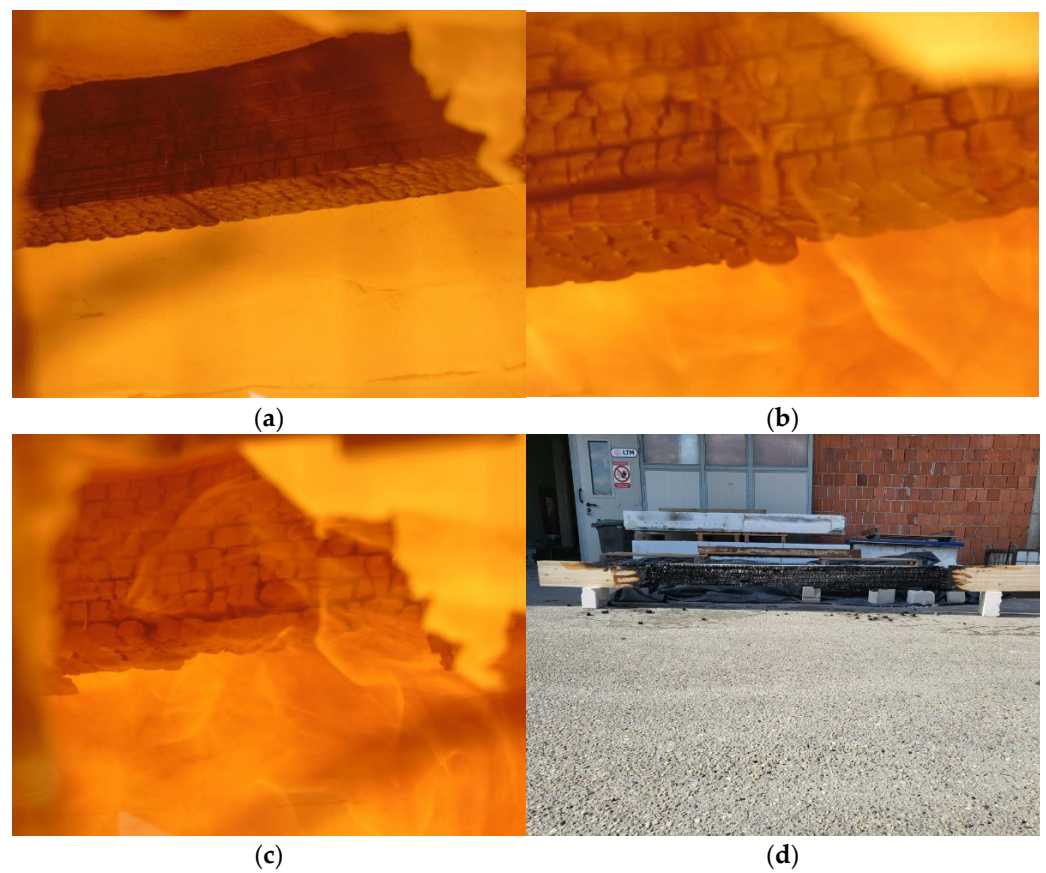
**Figure 15.** Normal beam—phases of the fire test: (a) 5 min; (b) 20 min; (c) 40 min; (d) the end of the test.

Different phases of normal GL timber beam in the fire tests are shown in Figure 15a–c, while burnt beam at the end of the test can be seen in Figure 15d.

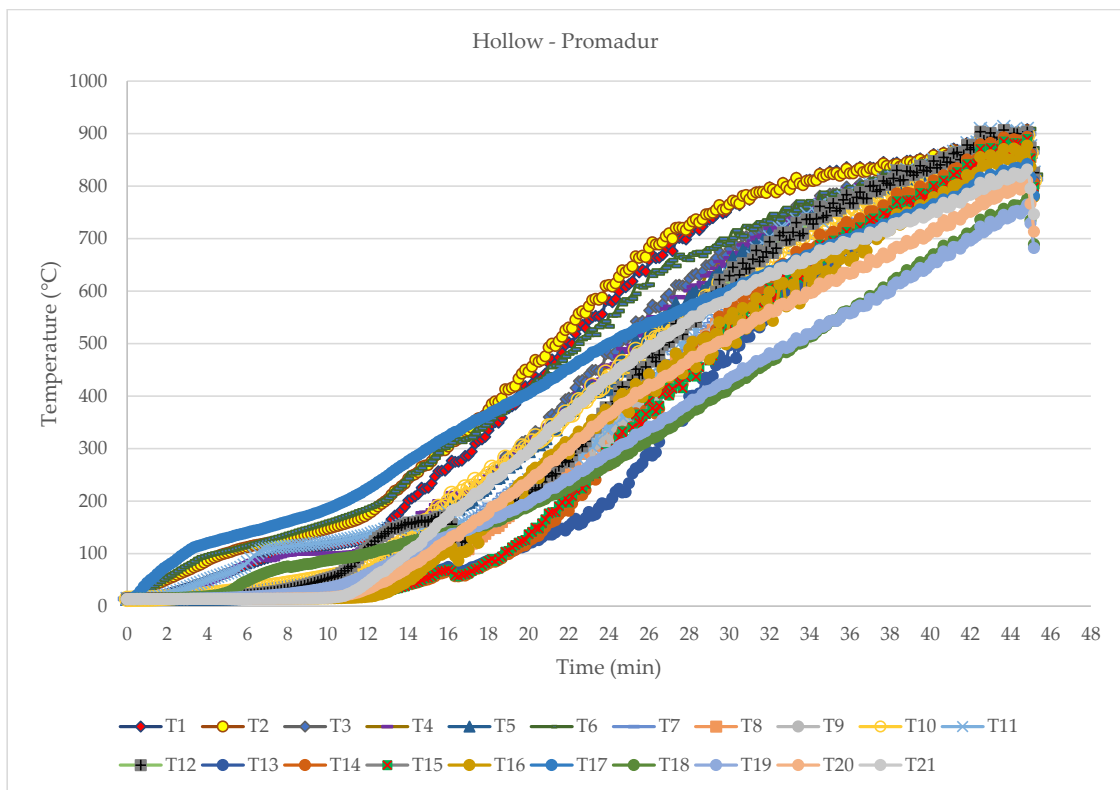
Figure 16. Temperature development diagram—hollow Promadur sample.

The main difference between normal beams and protected hollow beams was the slope of the temperature curves (Figure 16). These show the effect of intumescent paint, which protected samples for a certain time, which of course affected the final time of fire resistance of the samples. The general conclusion corresponds to the initial assumptions about the similar time of fire resistance of tested beams, which means that the fire protection fulfilled its purpose. The main observations during the fire tests can be seen in Table 6.

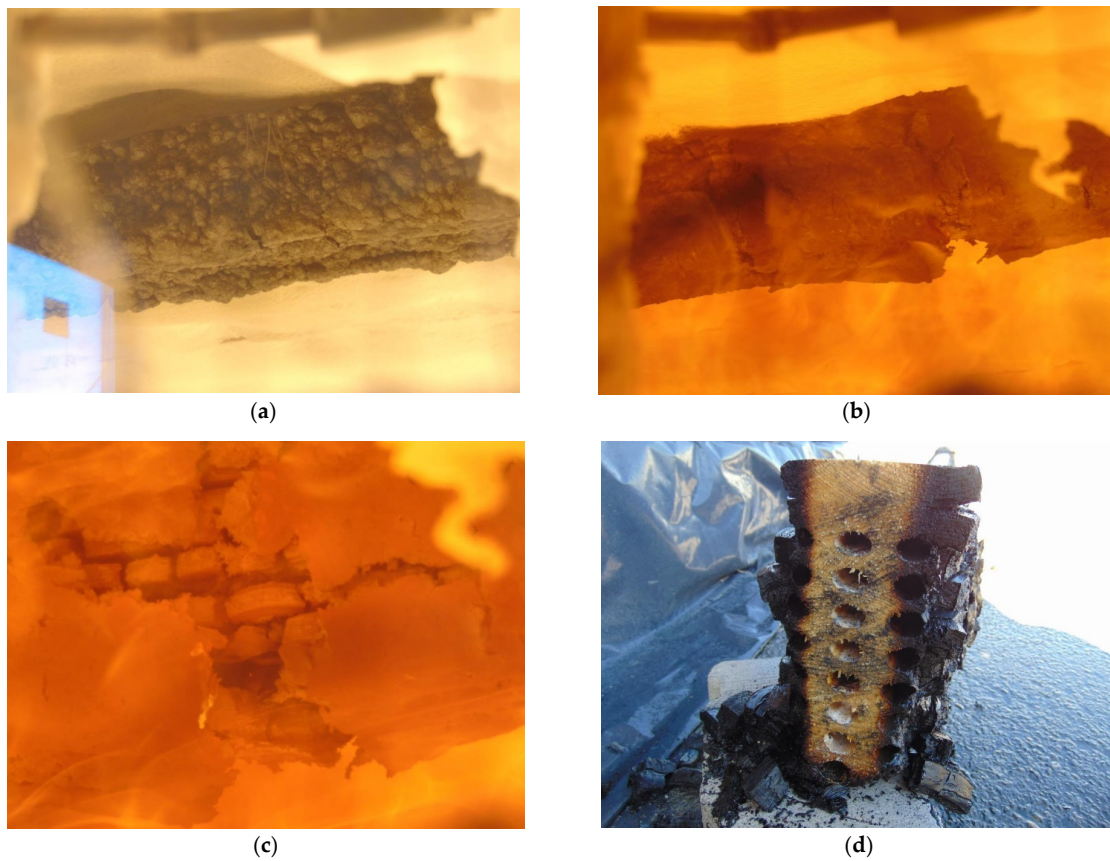
Figure 17. Hollow beam (Promadur)—phases of the fire test: (a) 5 min; (b) 20 min; (c) 41 min; (d) the end of the test.

Different phases of hollow (Promadur) GL timber beam in the fire tests are shown in Figure 17a–c, while burnt beam at the end of the test can be seen in Figure 17d.

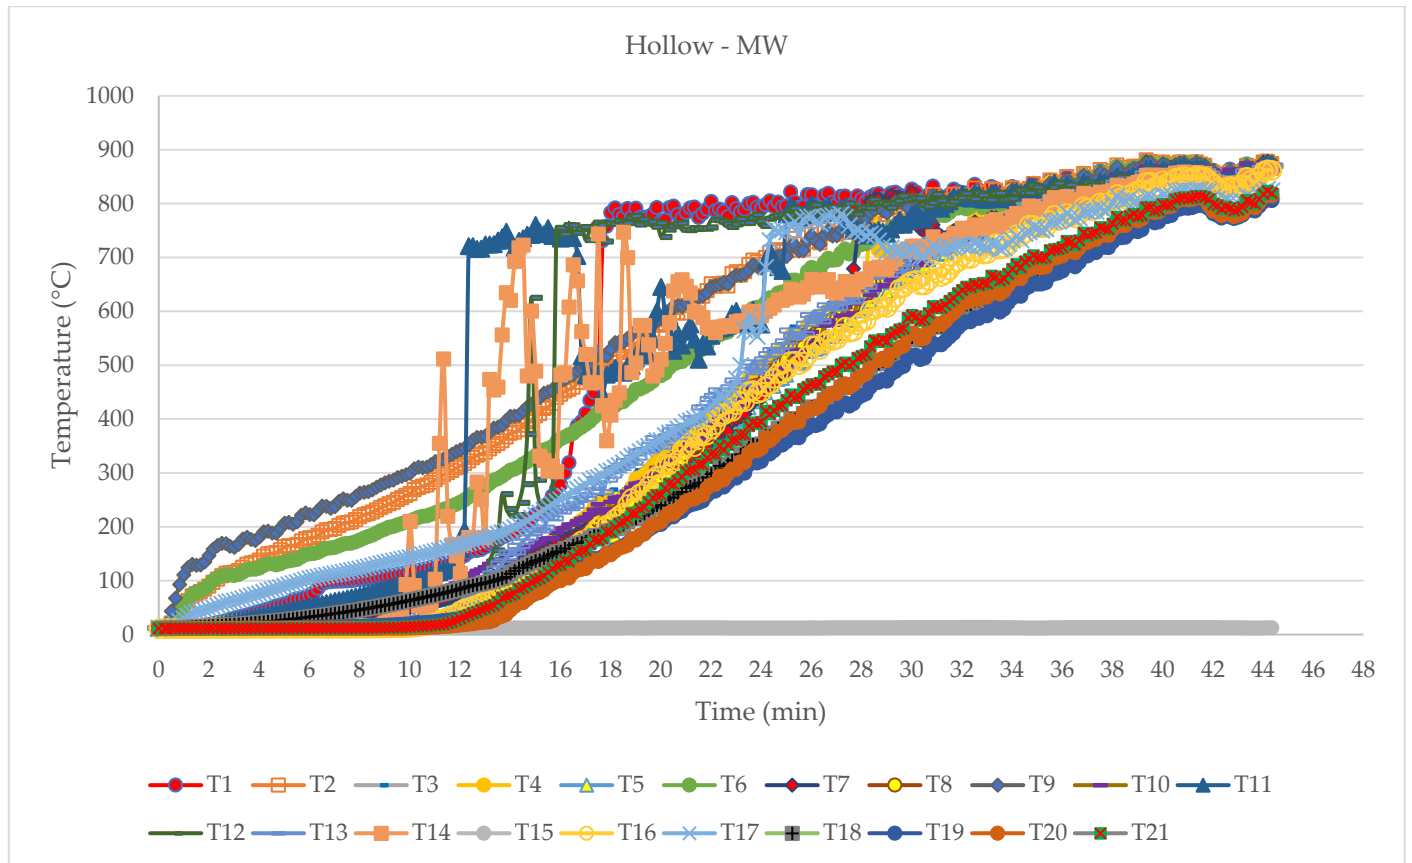
Figure 18. Temperature development diagram—hollow MW.

The sample with mineral wool infill behaved very similarly to the previous sample. The reason for this was that both samples had intumescent paint on the outside surface, and the difference was manifested in the fact that the mineral wool quickly fell off the sample and the fire reached the unexposed part of the timber sooner. This can also be seen in Figure 18, where we see more “lost” thermocouples that have fallen off the sample. The main observations during the fire test can be seen in Table 7.

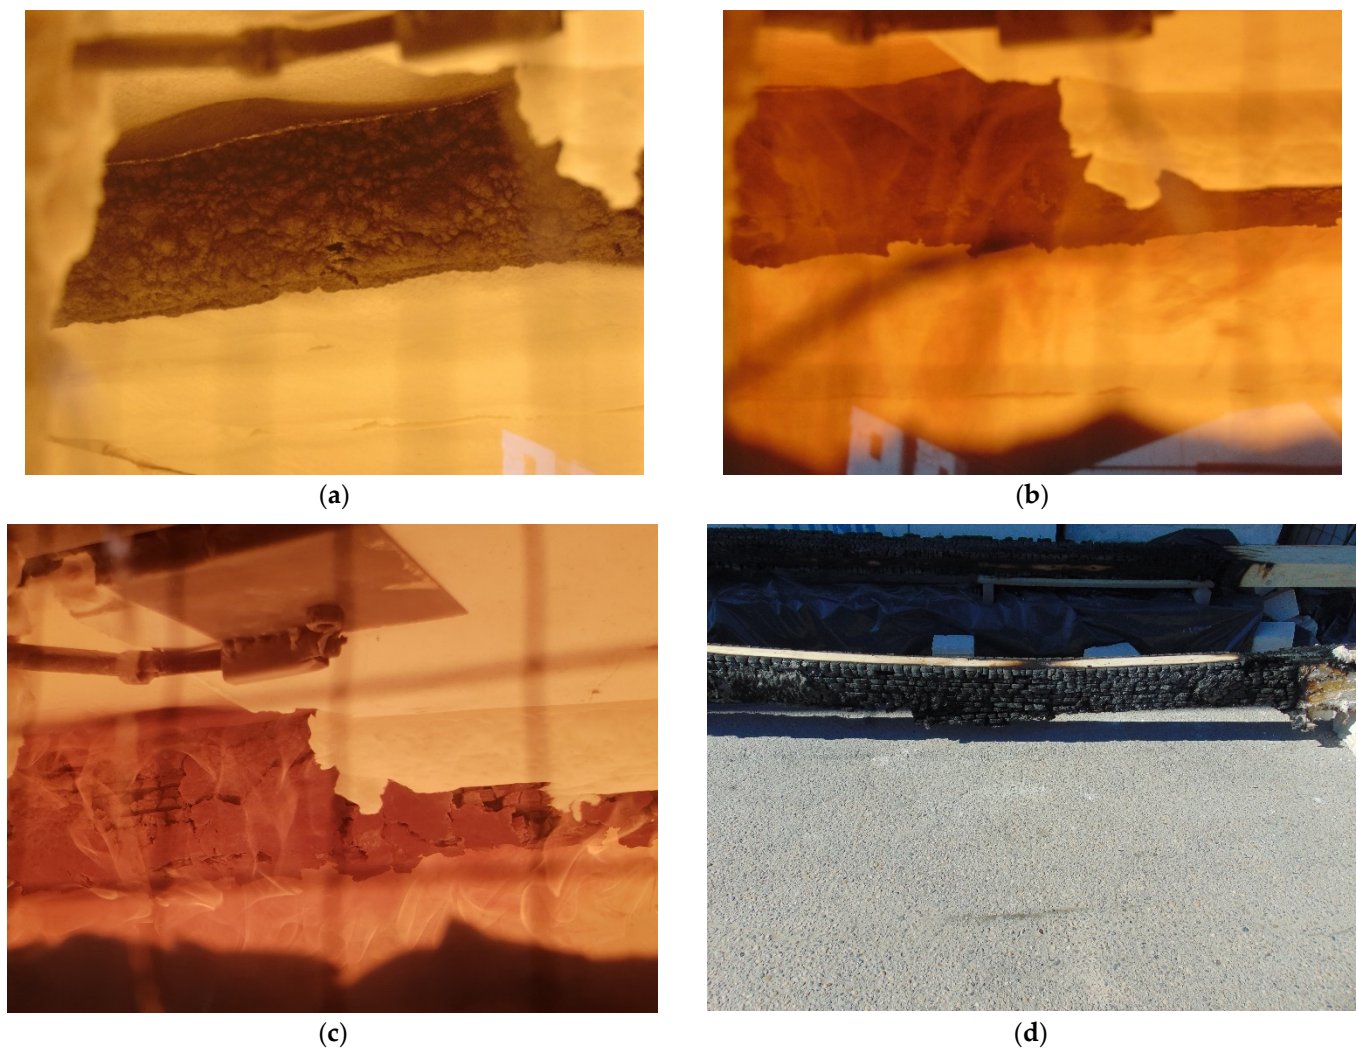
**Figure 19.** Hollow beam (Mineral wool)—phases of the fire test: (a) 5 min; (b) 20 min; (c) 41 min; (d) the end of the test.

Different phases of hollow (with MW) GL timber beam in the fire tests are shown in Figure 19a–c, while burnt beam at the end of the test can be seen in Figure 19d.

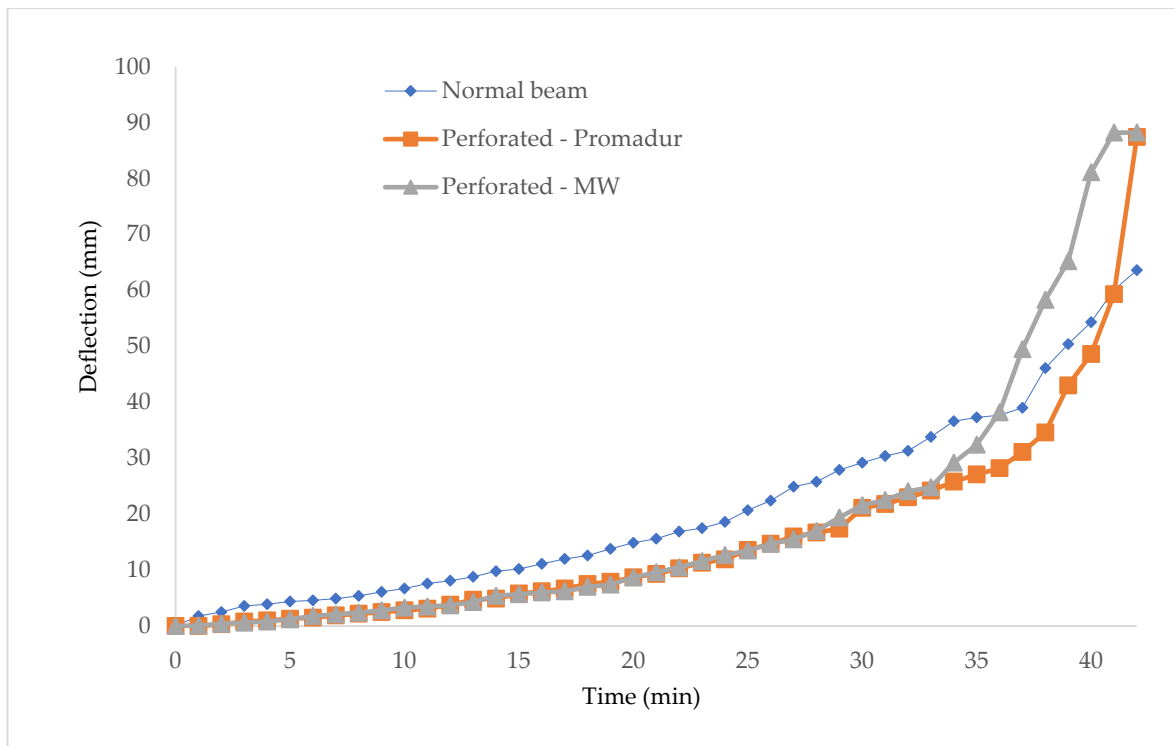
Figure 20. Deflection of the specimens in the midspan.

One of the main parameters for controlling the fire resistance of a beam is deflection. The deflection is conditioned and directly related to the burning of the beam and the development of temperature, as a physical consequence. Namely, during a fire event, a charred layer appears on the timber surfaces exposed to the fire, which protects the interior of the timber from heat development. Char depth is the distance from the outer edge of the element before the fire to the inner edge of healthy, unburnt timber, after the fire load. An increase in temperature leads to a decrease in material and geometric characteristics, which increases deflection. The size of the deflection and the rate of increase of the deflection can be seen below (Table 8, Figures 20 and 21).

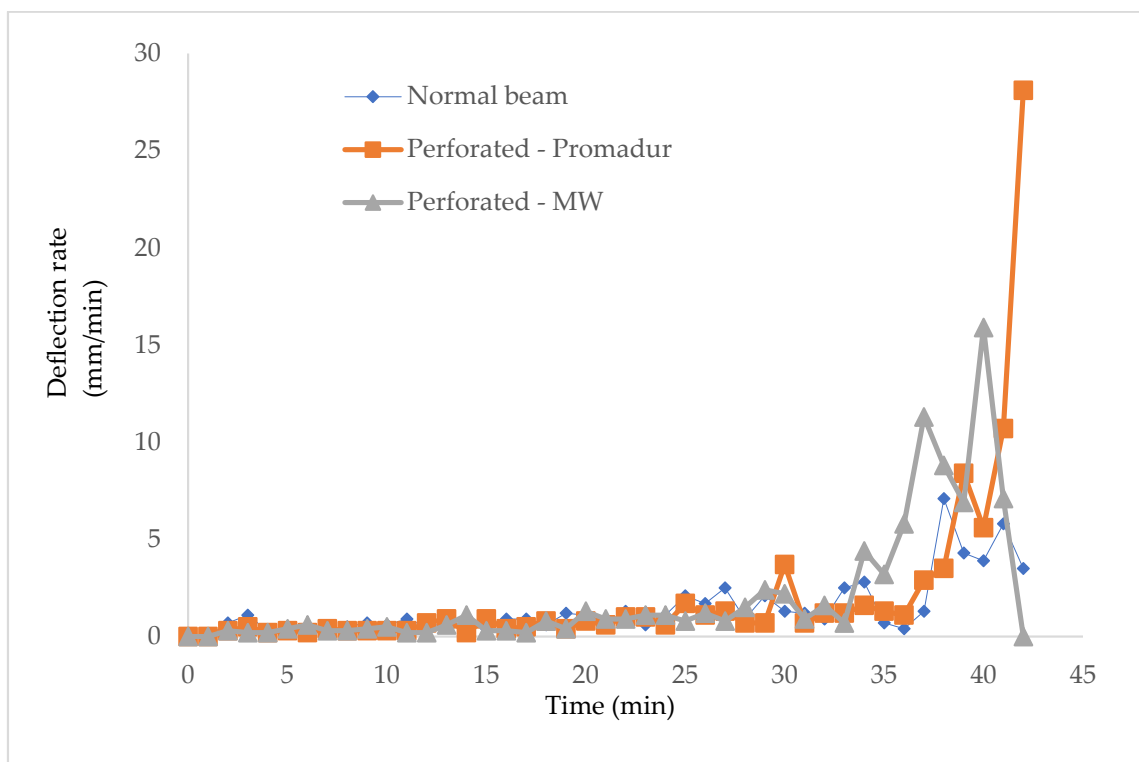
Figure 21. Deflection rate.

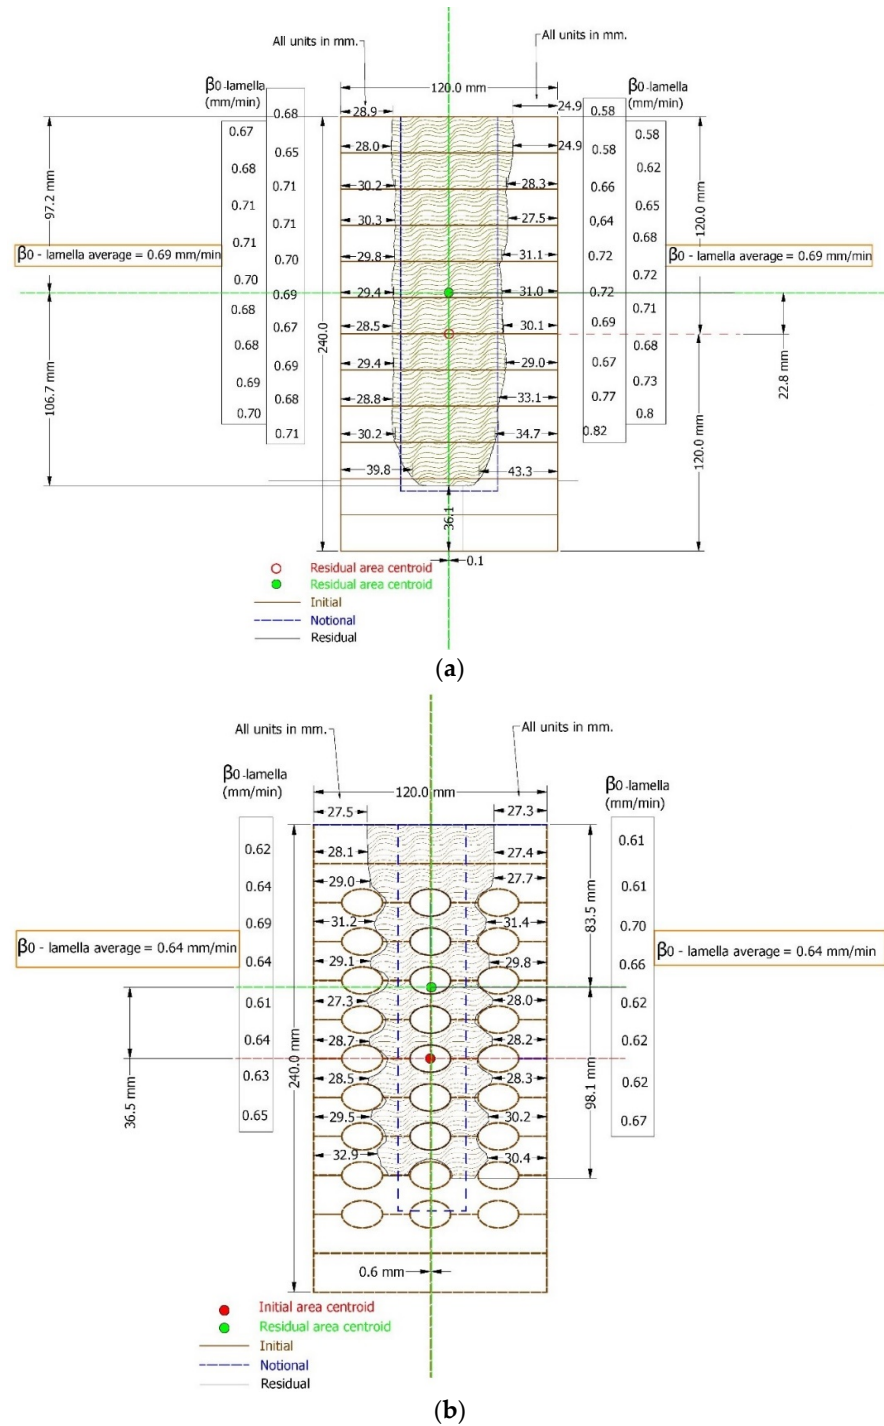
Figure 22. Residual cross-section analyzed with CAD software, dimensions in (mm): (a) normal GL beam; (b) hollow GL beam protected by intumescent paint.

The residual cross-section of the fire-exposed area of each beam was cut with equal spacing of 200 mm. After marking the cut parts, each part was scanned. The scanned files were then processed and imported into the CAD program for further analysis (Figure 22). In this way, the area, the moment of inertia, and the section moment of the residual cross-section were obtained. The last step was to determine the notional charring rate and notional section. Additionally, one-dimensional charring rates were measured for each lamella.

For a normal GL beam, the average one-dimensional charring rate  $\beta_0$  was 0.69 mm/min, while the notional charring rate was 0.78 mm/min. Due to fire protection and intumescent paint, for hollow GL beams the average one-dimensional charring rate  $\beta_0$  was 0.64 mm/min. When calculating the notional charring rate for hollow GL elements, a problem arose due to the existence of holes. When the notional charring rate was being measured, the section moment was considered, which was significantly lower for hollow GL beams (due to the presence of holes) compared to normal beams. Consequently, the notional charring rate would be quite a bit higher (0.95 mm/min). Therefore, the rule suggested by EN 1995-1-2 was used, which suggests that the ratio of one-dimensional charring rate to notional charring rate is 1.08, which results in 0.75 mm/min for a notional charring rate. Following Section 2.1 and Figure 3, the ideal residual cross-section is given by a blue dashed line in Figure 22.
