# Mechanical and Fire Performance of Innovative Hollow Glue-Laminated Timber Beams

*Source / Izvornik:* **Polymers, 2022, 14(16)**

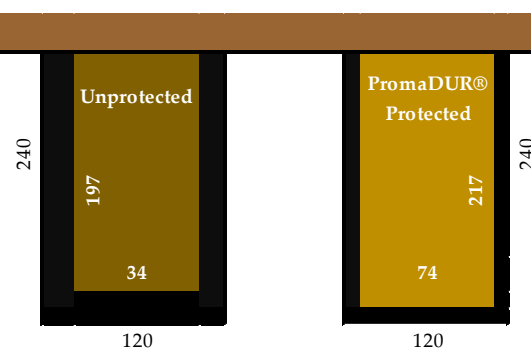
**Figure 23.** Comparison of the residual cross-section of unprotected and protected beams with Promadur after 45 min of fire exposure.

initially protected from fire exposure. The Eurocode 5 procedure divides the rated time periods into different intervals, with different charring rates, depending on the behavior of the protective material. As for the intumescent paint, PROMADUR coating was used. Fire rating of protected timber elements must be calculated based on the depth of char obtained from the value of  $t_f \rightarrow t_{ch}$  (start of charring) and  $k_\beta$  (charring rate), from fire tests EN 13381-7 [37], as required by the Eurocode EC 1995-1-2 [25]. Considering the amount of coating applied ( $1120 \text{ kg/m}^2$ ), the start of charring  $t_{ch} = 17 \text{ min}$  was calculated, which was confirmed by the experiment. Furthermore, when the dimensions of the normal beam with and without PROMADUR were calculated and compared (Figure 23), the residual cross-section dimensions of the sample after exposure to fire for 45 min were 197/34 mm for the unprotected beam, and 217/74 for the protected beam.
