# Non-Destructive Corrosion Inspection of Reinforced Concrete Using Ground-Penetrating Radar: A Review

Source / Izvornik: **Materials**, 2021, 14, 1 - 20

**Keywords:** ground-penetrating radar (GPR); non-destructive techniques (NDT); corrosion of reinforcement

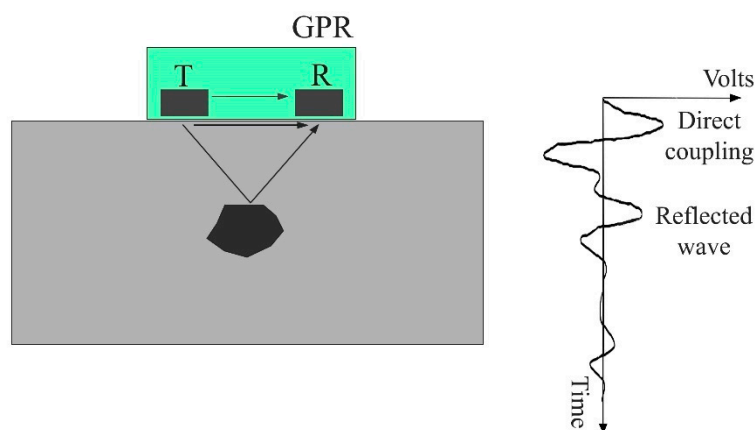
others is concrete [26]. The emitted electromagnetic wave propagates through the host material, as far as it encounters an interface between different materials, whereupon it is reflected back. The predominant types of GPR antennas used for civil engineering investigations are air-coupled and ground-coupled. The second type implies contact of the antenna with the ground and has a better penetration depth. The reflected wave is recorded with the receiving antenna and the recording is called an A-scan (Figure 2, right). When a wave is transmitted, the receiver first records a direct wave propagating through the air from the transmitter to the receiver. Then, a portion of the electromagnetic wave is reflected off the surface of the material. In a ground-coupled system, these two components superimpose to form the wave, called direct coupling, Figure 2. The rest of the wave energy passes through the material until it reaches the material with different dielectric properties. The electromagnetic wave is then reflected, and the receiver records it as a reflected wave. Therefore, the attributes of the A-scan that provide information about the target are the amplitude of the reflected wave and the travel time from the transmitter to the receiver. In addition, the most common representation of the results obtained with GPR is a B-scan, the two-dimensional slice that represents the area under investigation along the line.

**Figure 2.** Recorded signals for ground-coupled antenna.

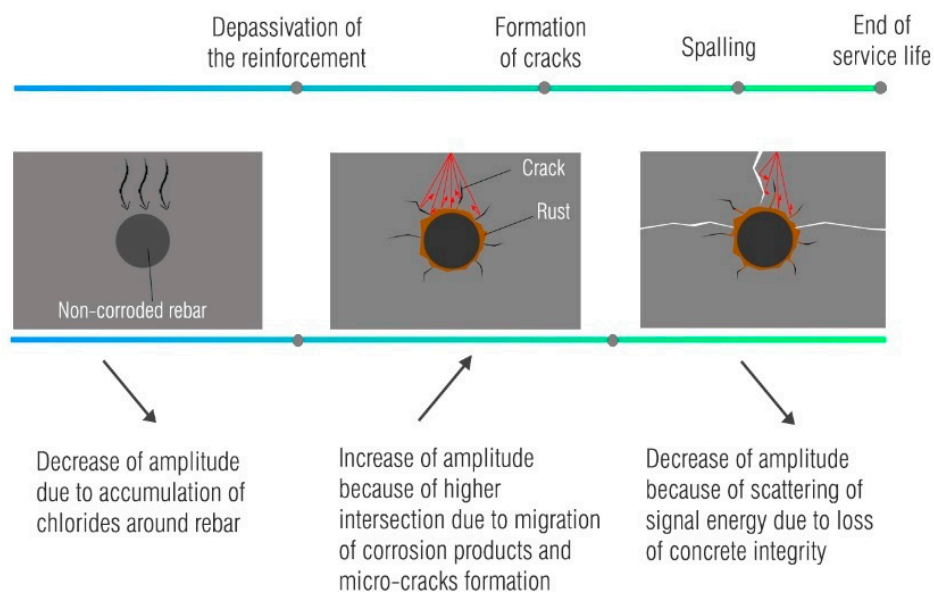
The corrosion process can be divided into the initiation and propagation phases, with each phase having specific effects on concrete microstructures. From the long-term corrosion monitoring experiments, the influence of corrosion promotion on GPR attributes was summarized, as in Figure 3.

**Figure 3.** Changes in the GPR signal during corrosion process.

The effects shown in Figure 3 are determined by the accelerated corrosion processes, in particular the formation of corrosion products on the surface of the reinforcing bar, their diffusion into the concrete cover and thus, crack propagation. These effects modify the amplitude in terms of different reflection coefficient and different dielectric properties of the concrete cover. The ability of corrosion products to migrate depends on the moisture content in the concrete cover since their movement is favored in the presence of moisture [59]. Similarly, the ability of their migration depends on the duration of the acceleration process. When accelerated corrosion with high current density is established in a short timeframe, it leads to increased crack width due to the sudden accumulation of corrosion products and increased pressure around the reinforcement [50,60]. Therefore, an appropriate current density should be selected to ensure the best possible simulation of natural conditions still within a reasonable timeframe [50,61].

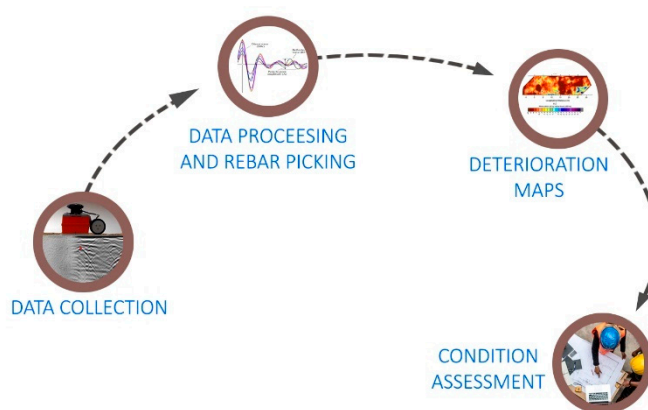
Numerical analysis is generally used to obtain the deterioration map, which in most cases is the spatial distribution of normalized amplitudes. The main steps of the numerical approach in the condition assessment of concrete bridge decks are shown in Figure 4. The ability of the numerical approach to provide autonomous assessment of concrete structures using GPR is one of the reasons for its predominant use, while the algorithms for automatic reinforcement selection can be found in References [79,80].

**Figure 4.** Numerical approach in condition assessment of concrete bridge decks.

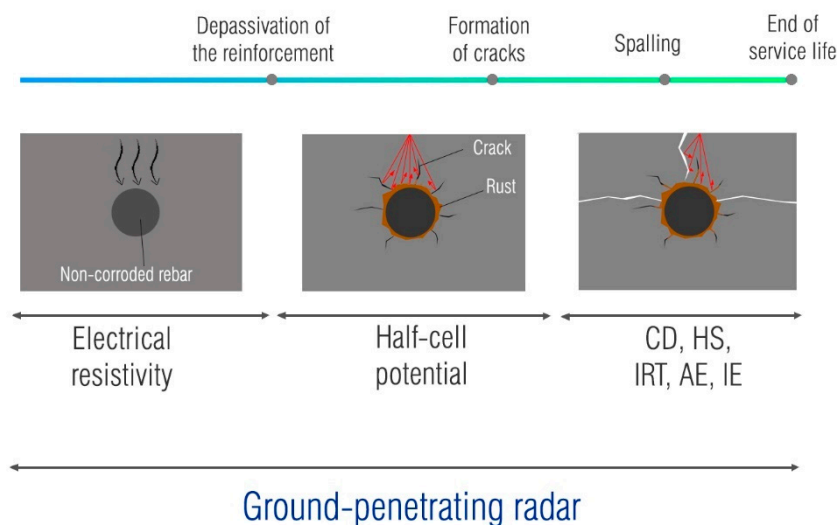
The previous section has shown that corrosion assessment in on-site corrosion testing is mostly based on the assessment of the attenuated areas identified by signal amplitude analysis. Most of the studies are carried out on the bridge decks. In terms of comparison with other NDT, GPR has been compared with various techniques used for the service life condition assessment of the structures, Figure 5.

**Figure 5.** Multiple NDT used for the condition assessment.
