Influence of train type and rail surface roughness on railway traffic noise

Lakušić, Stjepan; Bogut, Marijan; Haladin, Ivo

Source / Izvornik: **Mehanika. Transport. Komunikacii, 2011, 3**

Journal article, Published version

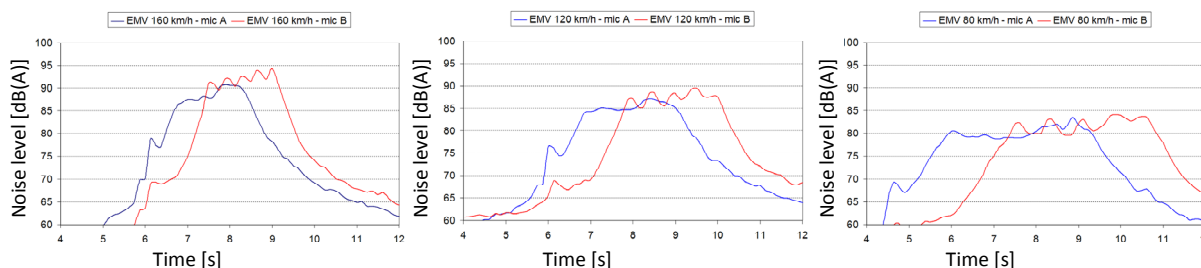
In all five measurements, microphone B measured higher A-valued equivalent continuous noise levels $L_{pAeq, Tp} @ 7,5 m$, that microphone A, dependent on the train operating speed. Highest measured difference is 3 dB (A) at 160 km/h. At 120 km/h for a passenger train and 120 and 80 km/h for the EMV the difference is 2 dB(A). Measured difference for the freight train at the speed of 80 km/h is 1 dB(A). The figures 14, 15 and 16 clearly show the mentioned difference in noise levels as well as the distinct peaks in noise measurements on microphone B due to each axel run over the irregularities.

Figure 14 Comparison of noise at stands A and B at different speed of passing EMV (160, 120 and 80 km/h)

According to the measurement results at microphones on stands A and B, elevation 1,2 m in Table II, the influence of rail roughness on overall passing train noise can be estimated. Namely, microphone on the stand B has been installed next to the insulated rail joint that directly affects the elevated noise levels of a passing train, Figure 7. On described position the recorded irregularities of the rail surface reach up to 0,5 mm in the vertical plain. Measured noise levels hence cannot be used for typical noise measurements, but give an interesting result for determining the influence of irregularities on elevated rolling noise levels.
