Mechanical and Fire Performance of Innovative Hollow Glue-Laminated Timber Beams

Source / Izvornik: **Polymers, 2022, 14(16)**

Journal article, Published version

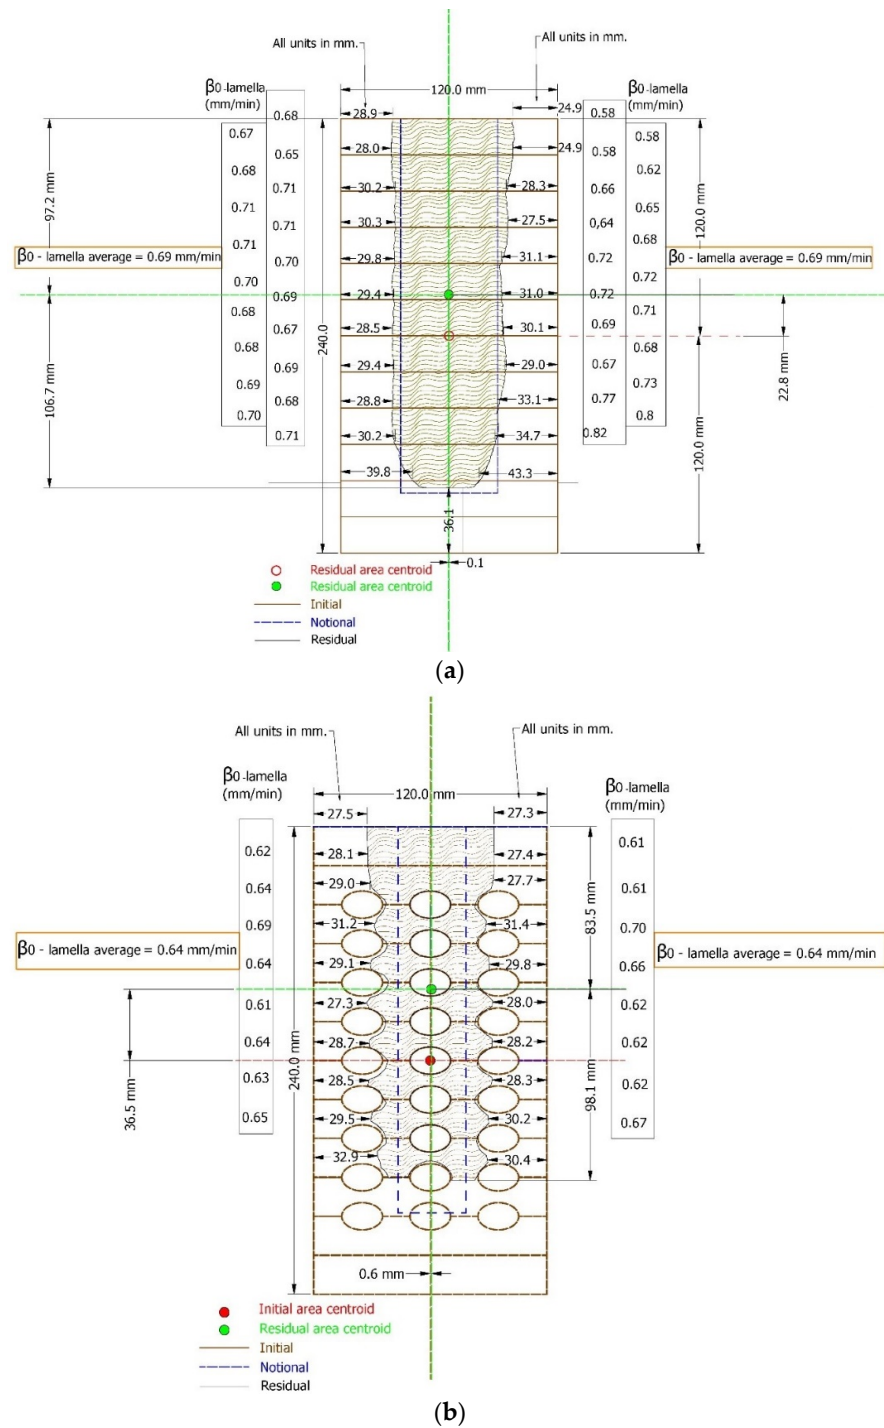
Figure 22. Residual cross-section analyzed with CAD software, dimensions in (mm): (a) normal GL beam; (b) hollow GL beam protected by intumescent paint.

The residual cross-section of the fire-exposed area of each beam was cut with equal spacing of 200 mm. After marking the cut parts, each part was scanned. The scanned files were then processed and imported into the CAD program for further analysis (Figure 22). In this way, the area, the moment of inertia, and the section moment of the residual cross-section were obtained. The last step was to determine the notional charring rate and notional section. Additionally, one-dimensional charring rates were measured for each lamella.

For a normal GL beam, the average one-dimensional charring rate β_0 was 0.69 mm/min, while the notional charring rate was 0.78 mm/min. Due to fire protection and intumescent paint, for hollow GL beams the average one-dimensional charring rate β_0 was 0.64 mm/min. When calculating the notional charring rate for hollow GL elements, a problem arose due to the existence of holes. When the notional charring rate was being measured, the section moment was considered, which was significantly lower for hollow GL beams (due to the presence of holes) compared to normal beams. Consequently, the notional charring rate would be quite a bit higher (0.95 mm/min). Therefore, the rule suggested by EN 1995-1-2 was used, which suggests that the ratio of one-dimensional charring rate to notional charring rate is 1.08, which results in 0.75 mm/min for a notional charring rate. Following Section 2.1 and Figure 3, the ideal residual cross-section is given by a blue dashed line in Figure 22.
