Assessment of Existing Masonry Resistance Using Partial Factors Approaches and Field Measurements

Source / Izvornik: **Buildings**, 2023, 13, 1 - 16

Keywords: masonry; existing structures; earthquake; assessment; DVM; APFM

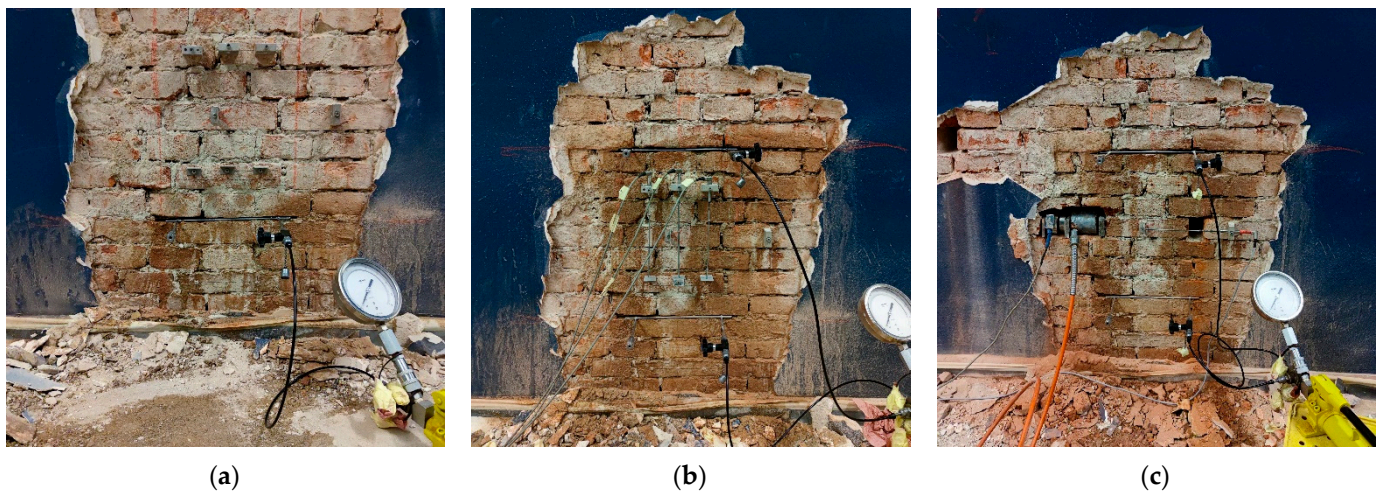
Figure 3. Flat-jack test setup for determining (a) vertical stress state, (b) modulus of elasticity and (c) shear strength.

Given that the mechanical properties of existing masonry structures can vary greatly, it is very useful to determine the actual values of these properties through in situ testing [52]. As part of the investigative work, flat-jack tests were performed on three original load-bearing walls from the same construction period that have a similar thickness. The locations of the tests are marked with red triangles in Figure 2b. All phases of the test itself are shown in Figure 3.

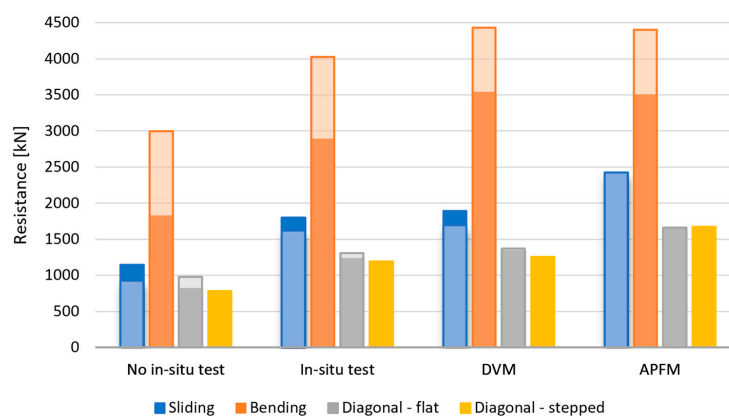
Figure 6. Results for URM wall resistance according to the current EN 1998-3 and the new proposal for EN 1998-3.

For a more complete understanding, Figure 6 graphically represents the obtained results. It shows a clear trend for all failure modes, with resistance increasing as a function

of the complexity of the method used. The colors of the columns represent the failure modes, while the intensity of these colors represents the version of the standard used. A lighter color is used for the current EN 1998-3, while a darker color is used for the new proposal of EN 1998-3. The yellow indicates an additional failure mode, diagonal stepped failure, that is not in the current standards. It is similar to diagonal flat failure and produces similar results, but diagonal stepped failure is slightly more dominant. Diagonal straight cracks characterize diagonal flat failure, which is typical for irregular masonry. It can also occur in regular masonry if the masonry units have low strength compared to the mortar strength. Diagonal stepped failure is characterized by a diagonal stepped crack propagating through the mortar joints and is more typical of regular masonry. Diagonal flat failure is predominant in all cases considered for the current EN 1998-3, except for the case where there are no in situ tests. This can be explained by the fact that the initially assumed values differ from the measured ones. However, diagonal stepped failure predominates in three of four cases for the new EN 1998-3 proposal. For this reason, the incorporation of the diagonal stepped failure mode in the new version of the Eurocode standard is certainly positive. Also, the observed change in the dominant failure mode by phases emphasizes the importance of checking all four failure modes in order not to overestimate the resistance.

The differences in the results (difference between max and min value divided by the minimum value) for the existing EN 1998-3 amount to 161% for the sliding failure, 48% for the bending failure and 70% for the diagonal flat failure. On the other hand, the differences in the results for the new proposal of EN 1998-3 are 112% for the sliding failure, 95% for the bending failure, 105% for the diagonal flat failure and 114% for diagonal stepped failure.
